REPUBLIC AVIATION CORPORATION  
FARMINGDALE, LONG ISLAND, NEW YORK  
SERVICE DEPARTMENT

December 5, 1946

DISTRIBUTORS BULLETIN No.18

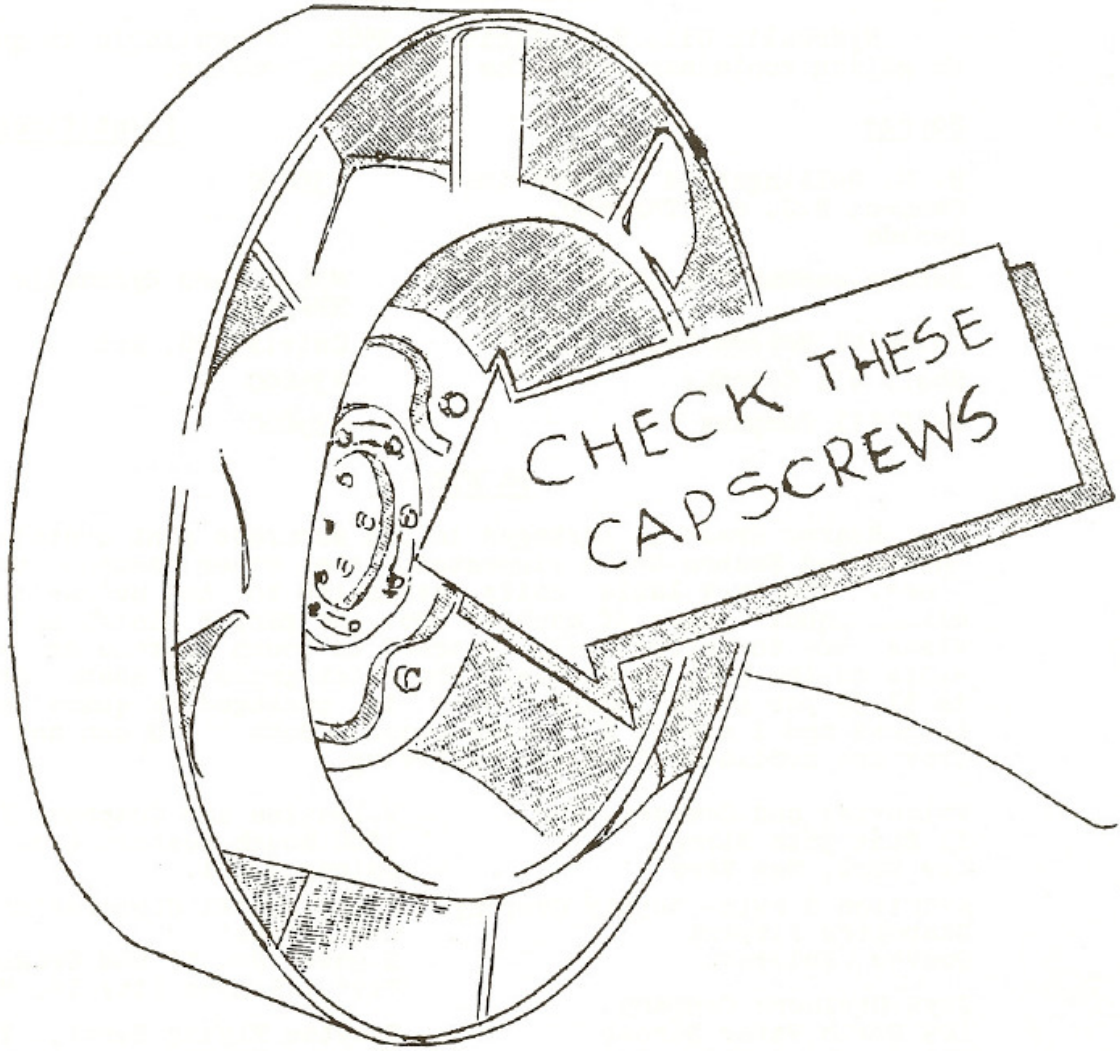
CHECK FAN ASSEMBLY CAPSCREWS FOR TIGHTNESS

Due to recent cases of loosening of the fan assembly capscrews, the following check is recommended for all Seabees. Remove the grill from the front of the engine cowl and carefully inspect the eight (8) capscrews comprising the intermediate bolt circle. (See illustration on reverse side.) Check for broken lock tabs or tabs which do not firmly grip the screw heads. Of the four tabs at each screw head, two should be in firm engagement and two should be flat. If there is any indication of looseness in any screw, bend the two holding tabs away from the screw head, tighten the screw to a torque of 15 to 20 foot-pounds, and anchor the screw-head by bending up the two unused tabs. Under no circumstances should tabs be rebent because of the possibility of cracking.
