MAJOR REPAIR AND ALTERATION (Airframe, Powerplant, Propeller, or Appliance)

1. Aircraft	Make Republic	Model RC-3
	Serial No. 1000	Nationality and Registration Mark N5166B
2. Owner	Name (As shown on registration certificate) Davey Darrell L Davey Deborah A	Address (As shown on registration certificate) 6613 Santa Rosa Rd Camarillo Ca 93012-5672

Republic RC-3
 N5166B ser# 1000
 Avionics Block Diagram

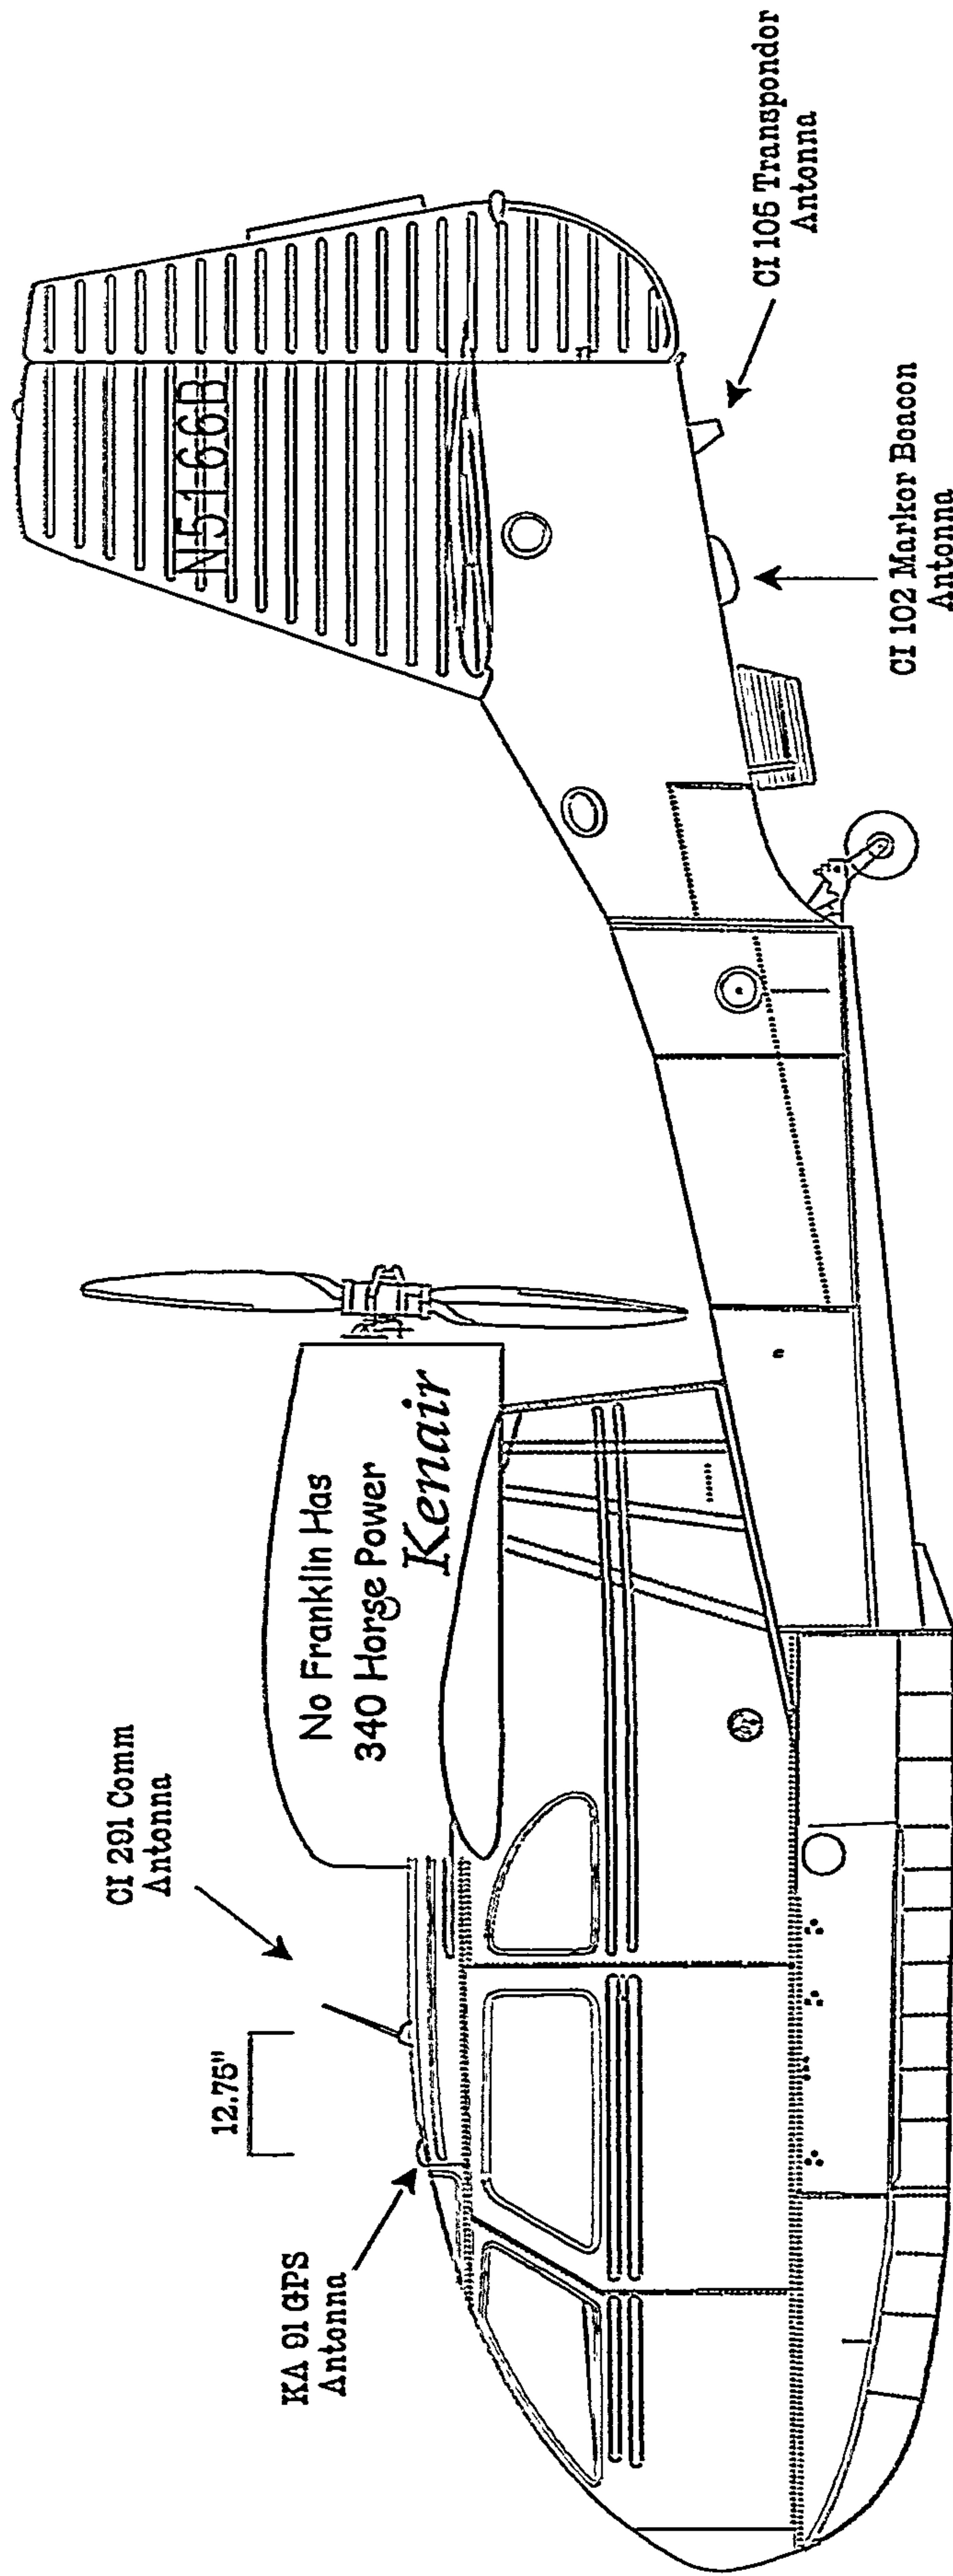
Avionics Antenna Location

2. Description: Installed Bendix/King KLX-135 communications transceiver/G.P.S. receiver TSO C37d, C38d, in radio rack. King KA 91 G.P.S. antenna installed on center forward top of cabin. Comm antenna is mounted on center aft top of cabin and is shared with #1 comm through a Comant CI 601 TSO c37b, c38b duplexer switching unit installed behind instrument panel on rear radio support bracket. Both antennas are sealed with PRC 1422-B2 polysulfide compound and are mounted with doublers fabricated from .050 2024 T3 and attached to top of fuselage with AN426-4 rivets similar to AC 43.13 2A Fig. 3.6. KX 135 fused with a 10 amp fuse and duplexer fused with a 1 amp fuse both located in fuse panel. Reference attached sheets. GPS inspected in accordance with AC 20-138 and no interference noted with VHF transmitter or any other aircraft system. All work done in accordance with Bendix/King installation manual# 006-10500-0001, rev. 1, dated June, 1994 and Comant installation instructions, AC 43.13 1A, Ch. 11, section 2, para. 424, 429, section 3, para. 442, 443, 445 thru 451, fig. 11.7a, section 7, para. 514 thru 520, AC 43.13 2A, ch.1, para. 1 thru 12, ch.2, para. 21 thru 28, ch.3, para. 36, 38, 39, 44, fig. 3.23 and fig. 3.24. Installed placard "GPS approved for VFR navigation only" on instrument panel near receiver in full view of the pilot.
