MAJOR REPAIR AND ALTERATION (Airframe, Powerplant, Propeller, or Appliance)

1. Aircraft	Make Republic	Model RC-3
	Serial No. 1000	Nationality and Registration Mark N5166B
2. Owner	Name (As shown on registration certificate) Davey Darrell L Davey Deborah A	Address (As shown on registration certificate) 6613 Santa Rosa Rd Camarillo Ca 93012-5672

Republic RC-3 N5166B Ser.# 1000

ADC Spin-On Oil Filter Adapter w/ Chip Detector

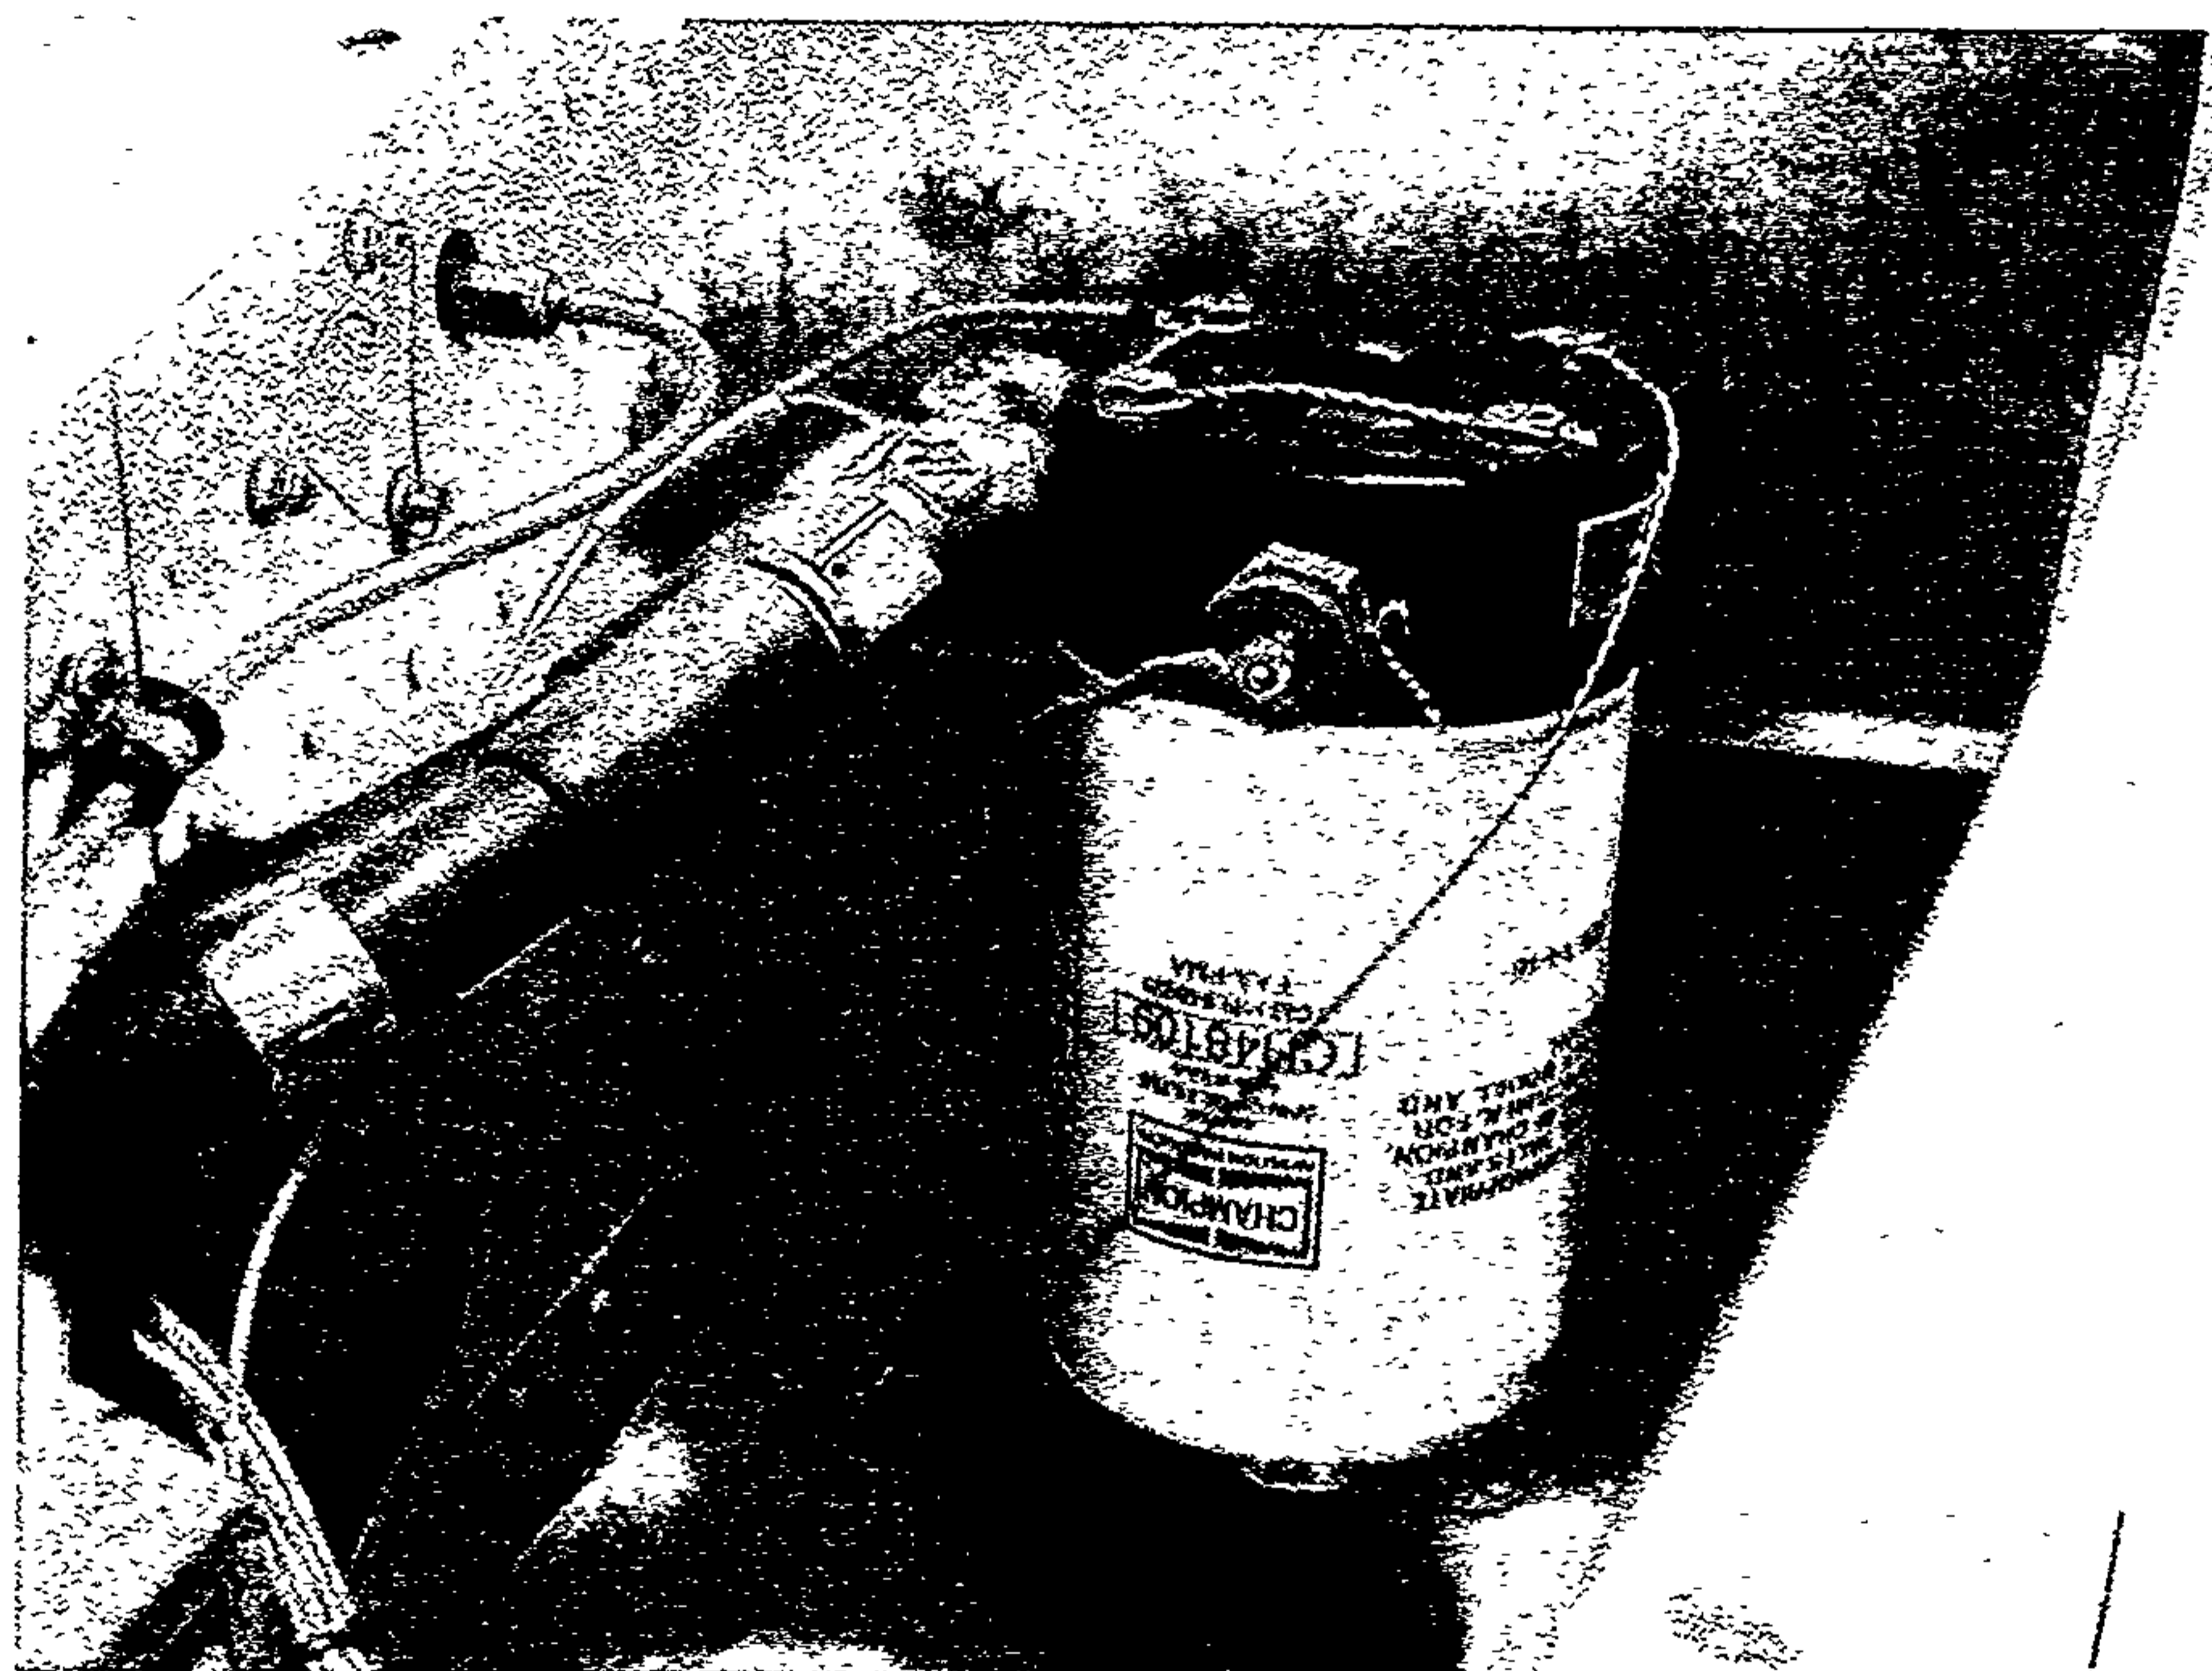
ADC, Inc. Spin on Oil Filter and Chip Detector

Located in forward left side of engine compartment

2. Description: Installed Aviation Development Corporation Spin-On Oil filter system P/N 07-06925 and chip detector P/N 2003 in left forward engine compartment. Oil filter adapter attached with AN3 bolts and AN363 nuts. Aeroquip 666-8 fluid hose TSO-C53a, Type D, with fire sleeve was used to connect the filter adapter to the engine and oil cooler. Chip indicator light P/N MS25041-2, push to test mounted in top center of instrument panel and uses a 1 amp circuit breaker for circuit protection. All work done in accordance with Aviation Development Corporation Report No. SP025, dated 10-17-96, ADC drawing# 50000 dated 9-2-96, 50010 dated 8-29-96, 50045 dated 10-14-97 (filter adapter), ADC Report No. CD30 dated 2-1-97, drawing# 1001 dated 3-4-94 (chip detector) and AC 43.13 1A, ch. 11, section 2, para.424, 429, section 3, para. 442, 443, 445 thru 451, fig. 11.7a, section 7, para. 514 thru 520.

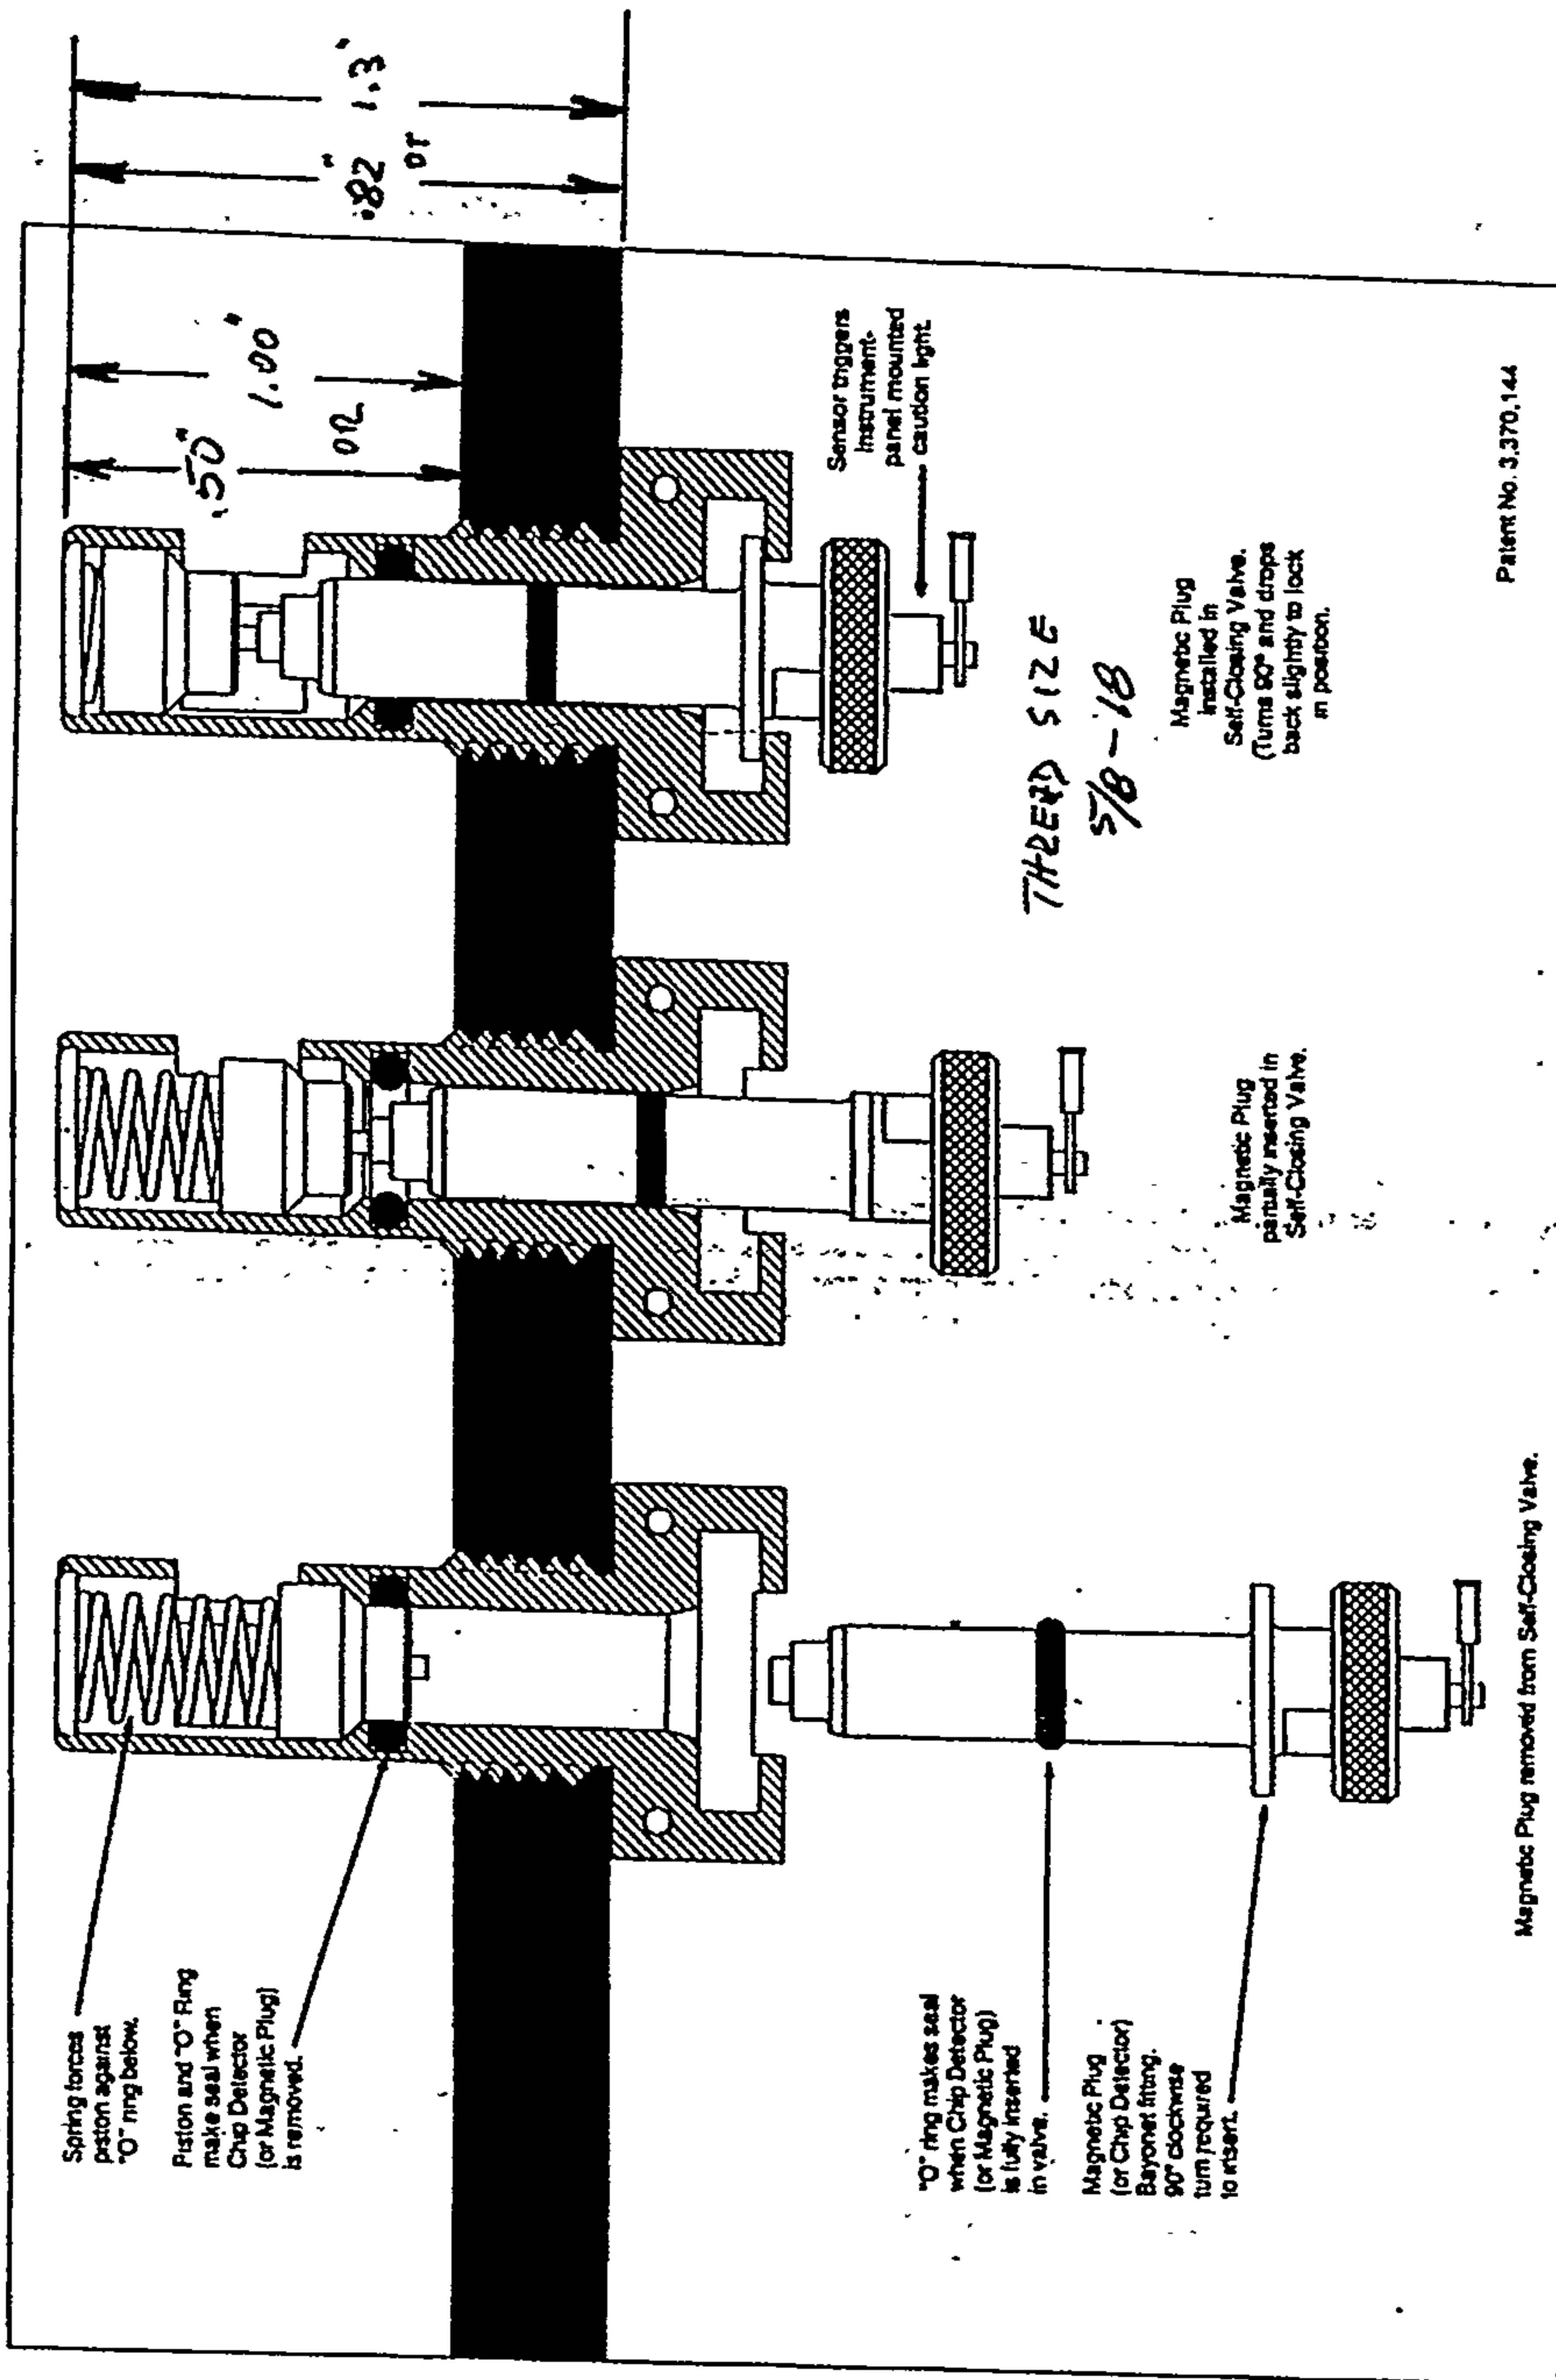
ADC Chip Detector Details

ADC Bayonet-type Chip Detector
