MAJOR REPAIR AND ALTERATION (Airframe, Powerplant, Propeller, or Appliance)

1. Aircraft	Make Republic	Model RC-3
	Serial No. 1000	Nationality and Registration Mark N5166B
2. Owner	Name (As shown on registration certificate) Davey Darrell L Davey Deborah A	
	Address (As shown on registration certificate) 6613 Santa Rosa Rd Camarillo Ca 93012-5672

Republic RC-3 N5166B Ser.# 1000

Elevator Trim

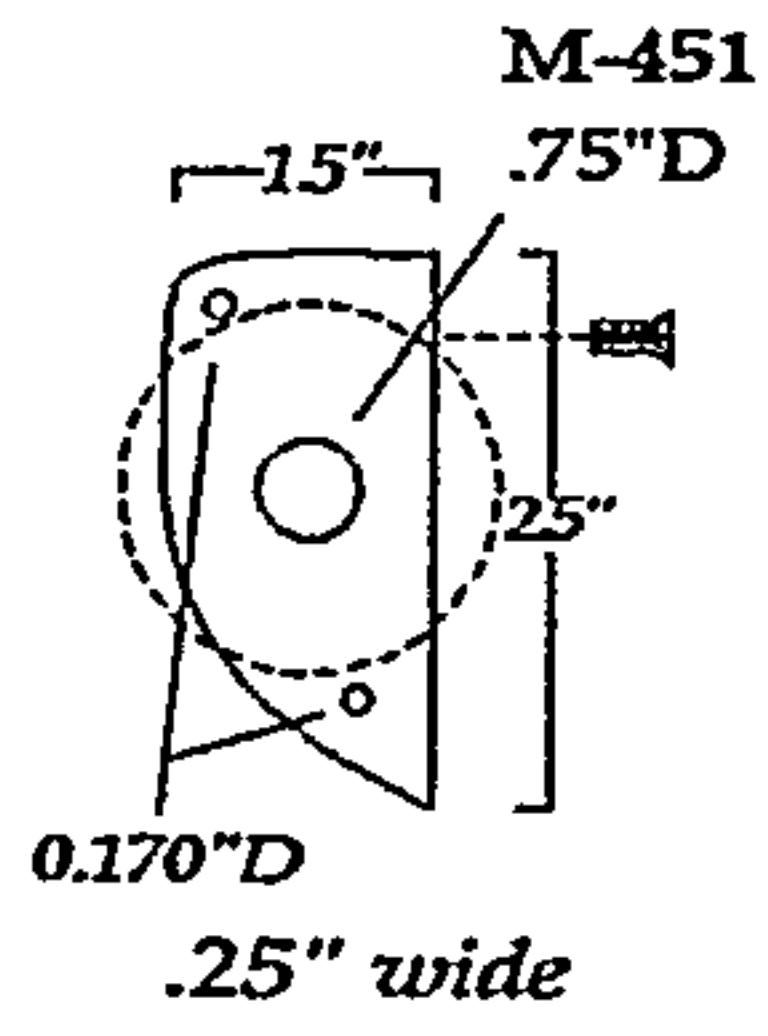
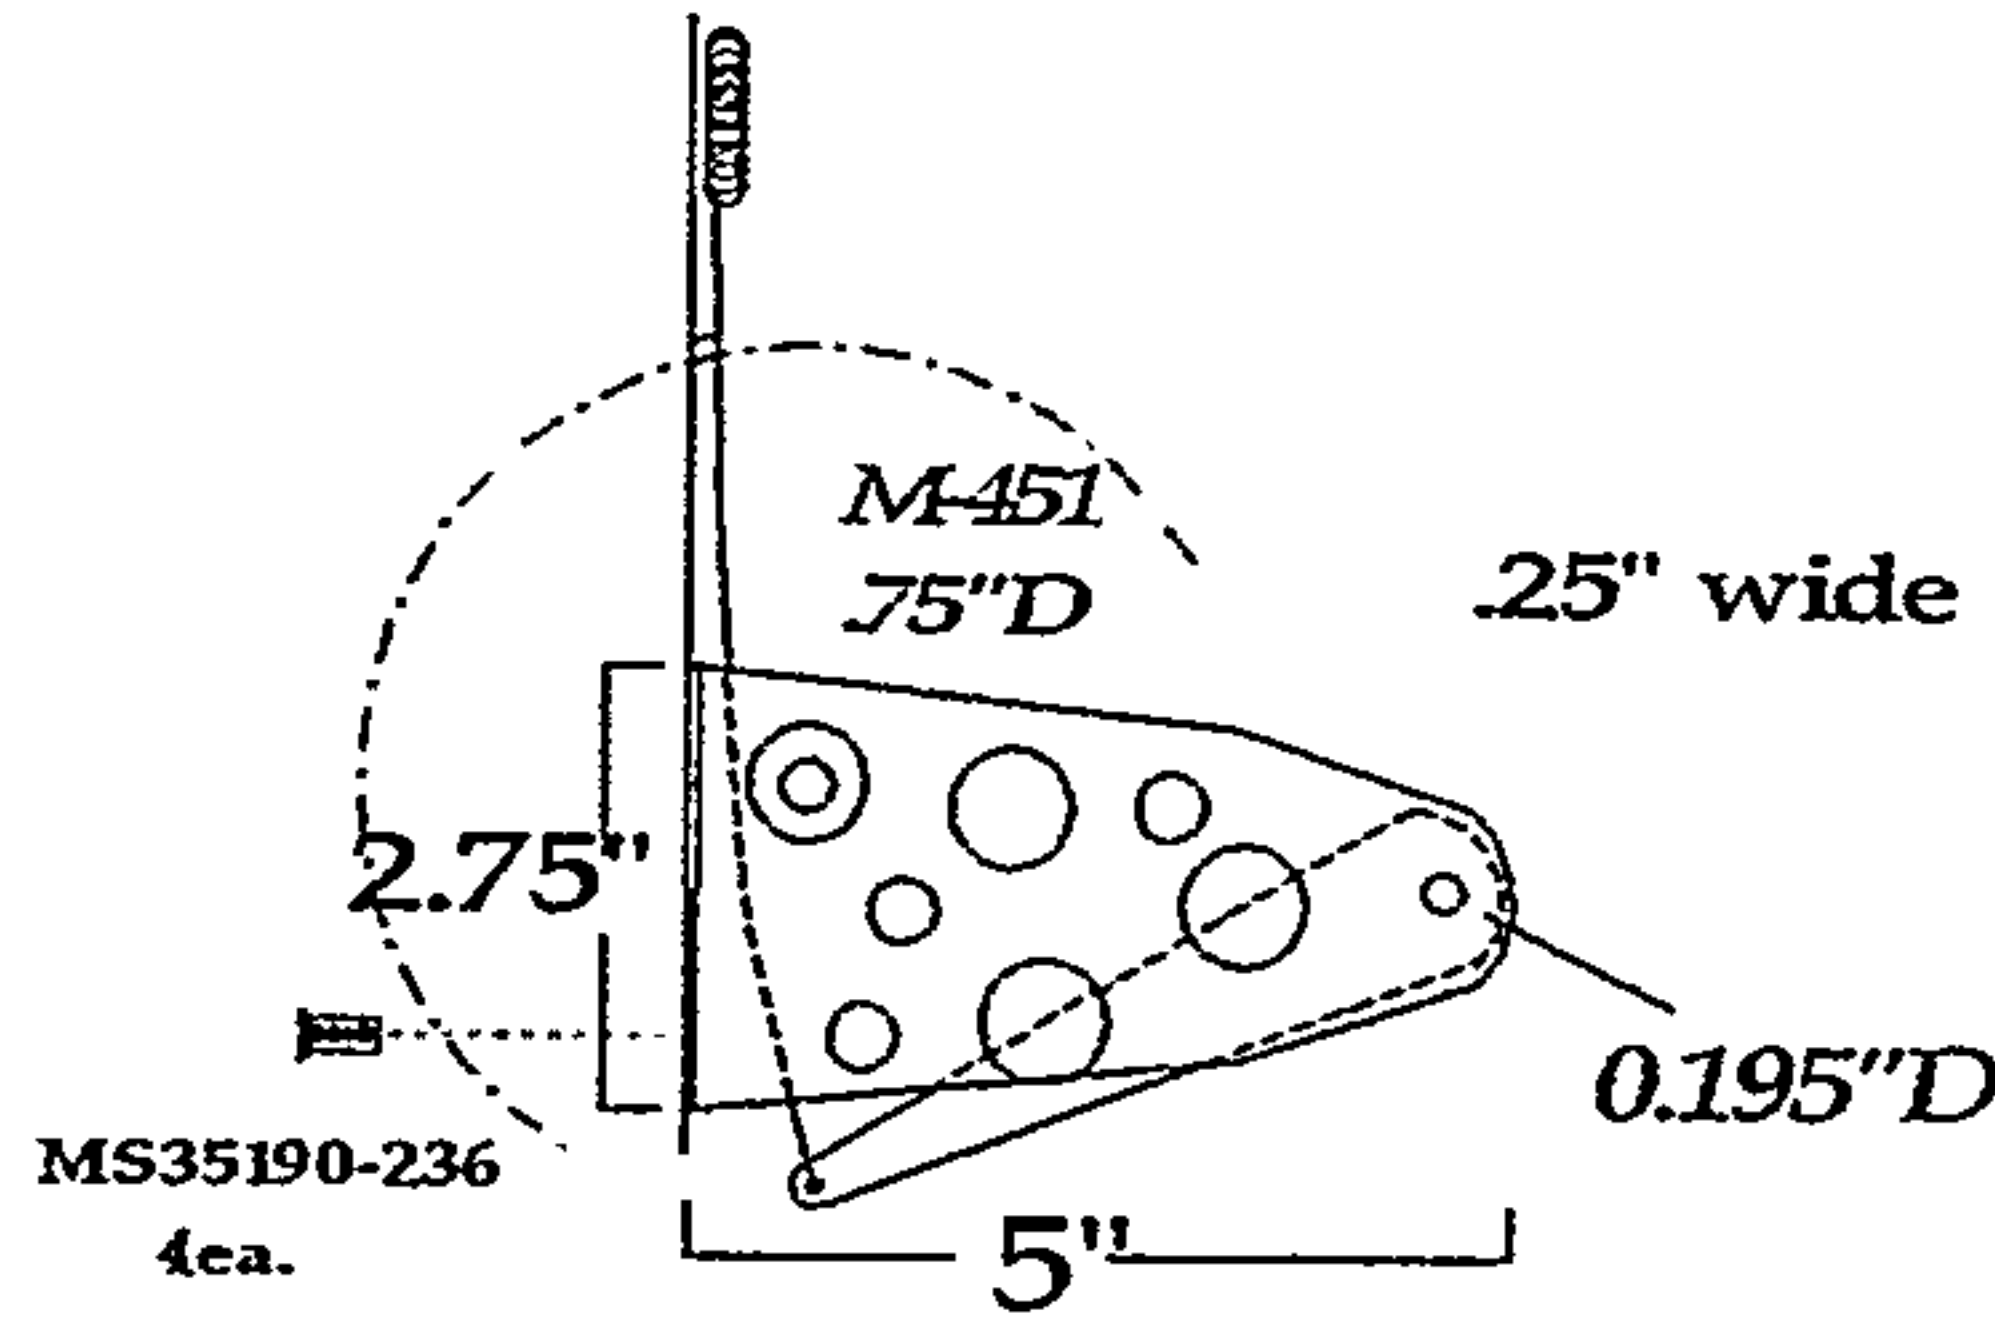
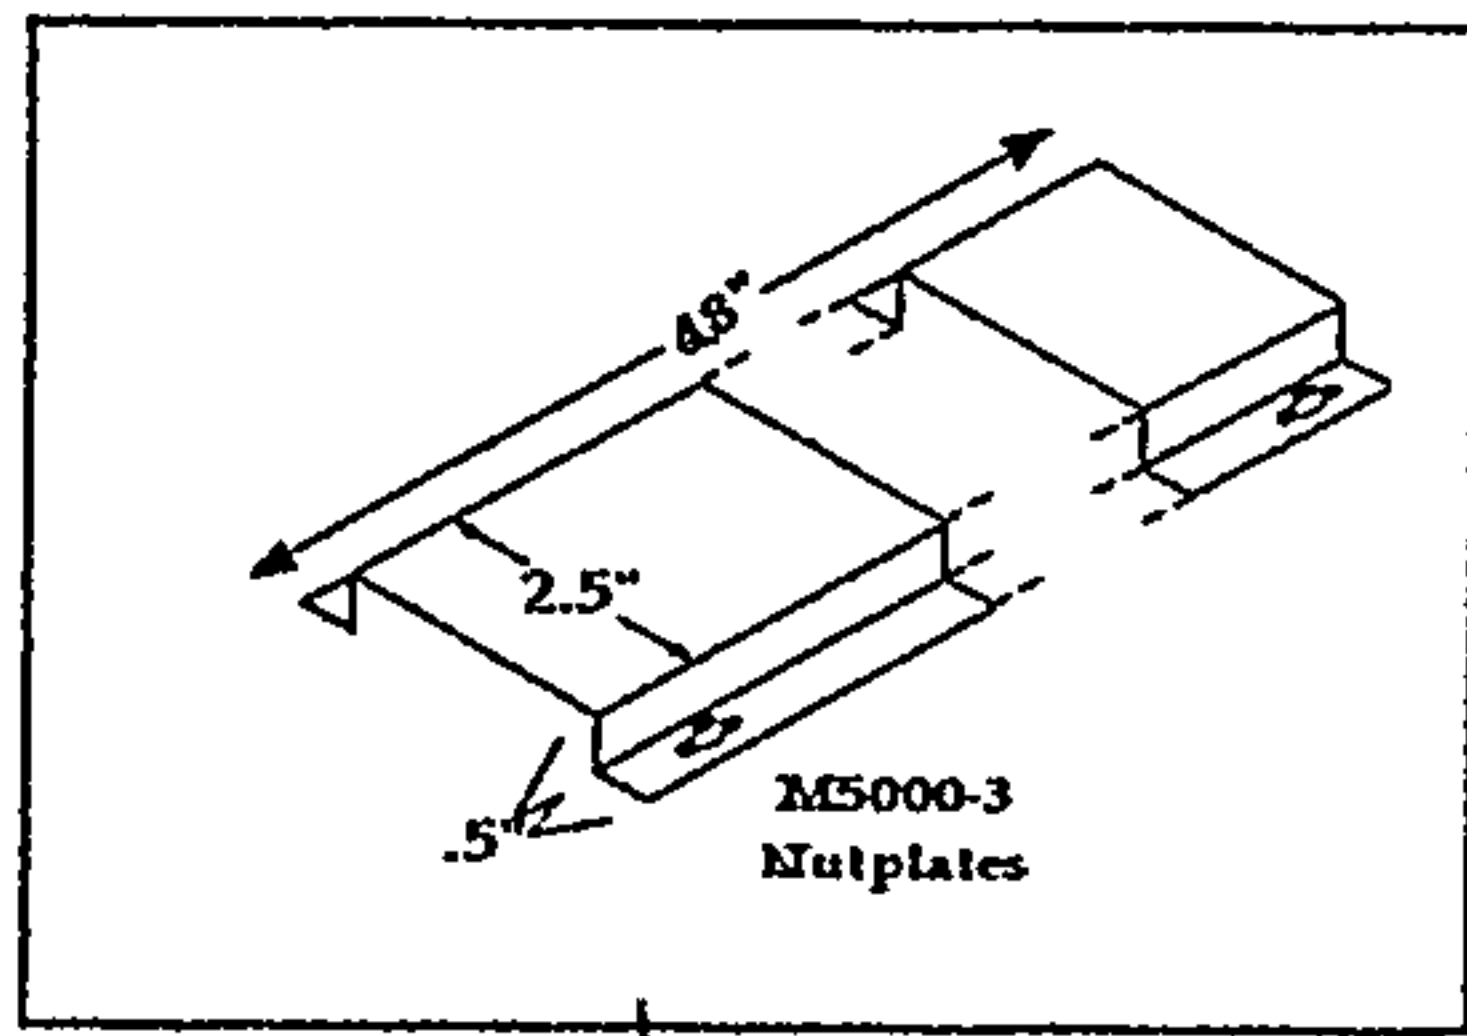
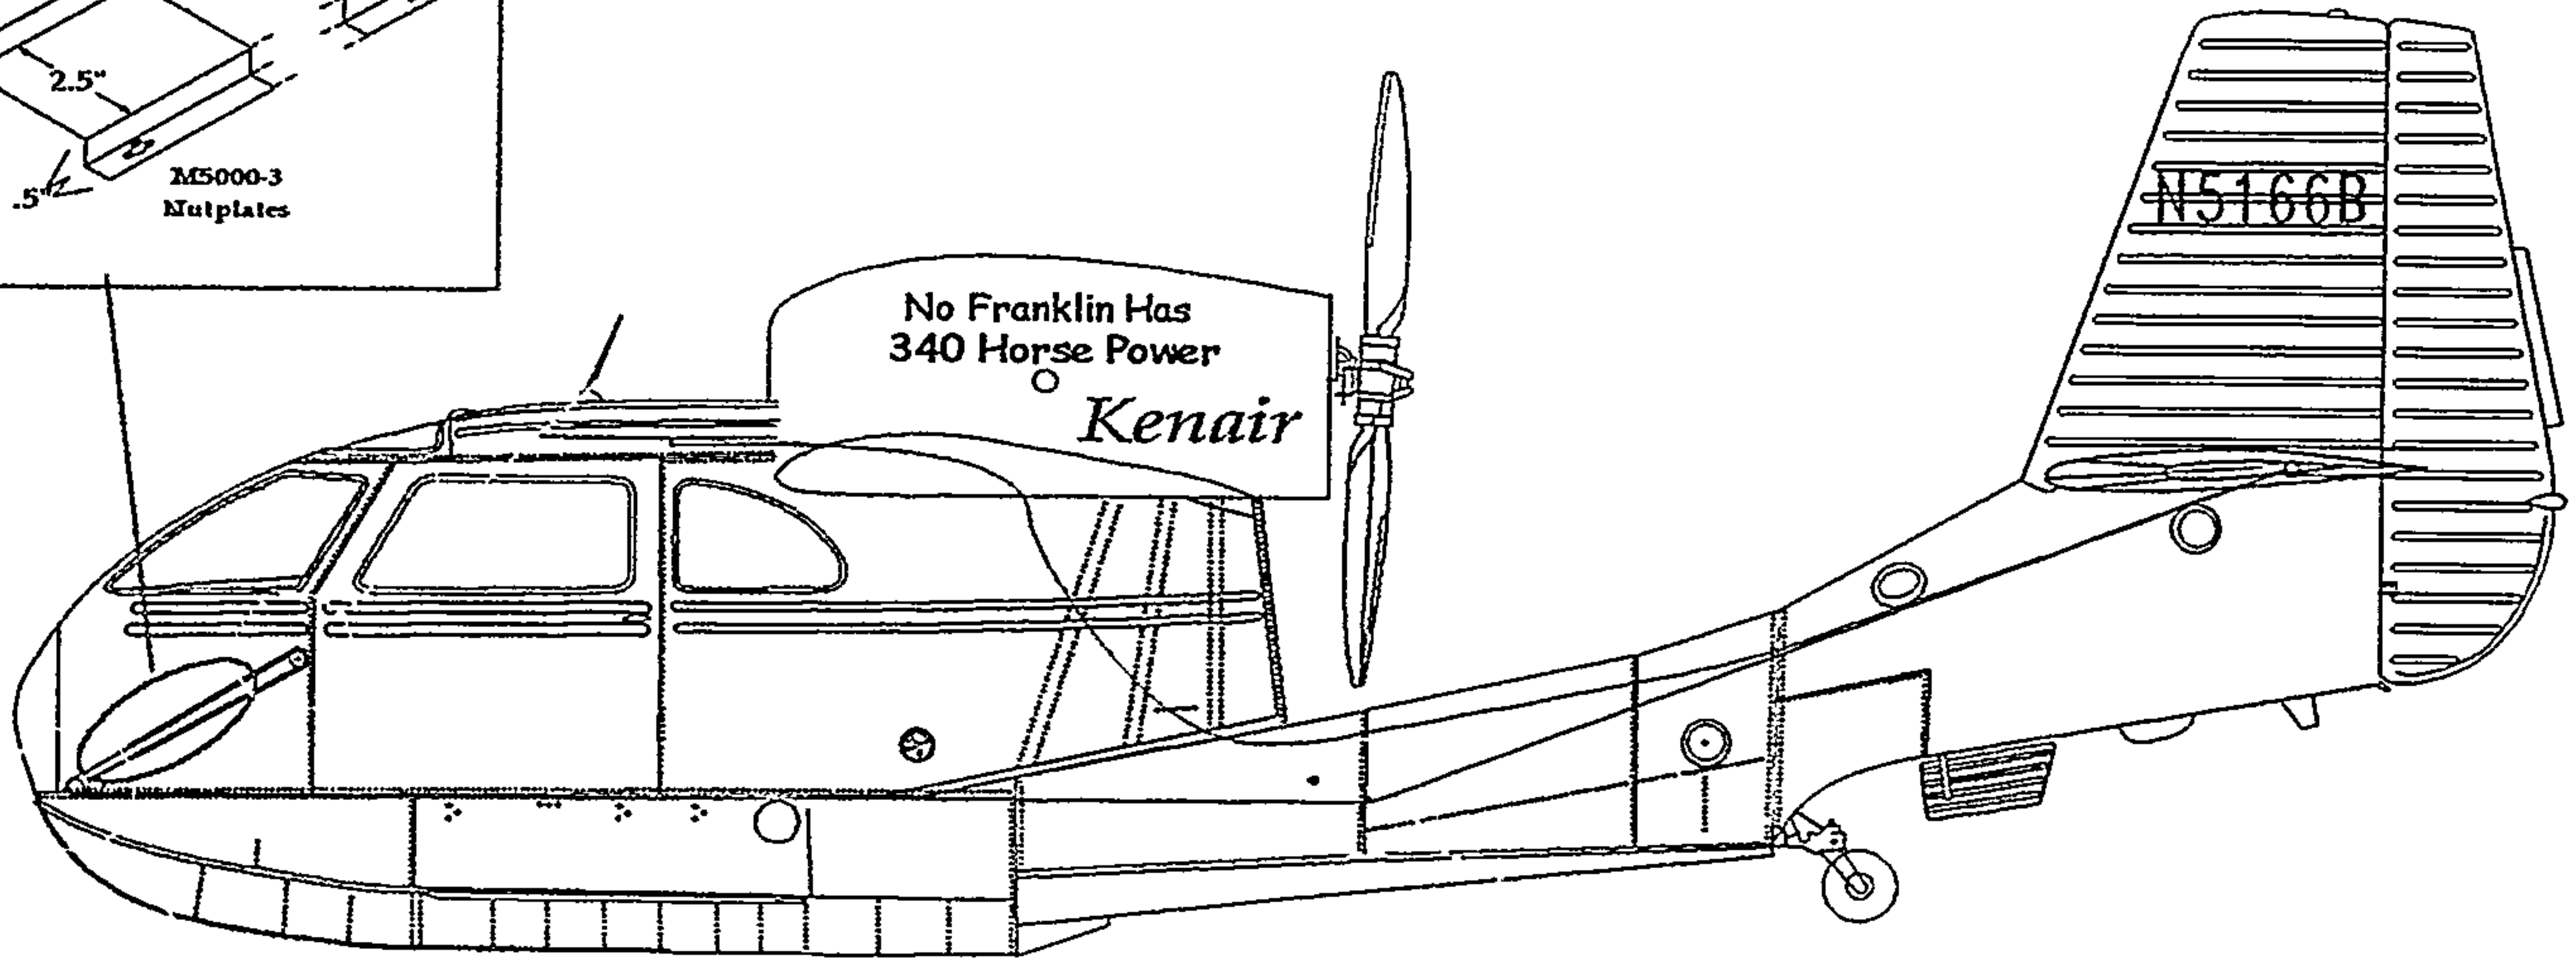
Blue - Original Routing of Trim Control
 Red - Modified Trim Control Routing

2. Description: Modified elevator trim control by removing original trim control from top of cabin to instrument panel. Installed Cessna P/N 0510127-2 Wheel, tab control and Cessna P/N 0432134-1 Sprocket, tab control on .250" 303 stainless steel shaft with roll pins, Cessna P/N NAS561P3-4, mounted with Torrington bearings, Cessna P/N M-451 (2ea.), in brackets fabricated from .250" 6061 T6 aluminum plate and secured to instrument panel with MS24693C screws. Trim position indicator fabricated from 1/16" welding rod and attached to trim wheel position follower fabricated from .040 2024 T3 aluminum sheet. Position indicator is held in place with groove cut in avionics mounting support. Trim control cable, 1/16" stainless flexible control cable conforming to MIL-W-83420, is attached to trim control chain, Cessna P/N 0432138-7, with modified MS21260-S2RH swage end turnbuckle end. Trim control cables are protected underneath instrument panel with enclosure panel, fabricated from .032 317 stainless steel. Trim control cables are routed down thru cabin floor with 2 ea. MS24566-2B control pulleys mounted on 6061 T6, 1 1/2" X 1 1/2" X 1/4" extruded aluminum 90 deg. angle, and bolted to cabin floor with 2 ea. AN3 bolts. Trim control cable routed at bulkhead #4 thru pulleys, Cessna P/N S-378-1(2 ea.), mounted in bracket fabricated from .032 303 stainless steel and attached to bulkhead with AN3 (2 ea.) bolts. Trim control cables attaches to original aft control chain with modified MS21260-S2RH swage end turnbuckle end. Elevator trim control gear box and attachment to trim tabs unchanged.
