MAJOR REPAIR AND ALTERATION
(Airframe, Powerplant, Propeller, or Appliance)

1. Aircraft	Make REPUBLIC	Model RC-3
	Serial No. 443	Nationality and Registration Mark N6240k
2. Owner	Name (As shown on registration certificate) HARLAN ASSOCIATES OF SPRUCE CREEK	Address (As shown on registration certificate) 3511 SILVERSIDE RD STE 105 WILMINGTON, DE 19810-4902

INSTALL INTERAV INC. ALTERNATOR KIT #015-01236 AS PER
INSTRUCTIONS CONTAINED IN STC SA334SW REVISION 16 DATED
JULY 20, 1981, ALSO USING WIRING DRAWING #65-113

Downer (Republic) RC-3 / SEABEE / Franklin 6A8-215

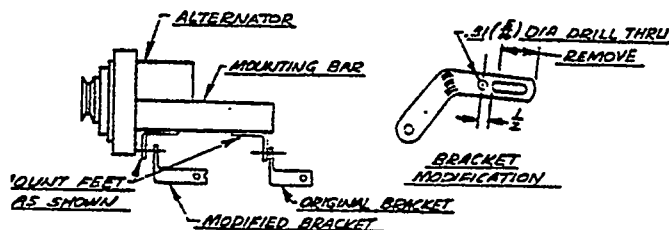
Secure the Alternator feet on the Alternator mounting bar and install the bar on the front side of the original generator brackets, using the original bolts, as shown on the sketch.

In order to properly align the alternator belt it will be necessary to modify the existing front generator steel mounting bracket by drilling one 5/16" hole 2" ahead of the slot. Cut the slotted end off and reinstall the bracket on the engine, using the same cap screw.

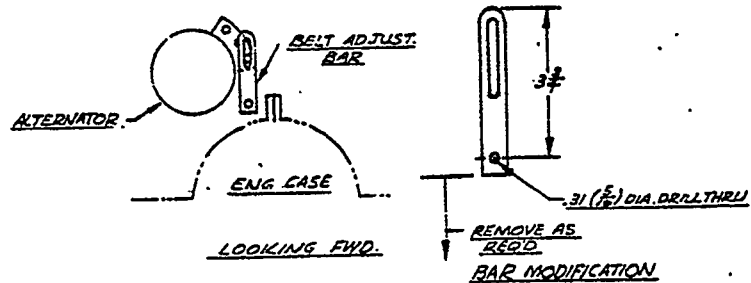
3. The generator belt tension adjustment bar is turned upward and attached to the threaded hole in the Alternator, nearest the engine case. It may be necessary to add washers to the lower end of the bar in order to align the bar with the Alternator. In the event your belt adjustment bar is the long type, drill a new hole in the bar per sketch and cut off excess material. Use Franklin P/N 14883 or Goodyear 5L380 belt.
