HARTZELL PROPELLER, INC.
PIQUA, OHIO

BULLETIN No. 67

Subject: Adjustment of Travel of B-299 Servo Valve

Effectivity: Propeller models HC-12X20-3E and HC-13X20-5L or 6L installed on RC-3 Seabee Aircraft.

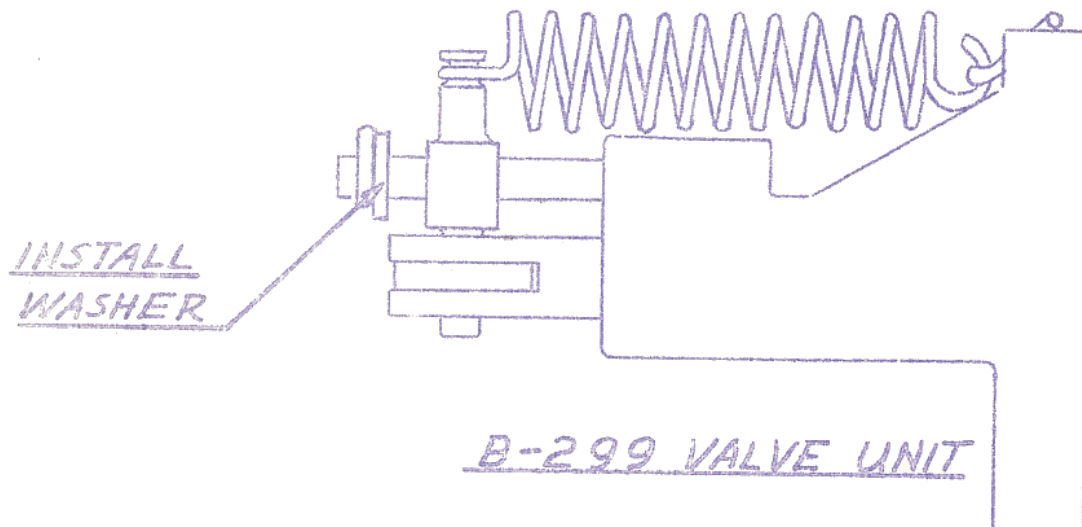
Discussion: It has been discovered that with some B-299 servo valves, the travel of the spool is excessive in the out direction, as shown in the sketch below, which allows oil to enter the cylinder, instead of draining oil as intended. The consequence of this action is to put the propeller into reverse pitch, instead of high pitch as called for by the pilot.

Action: For propellers which fail to respond properly, install a 1/16" washer as shown below.
