**FAA
Aviation Safety**

SPECIAL AIRWORTHINESS INFORMATION BULLETIN

SUBJ: Exhaust Turbocharger; V-band Couplings Used in Exhaust Systems on Turbocharged Reciprocating Engine Powered Aircraft **SAIB:** CE-18-07
Date: December 14, 2017

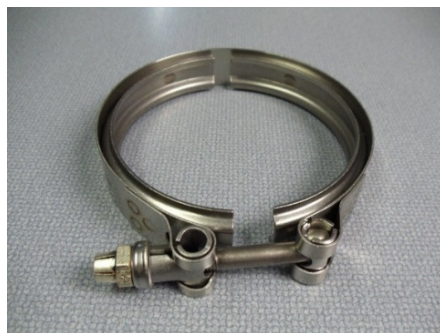
2 segment, coupling, new

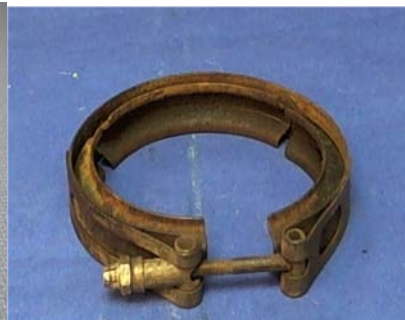
3 segment, coupling removed from service

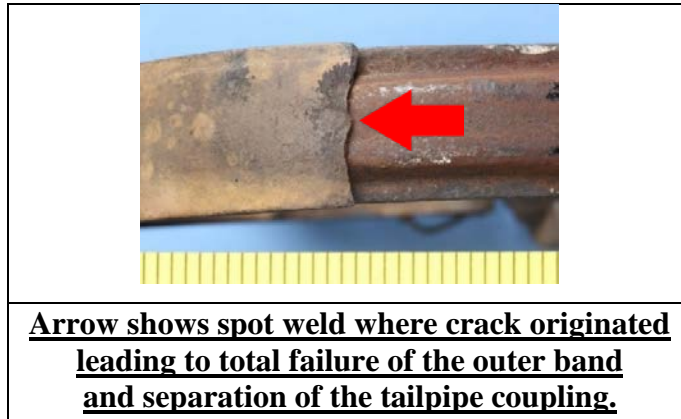
Reference: turbocharger to tailpipe interface

The FAA is aware of three recent accidents/incidents, involving cracked and/or separated multi-segment, spot welded, v-band couplings, which resulted in four fatalities. The failed and cracked v-band couplings pictured below are from the accident/incidents noted above.

- cracks in the outer flat band at or near a spot weld;
- signs of over opening of the coupling or excessive twisting;
- misuse of the coupling(s) to bring exhaust system components together and into alignment;
- over-torquing, outer band material stretching and deformity; and
- exhaust gas leakage, overheating, heavy accumulation of oxides, and corrosion.

If any of the above conditions are found, the v-band coupling is considered unairworthy and should be removed and replaced before further flight with a new, zero time in service (TIS), FAA-approved coupling according to the instructions and procedures found in the airframe or engine ICA's, as applicable. All v-band couplings removed from service should be permanently destroyed and not used on any other aircraft or aircraft application.

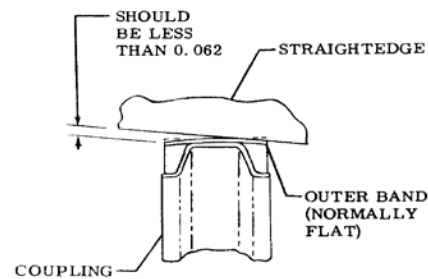
1. The FAA recommends at the next scheduled inspection and at each annual or 100-hour inspection thereafter that you perform a detailed visual inspection of the turbocharger exhaust v-band coupling(s) for signs of:
 - a. Cracks in the coupling outer band (flat) material, primarily at or near a spot-weld.
 - b. Cupping or bowing of the coupling outer band beyond 0.062 inches in depth as shown below.

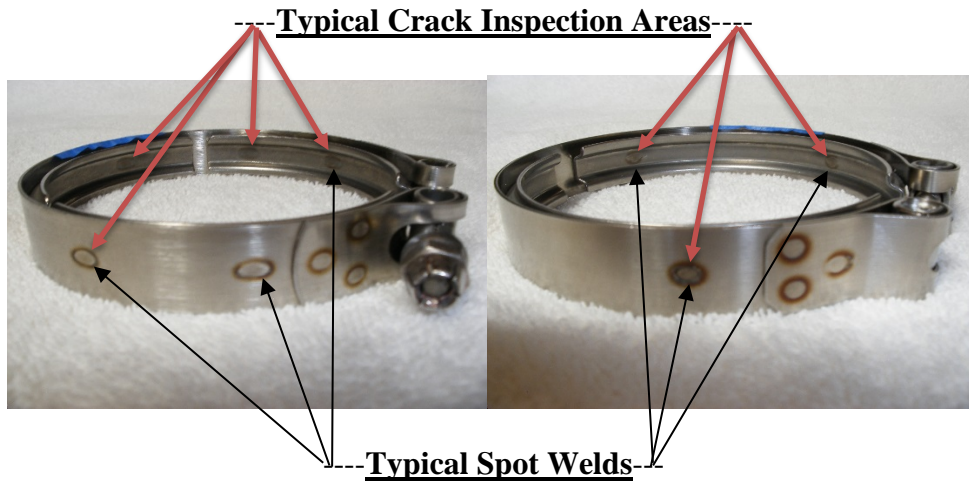
- c. Cracks in the coupling v-retainer segment interior or exterior surface, e.g. at bend radii.
- d. Looseness, separation of the outer band to v-retainer segment(s) at any spot-weld.
- e. Gaps between the v-retainer segments and the outer band at or between spot-welds.
- f. Corrosion that is not easily removed from any component of the coupling.
- g. Deformity, including but not limited to, out of round, twisted, re-formed by any method.
- h. Physical damage, including but not limited to, cracks, gouges, tears, bulges, fractures.
- i. Repairs or any indications of past repairs, as no repair process is known to be effective.
