HARTZELL PROPELLER COMPANY
PIQUA, OHIO

BULLETIN NO. 8 (Seabee and Widgeon)
MANDATORY

May 28, 1949

SUBJECT: Service Life and Periodic Inspection of Propeller
Hub Spider (Models HC-12X20-2,-3)

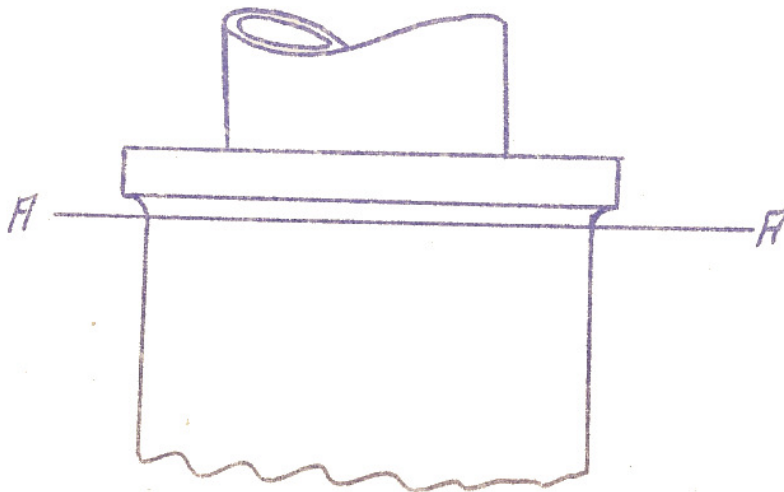
3. For hub spiders that have less than 500 hours, periodic inspections must be made at intervals of 200 hours, or six calendar months, whichever occurs more frequently. After the 500 hour period is reached the new type hub spider, C-49-2C must be installed. This type of inspection may then be discontinued. These inspections should consist of a visual determination of the presence of rust pits, tool marks, or fatigue cracks at section A-A of sketch below.

The area in the fillet and that immediately adjacent to it should be polished to a mirror finish with emery and polishing paper wrapped around a 1/8" file or rod. If any rust pits cannot be readily removed by polishing the surface, the hub must be retired. In removing tool marks, it is best to chuck the opposite pilot tube in a lathe and use 1/8" diameter fine file in working out the surface irregularities. Final polishing is done with emery paper, and then polishing paper. Care must be exercised in this operation to avoid changing the radius shape. The shoulder proper should not be touched.
