## **Tail Wheel Microswitch**

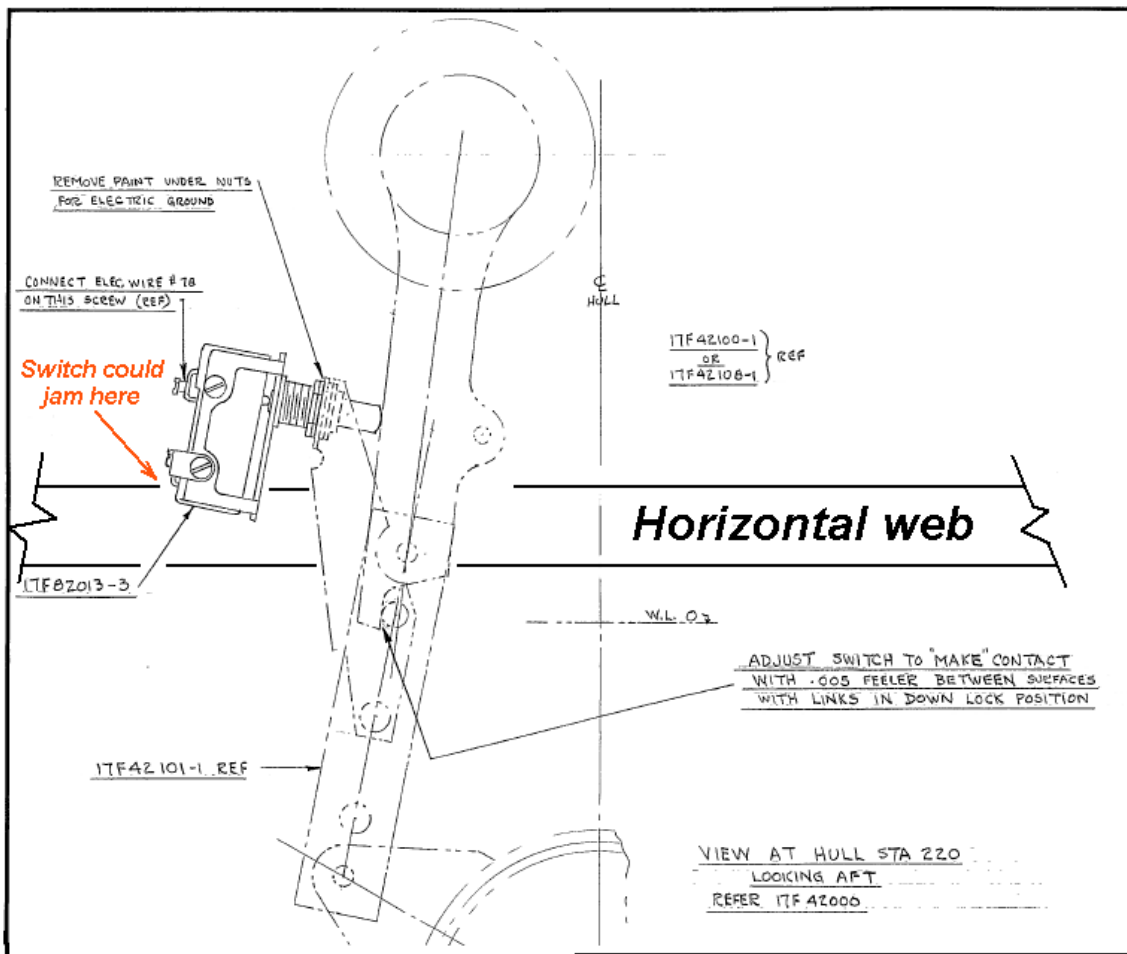
When the tail wheel microswitch was inspected closely we noticed it was able to rotate about the plunger axis. The switch mounting nuts were tight but the plunger collar on the switch “cage” was rotating (see drawing page 3). Any amount of nut tightening wouldn’t have prevented the whole switch from twisting thence jamming the switch against the horizontal web just behind it. Miller is in the process of changing the “cage” (with the loose collar) as we speak. This will determine if it is, in fact, the culprit.

Tail wheel linkage with switch

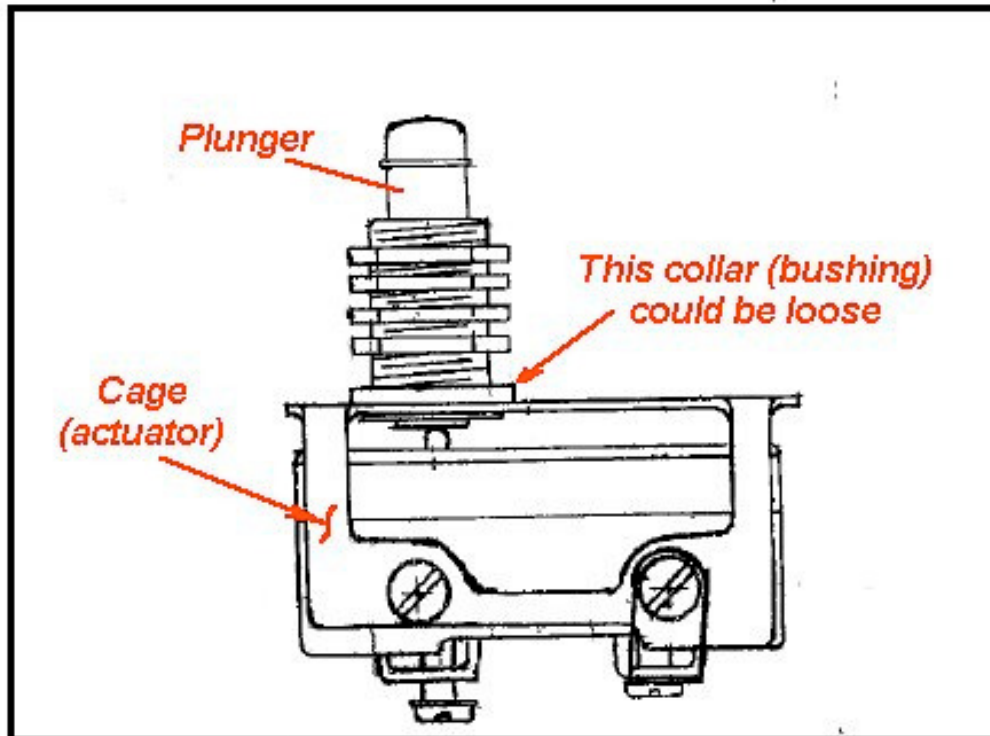
The “collar” on the microswitch “cage” may be able to be silver soldered or epoxied in place but a new cage is preferable. It appears that the collar is bronze and the cage is steel.

Microswitch with suspect collar shown

If you find that no matter how tight the lock nuts are on your switch and your switch still rotates, you may need to change the “cage” around the switch. This is a separate part (with the loose collar) and is still available from Honeywell (Part No. MC2711 or AN3168-2). The microswitch is also available (Part No. BZ-2R-A2).

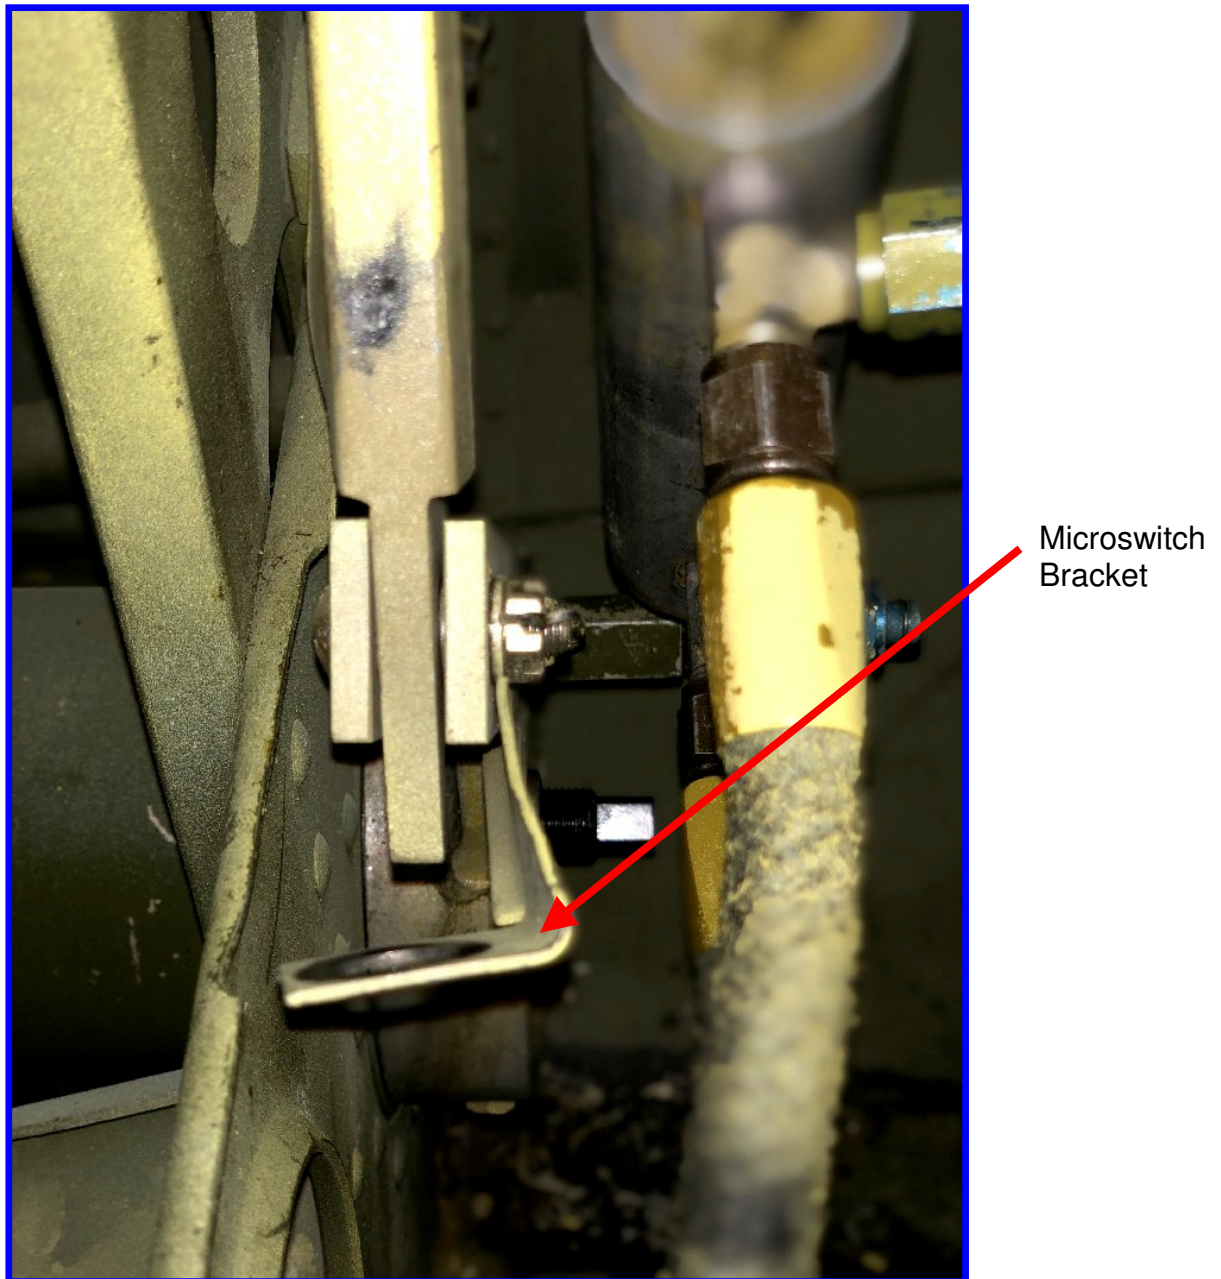
It turns out that there was another issue with the microswitch; the bracket holding the switch was bent (see photo below). This, along with the above symptom, must have caused the tail wheel mechanism to “jam up”. Please check your microswitch and bracket. Unfortunately the bracket may be riveted to the control arm of the tail wheel mechanism. You may have to remove the lower linkage of the mechanism to straighten it out or replace it (see drawing page 5).

Microswitch bracket bent
