FRANKLIN SERVICE BULLETIN

AIRCOOLED MOTORS INC.

NO. FSB 47 Page -1of 2

SUBJECT: ENGINE MOUNT BOLT LOCK WASHERS FOR 6A-215-B8F ENGINES

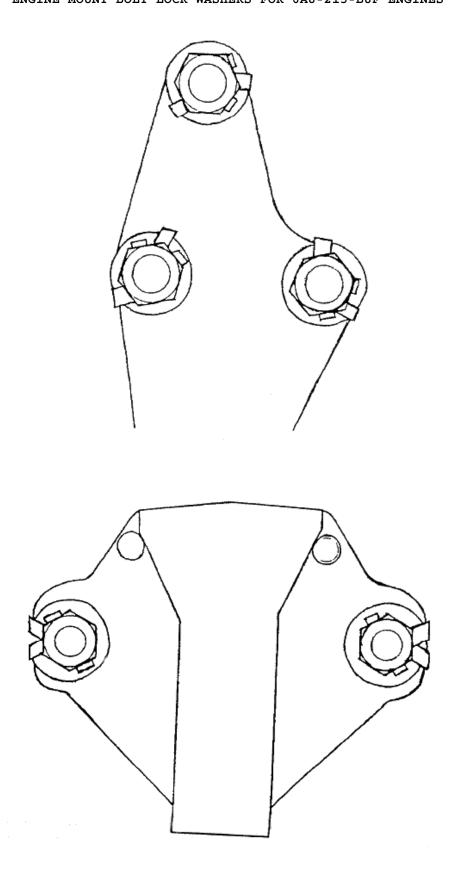
SKETCH SHOWING METHOD OF INSTALLATION OF ENGINE MOUNT BOLT LOCK WASHERS FOR 6A8-215-B8F ENGINES

In your periodic checks, as outlined in Bulletin #40, if any loosening of the engine mount bolts is observed, the new type lock washer should be installed.

The lock washers are the $\underline{\text{tab}}$ type for bending down against the casting and up against the bolt head.

Lock washer, part #15175, with 3/8" hole, is used for the 3/8" bolts at the op of the mounts on each side of the crankcase and for the two 3/8" bolts at the single mount on the propeller housing. Lock washer, part #15176, with 7/16" hole, is for the two lower 7/16" bolts in the nounts on each side of the crankcase.

Torque on the 3/8" bolts should be 25 ft. lbs. Torque on the 7/16" bolts should be 30 ft. lbs.

Atached is a sketch showing the method of istallation of locks. Locks, as shown, have tabs bent up at the bolt head and tabs bent down at the casting section.
