SERVICE NEWS

AIRCOOLED MOTORS INC.

No. FSN 14

**SUBJECT: EXHAUST VALVES AS USED IN FRANKLIN MODEL 6A4-150,
6A4-165, 6V4-178, 6V4-200 AND 6A8-215 ENGINES**

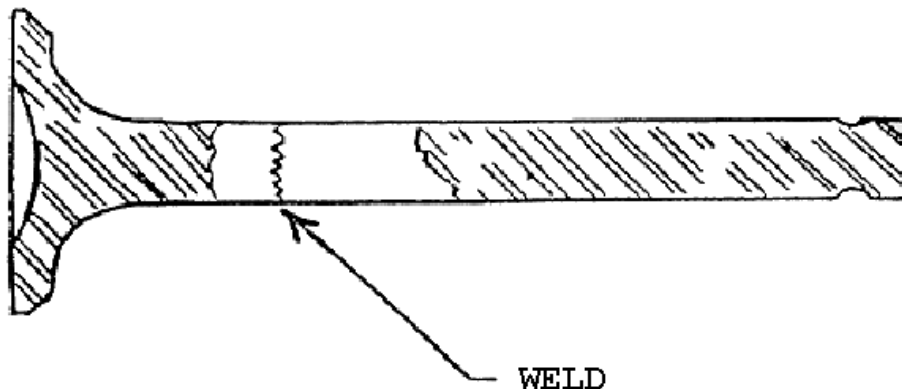
The indications observed are at the location where the valve head and valve stem are welded together. The indications are apparent at the weld, since the valve head and the valve stem are of different materials; not having identical magnetic properties.

We have never had reported a valve failure at the weld location and it is felt that the magnetic particle indications observed at the weld do not prove that flaws are present and such indications are not the cause for rejection of the valve. Below is a sketch showing the location at which the indications have been noted.
