**REPUBLIC AVIATION CORPORATION  
FARMINGDALE, LONG ISLAND, NEW YORK  
SERVICE DEPARTMENT**

**MANDATORY CHANGE**

SERVICE BULLETIN NO. 1

MODIFICATION FIREWALL TERMINAL BLOCK

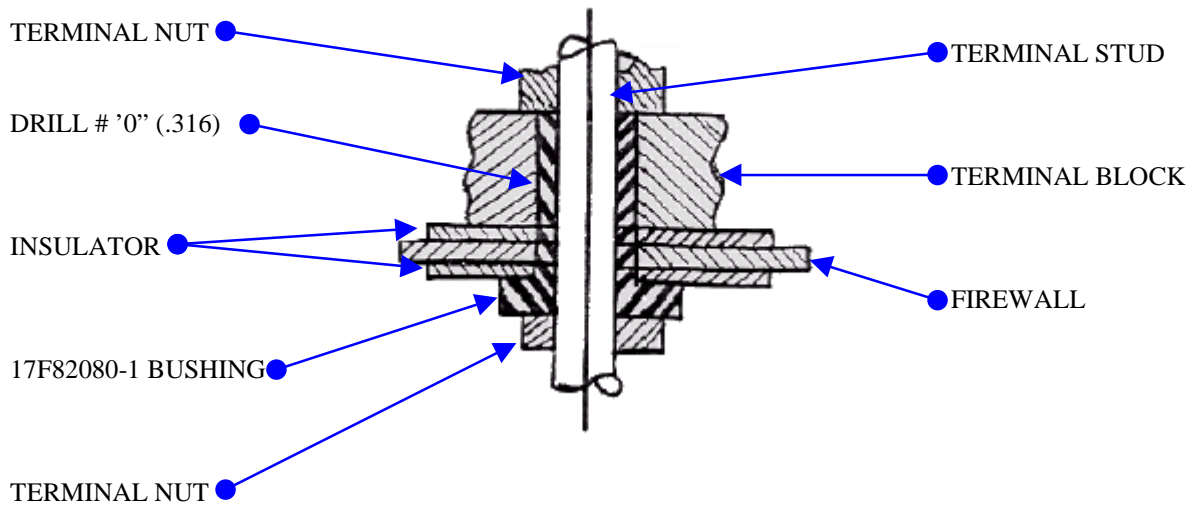
FIGURE 1

Reason for Change: To prevent short circuiting of terminal studs on the firewall.

1. Open top engine cowl and remove right hand side cowl.
2. Disconnect wires from one terminal and remove stud.
3. Open up existing hole by drilling through with No. "0" (.316) drill.
4. Insert 17F82080-1 Bushing from bottom side. Refer to Fig. 1.
5. Reinstall terminal stud and reconnect wires, omitting the AN960-10 washer.
6. Repeat the above process for all seven terminal studs.
7. Replace cowling.
8. Check electrical circuits for operation and make suitable entry in airplane log book.
