# SERVICE BULLETIN

REPUBLIC AVIATION CORPORATION  
FARMINGDALE, LONG ISLAND, NEW YORK  
SERVICE DEPARTMENT

SERVICE BULLETIN NO. 4

## REPLACEMENT OF AFT ENGINE LORD MOUNTS

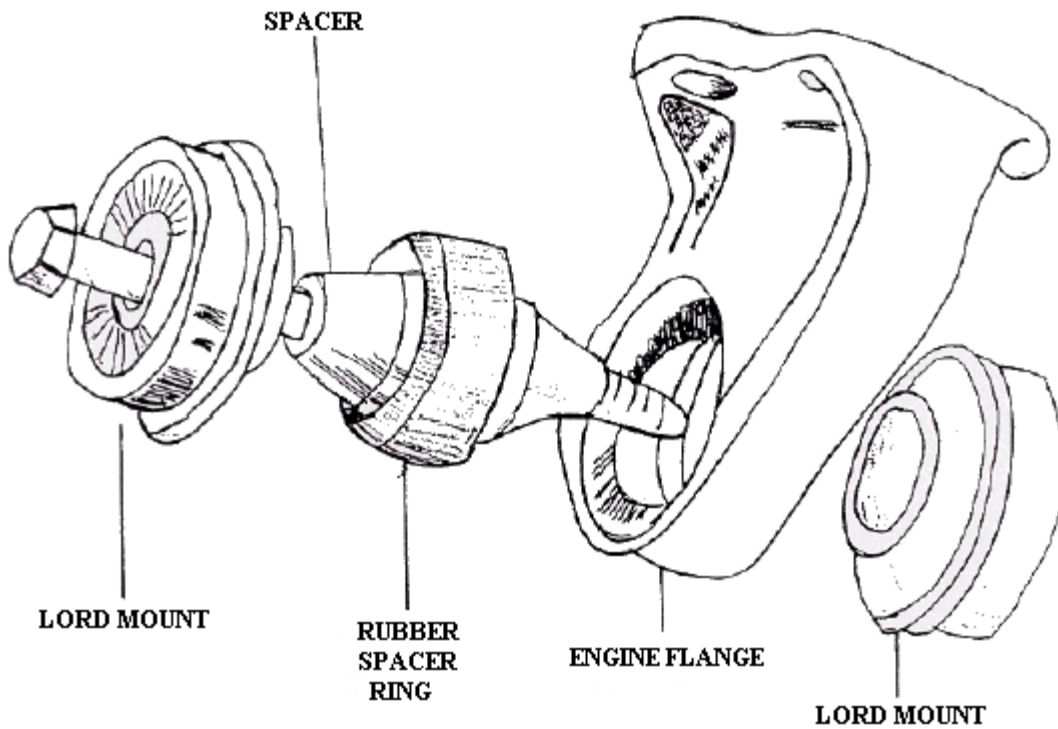
Figure 1

REASON FOR CHANGE: To prevent shearing of rubber bonding on conical halves of the mount  
Resulting from engine static load imposed on them.

4. Install the new J-2860-5 Mount Assembly consisting of two conical bonded rubber halves, which in appearance are the same as those removed, and the spacer. Before installing the spacer, the rubber spacer ring should be assembled on the spacer by pulling it over the end and sliding it to the center. Install the left hand cone in the engine flange, apex of cone facing inboard, move the left hand mounting bracket flange forward and over this half and start the bolt through the flange and cone. From the right hand side, install the spacer over the bolt and insert the other cone, apex facing inboard. Slide the bolt through the entire assembly. Assemble the washer and nut on the bolt. This bolt should be torqued 38 to 42 foot pounds. This completes the change. Refer to figure 1.
