# SERVICE BULLETIN

REPUBLIC AVIATION CORPORATION  
FARMINGDALE, LONG ISLAND, NEW YORK  
SERVICE DEPARTMENT

SERVICE BULLETIN NO. 5

## INSTALLATION NEW TYPE ELEVATOR PULLEY GUARD

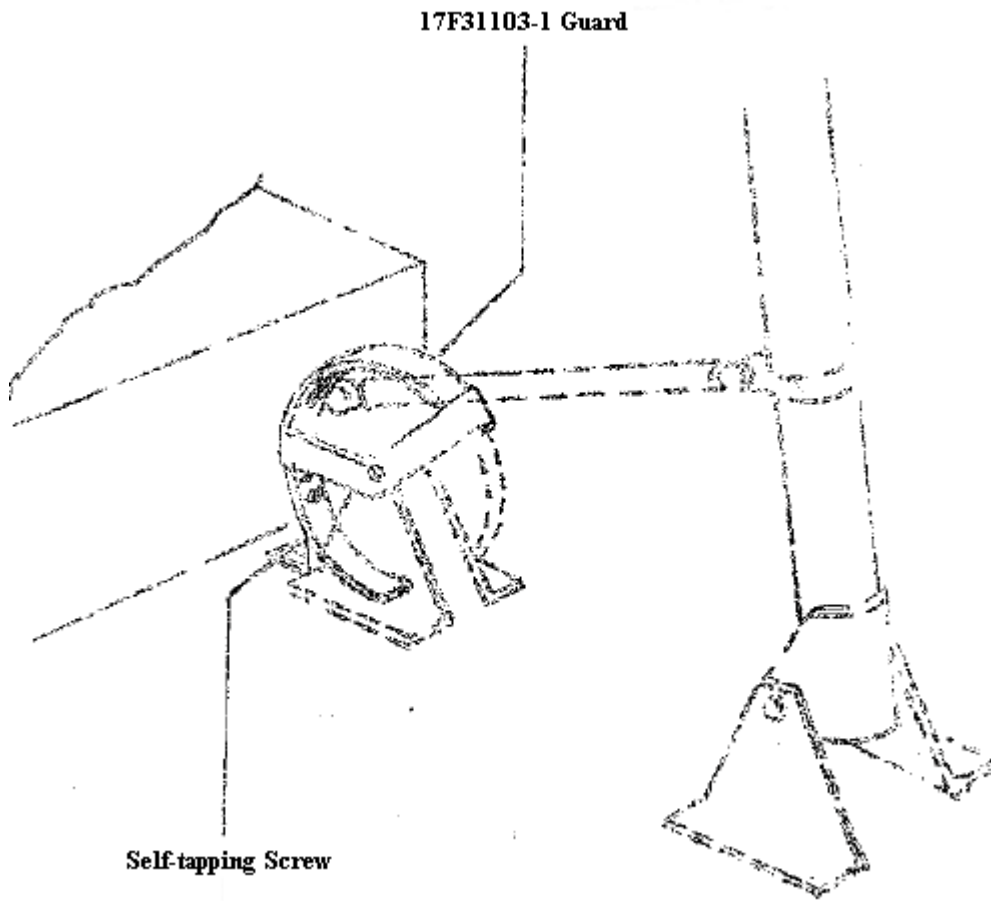
Figure 1

Reason for Change: To provide a more definite means of preventing elevator control cable from coming off pulley.

3. Loosen bolt and nut holding elevator control pulley forward of control column to its support. This will permit the removal of the present guard.
4. If the head of the bolt holding the pulley is on the right hand side of the pulley support, remove the nut from the bolt and slip the new guard in place on the left side of the pulley. However, if the head of the bolt holding the pulley is on the left side, this bolt must be removed using another 1/4" diameter bolt to push the bolt out and to hold pulley in place because of existing tension in elevator control cable. Place Guard 17F31103-1 in position on outside of left hand pulley support and fasten it in place using original hardware. Refer to figure 1.

5. Attach forward tab of guard to deck using self-tapping screw. Drill a #34 (.111) hole in the deck using hole in tab of guard as a guide.
6. Replace ballast and pedals and make suitable entry in log book.
