REPUBLIC AVIATION CORPORATION
FARMINGDALE, LONG ISLAND, NEW YORK
SERVICE DEPARTMENT

JANUARY 16, 1947

SERVICE BULLETIN NO. 6

INSPECTION OF RIVETS – ELEVATOR CONTROL COLUMN

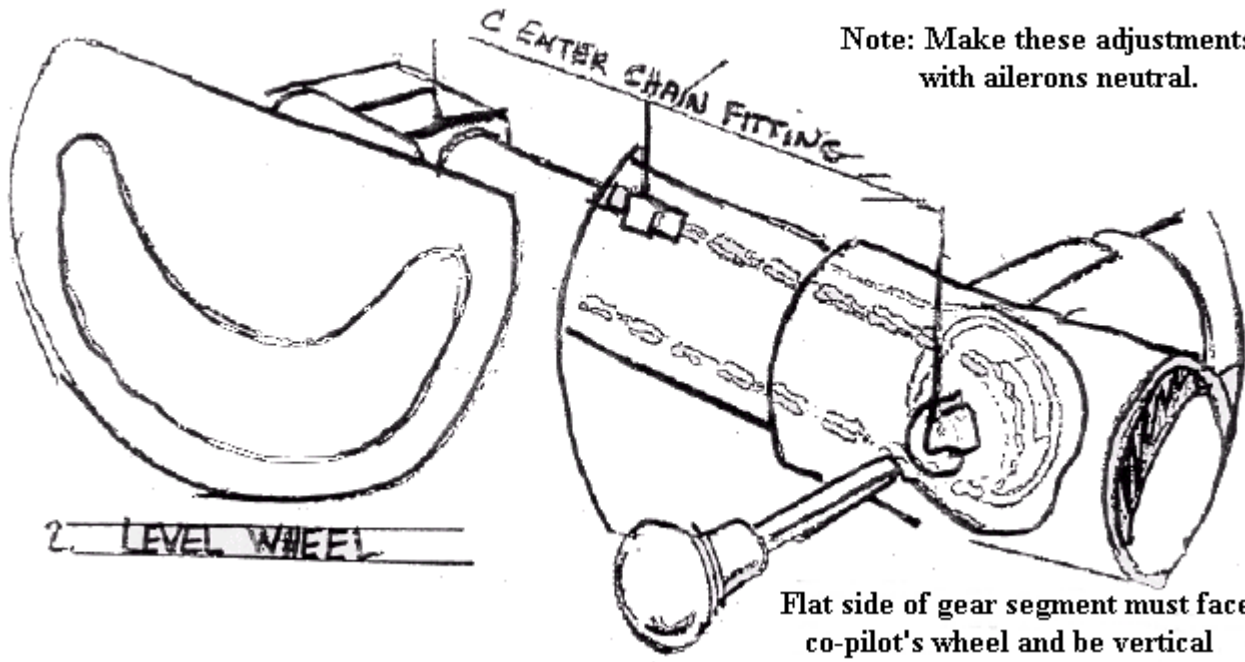
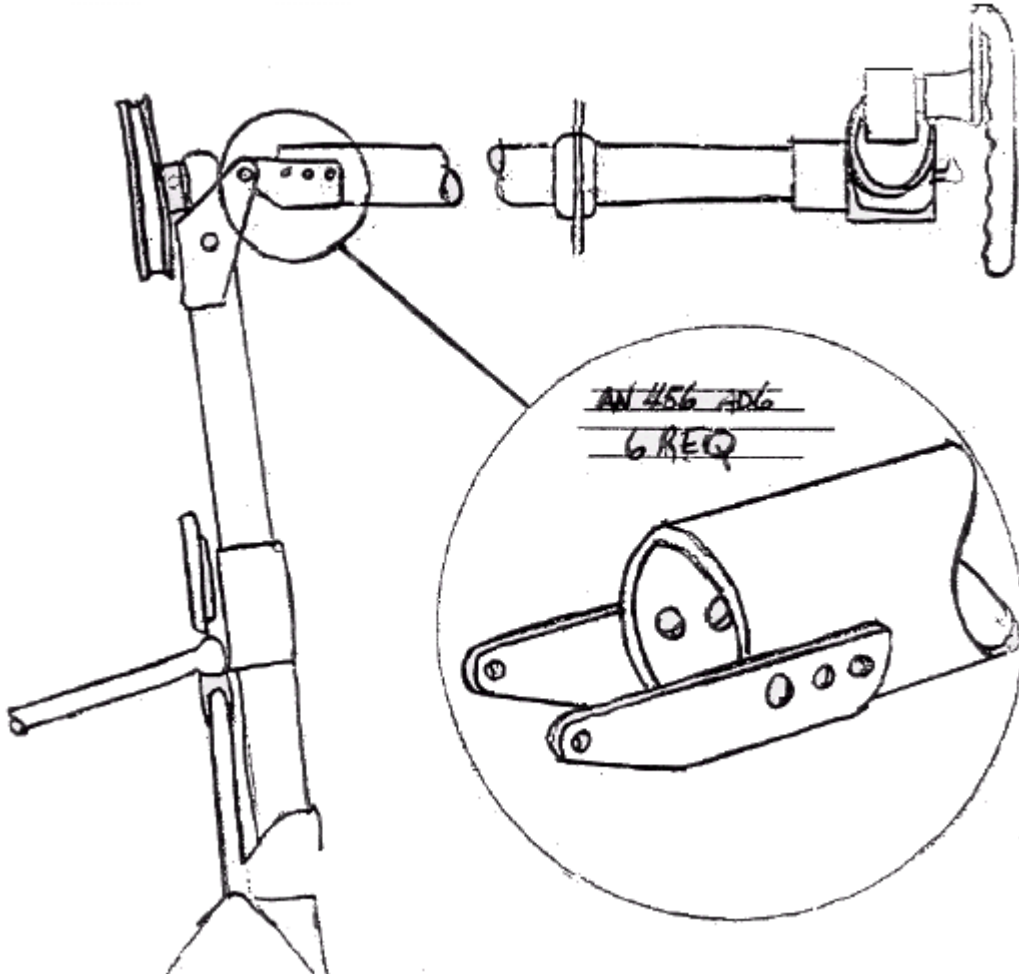
Note: Make these adjustments with ailerons neutral.

Flat side of gear segment must face co-pilot's wheel and be vertical

1. Remove torque tube shaft inside of push-pull tube by removing pin and sprocket on aft end of assembly and pulling torque tube shaft out forward end of tube.
2. Four (4) rivets holding the forked fitting on forward end of push-pull tube, if found to be 5/32", will be replaced with 6 (six) 3/16" rivets, AN456-AD6-6. If four (4) 3/16" rivets are already installed two (2) additional 3/16" rivets may be added (one on each side evenly spaced).
3. Check for satisfactorily formed riveted heads, then reassemble torque shaft and sprocket.

1. Install reworked push-pull tube assembly through instrument panel from forward side.
2. With ailerons in neutral set half moon on rear sprocket of tube assembly in vertical position (to match co-pilot assembly when installed).
3. Insert universal square into mating socket of pulley.
4. Install two (2) 1/4" clevis bolts, shear nuts and safety (tighten snug then back off one castellation).
5. Install yoke with three (3) AN502 screws and pilot's control wheel. Connect chain making sure wheel is horizontal and ailerons are in neutral. Check for proper aileron travel in both directions and correct tension of chain (tight with free movement of wheel).
6. Safety chain and fasten dust cover and reinstall co-pilot's wheel and pin.
