SERVICE BULLETIN

REPUBLIC AVIATION CORPORATION
FARMINGDALE, LONG ISLAND, NEW YORK
SERVICE DEPARTMENT

SERVICE BULLETIN NO. 10

ADDITION OF RELEASE INSTRUCTION ON AIR ASSOCIATES' SAFETY BELT

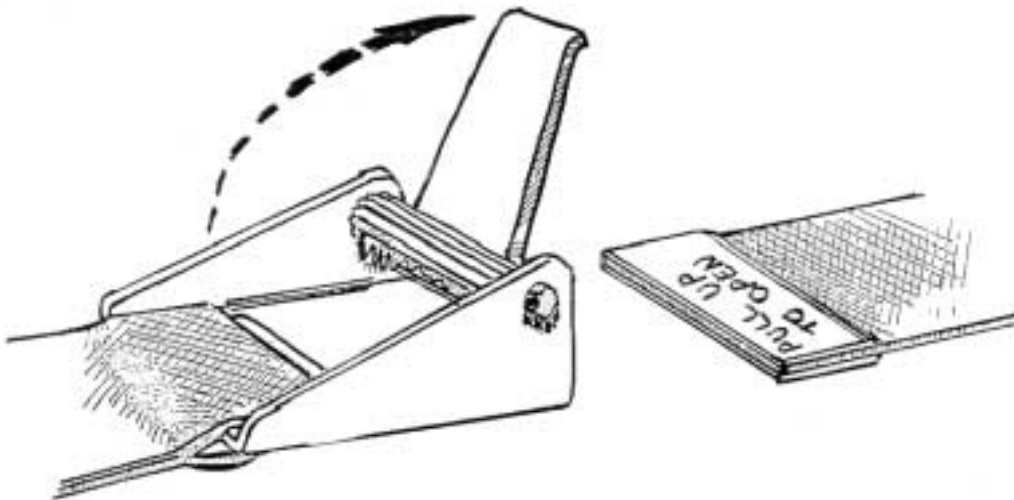
Reason for Change: To place the correct releasing instructions on each safety belt. If a load of 4 to 5 "G" has been placed on the buckle of these belts, it is extremely difficult to open the buckle by pulling up on its release lever even after this load has been reduced to 1 "G". However, the belt may readily be released by gripping the loose end of the belt and pulling upwards.

Airplanes Affected: Republic Serial Nos. 5 through 435 inclusive which have the Air Associates' Belt No. M265-50-C3; this is a C.A.A. (FAA) approved belt. Serial Nos. 436 and up have already had this change accomplished in production.

Description of Change: This change involves painting on the loose end of all Air Associates' No. M265-50-C3 belts "PULL UP TO OPEN". Refer to illustration of type of belt affected since alternate types of safety belts have been used on the Seabee.
