**REPUBLIC AVIATION CORPORATION
FARMINGDALE, LONG ISLAND, NEW YORK
SERVICE DEPARTMENT**

MANDATORY CHANGE

SERVICE BULLETIN NO. 11

**INSPECTION AND REINFORCEMENT OF MIXTURE CONTROL
SUPPORT FLANGE ON AIR FILTER HOUSING**

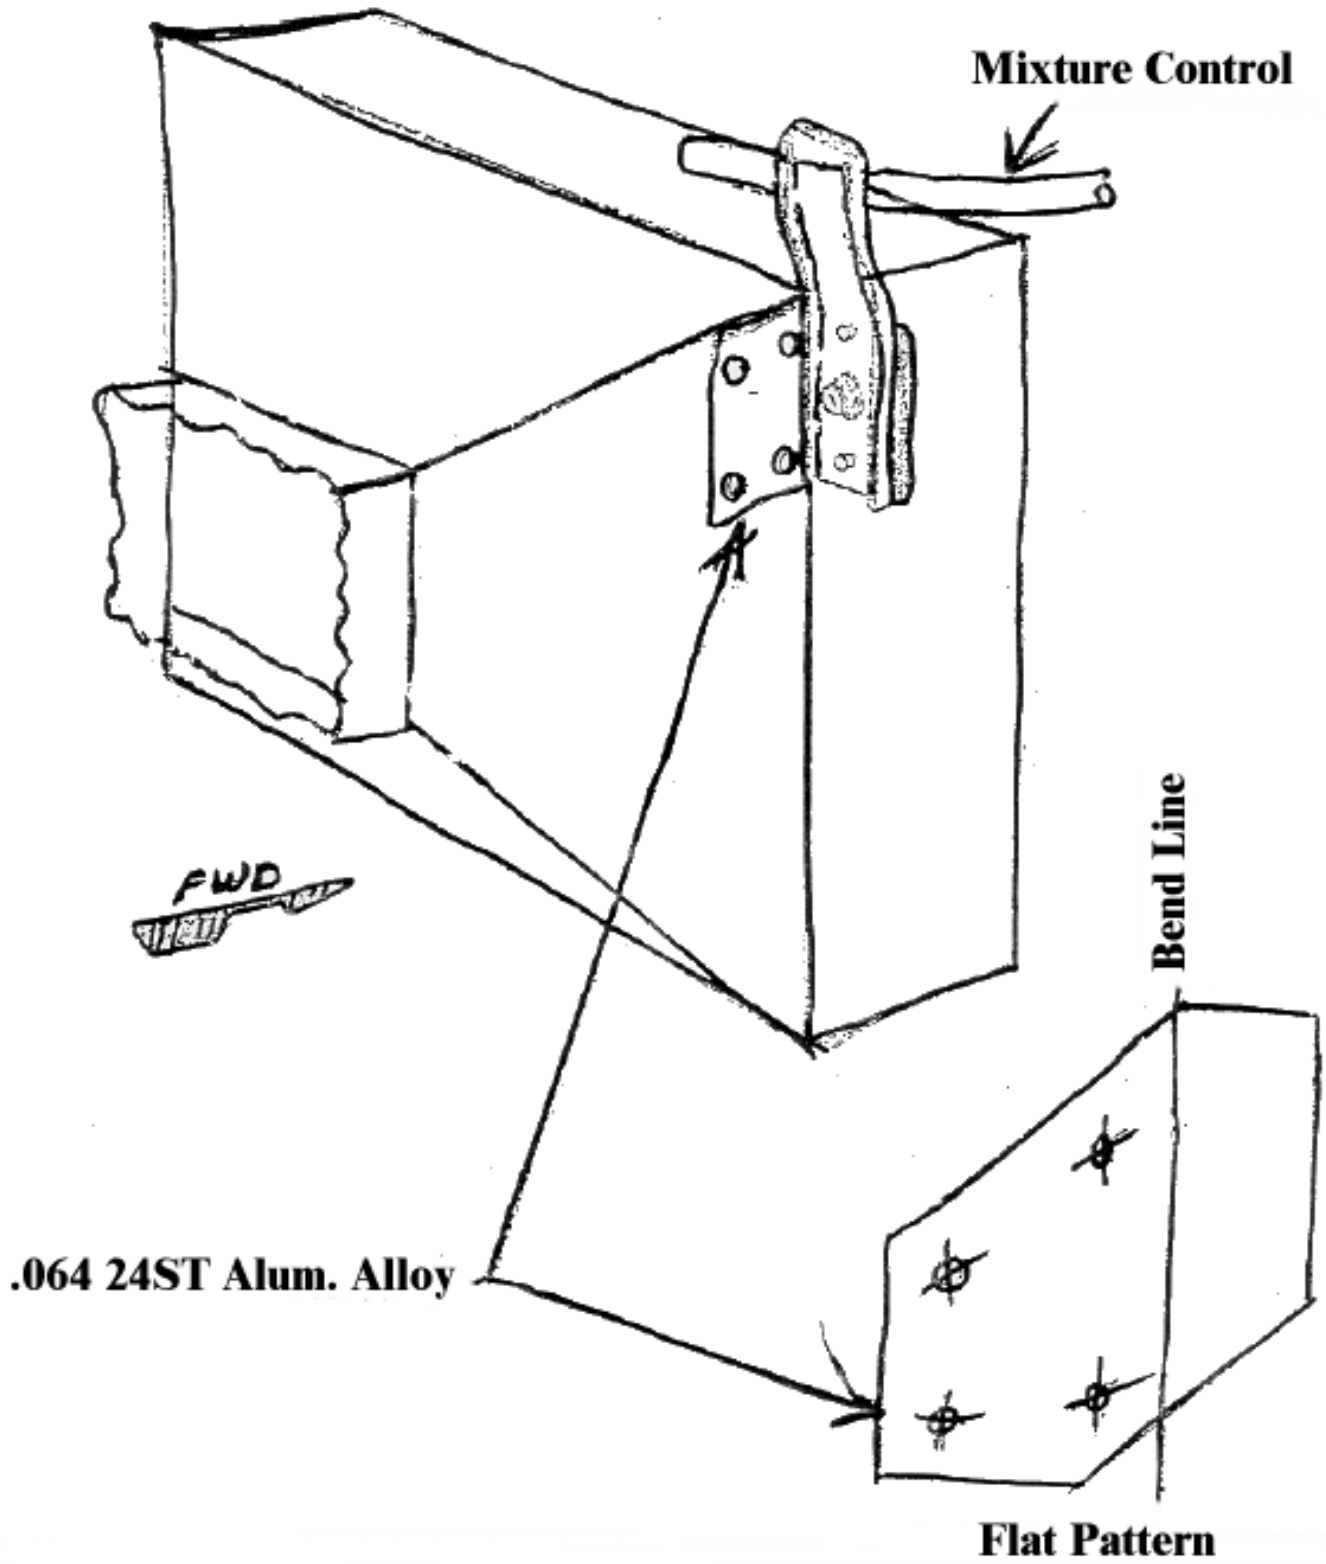
Due to three present failures the following modification is being made to prevent the mixture control support flange on air filter housing from breaking loose due to vibration and causing mixture control to go into idle cut off. Such a failure in flight could cause a forced landing.

1. Remove right hand side cowl if desired for greater accessibility.
2. Remove fuel strainer blast tube.
3. Detach mixture control from support at filter duct.
4. Remove air filter unit.
5. Drill out the two rivets holding the channel support to flange on side of air filter housing.
6. Make up a reinforcing piece from .064 aluminum alloy sheet approximately as shown on Fig. 1. Attach this reinforcing piece to the air filter housing with four No. 8 screws or bolts and self-locking nuts. Be sure that all chips resulting from drilling are cleaned out of the air filter housing.

7. Attach mixture control support to reinforcement and flange on air filter housing with No. 6 flush screws and self-locking nuts.
8. Reassemble mixture control to support, replace air filter unit, blast tube and cowling. Make suitable entry in log book.
9. Check mixture control for proper travel.
