**REPUBLIC AVIATION CORPORATION
FARMINGDALE, LONG ISLAND, NEW YORK
SERVICE DEPARTMENT**

MANDATORY CHANGE

SERVICE BULLETIN NO. 14

INSTALLATION ELEVATOR CABLE GUIDE

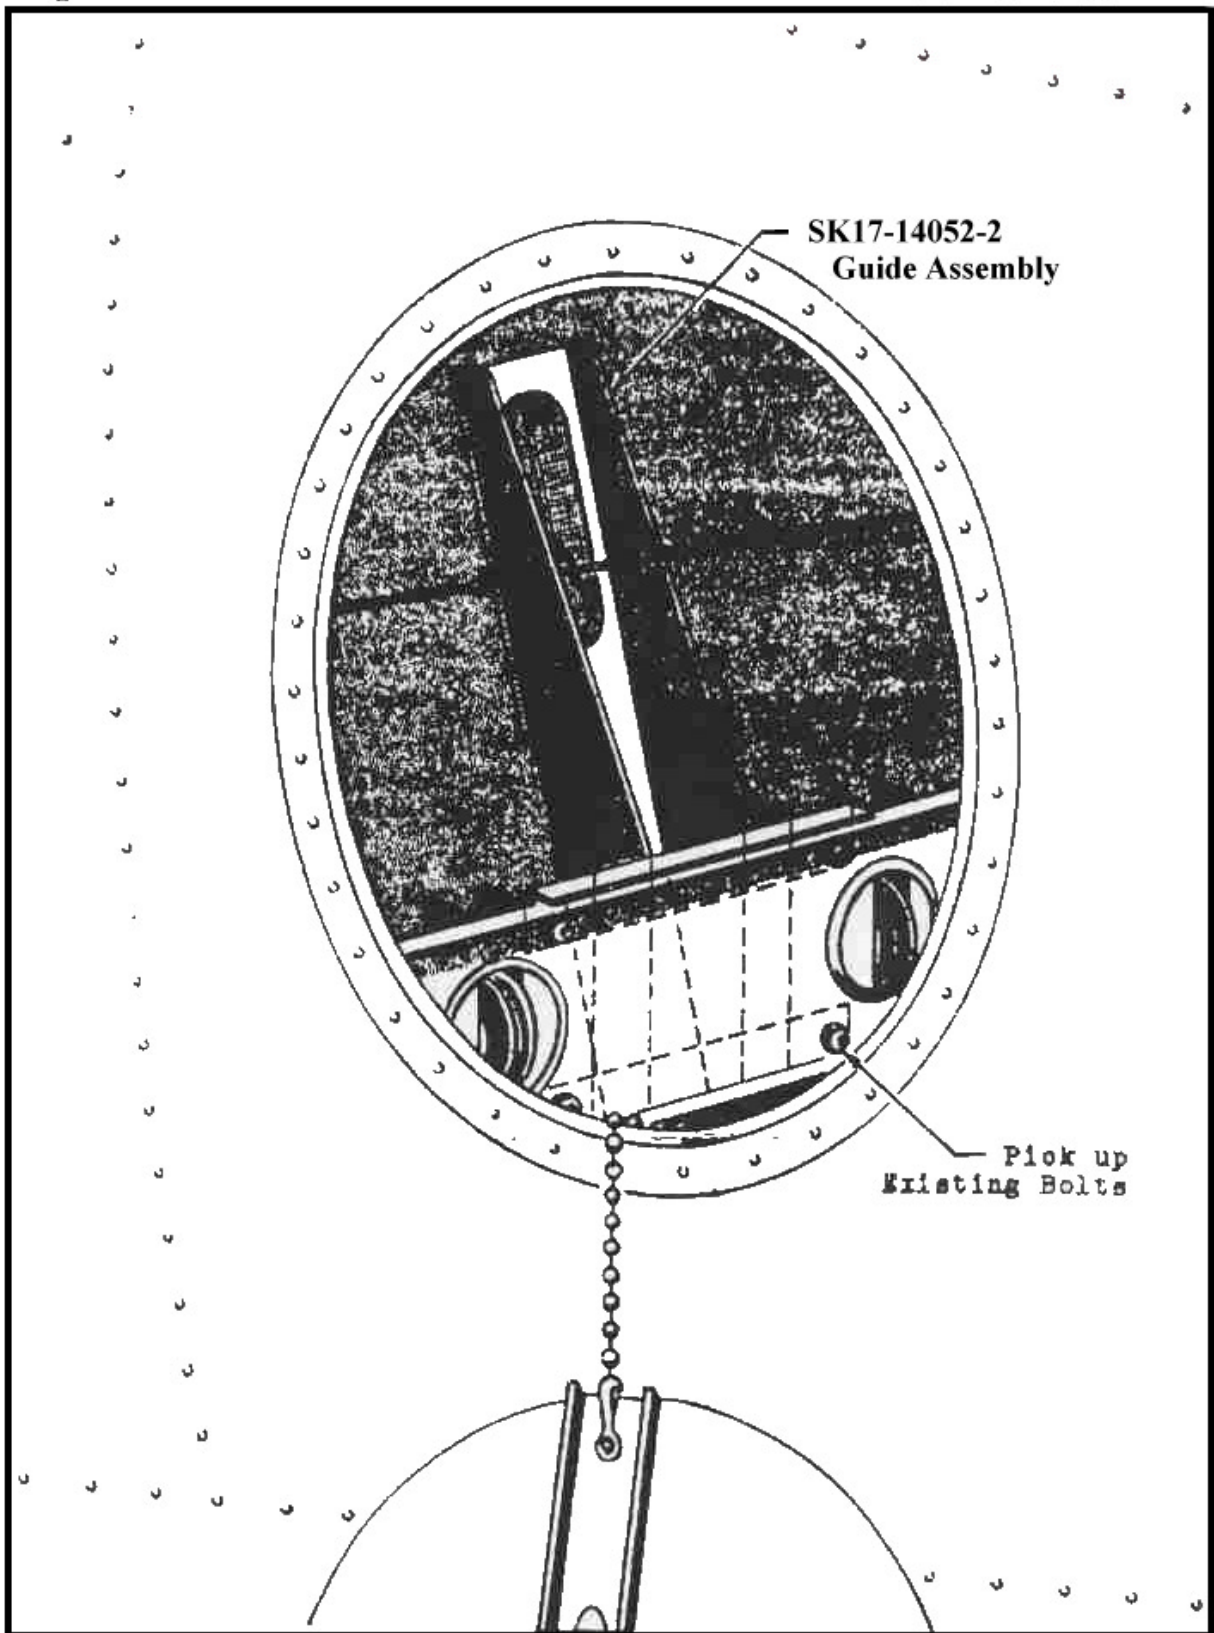
Reason for Change: To prevent the lower elevator cable in the tail boom from catching on the elevator bob weight.

1. Open aft handhole on left-hand side of tail boom.
2. Disconnect lower elevator control cable at forward end of turnbuckle accessible from the handhole.
3. Elevator Cable Guide SK-17-14052-2 is to be located as shown on figure 1. This is to be attached to the cross channel with the existing bolts holding the two inboard rudder pulley brackets. As only one hand may be used, it will be necessary to hold the nut while tightening the bolts by jamming a wrench against the structure.
4. Pass lower elevator control cable through the guide and reconnect turnbuckle putting sufficient tension on the cable. Proper cable tension is 20 ± 5 lbs. Safety wire turnbuckles.
5. Check operation of elevators, close handhole and make suitable entry in logbook.
