REPUBLIC AVIATION CORPORATION
FARMINGDALE, LONG ISLAND, NEW YORK
SERVICE DEPARTMENT

October 10, 1947

SERVICE BULLETIN NO. 20

INSPECTION OF TRIM TAB HORN AND ROD ATTACHMENT

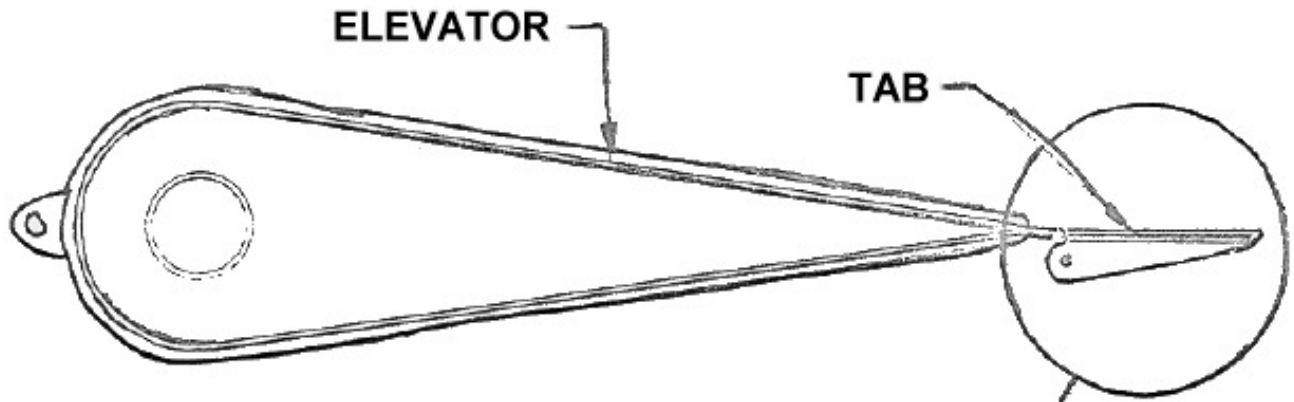
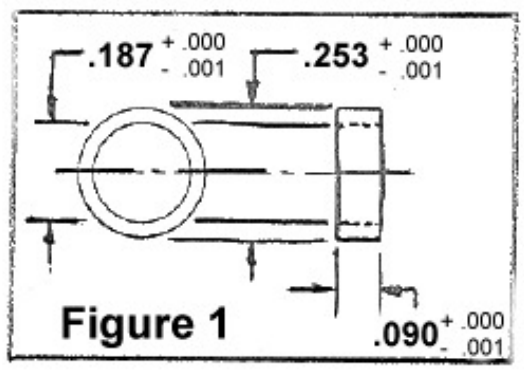
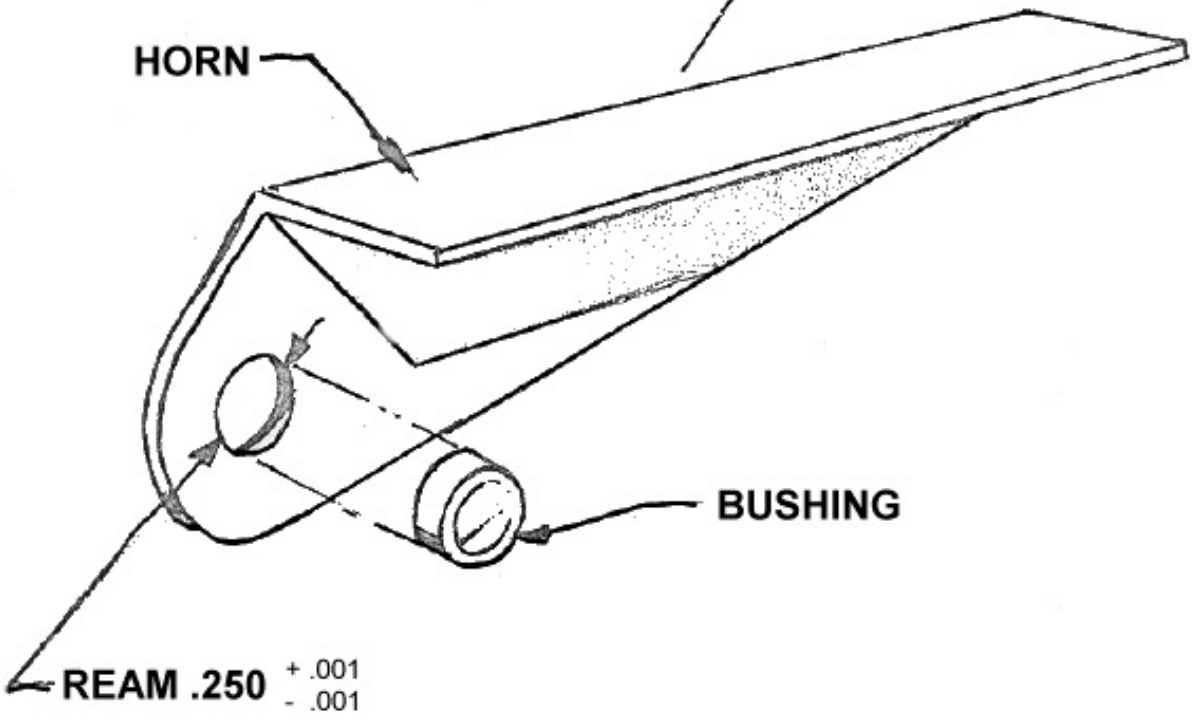
Reason for Change: An investigation of several recent reports of excessive vibration or buffeting in flight disclosed a wearing or elongation of the trim tab horn attaching hole which permitted play in the tab and resulted in the unsatisfactory flight characteristics such as elevator chatter.

Hold control rod forward of the attaching clevis fitting and check trim tab for play at the attachment. A maximum of 1/8" play is permissible when measured vertically at the trailing edge of the trim tab.

NOTE: A sketch of the bushing (see Figure 1) is reproduced to expedite immediate repair. If facilities are not at hand to accomplish this, these bushings will be available to you through your distributor at no charge.

1. Remove the cotter key and pin from the clevis fitting.
2. Enlarge hole in tab to 15/64".
3. Ream to $.250 \pm .001$.
4. Use a pair of parallel pliers or a suitable clamp to press the bushing into the hole.
5. Reassemble and lubricate the attachment,
6. Make suitable notation of compliance in the Aircraft Log Book.

1. For fabrication of the bushing described in Service Bulletin No. 20 use the following material:

5/16 dia., .065 thick – Seamless steel tubing – Cad. Plate.

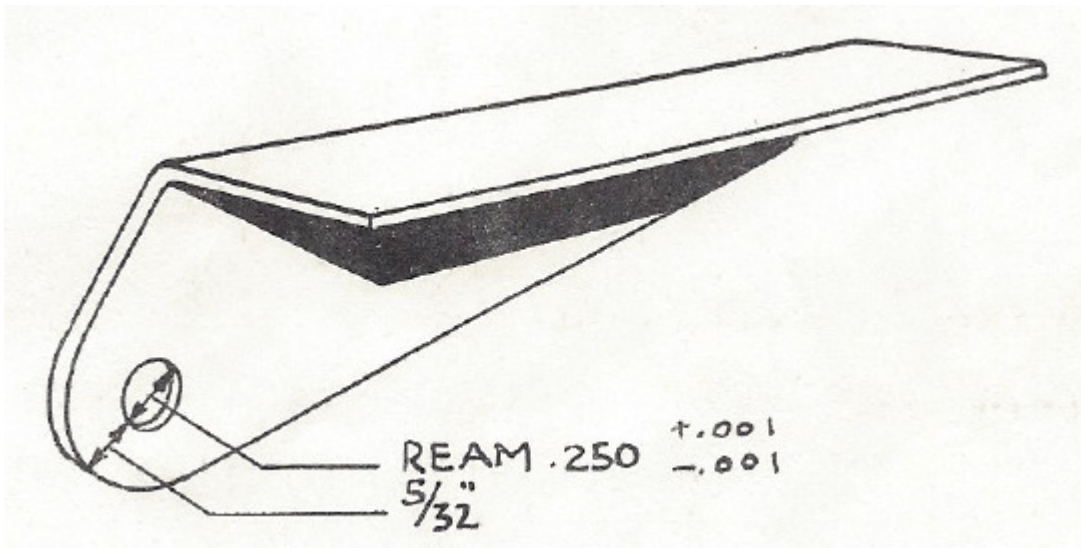
2. When reaming the bushing hole maintain a minimum distance of 5/32" at the radius edge of the trim tab. In the event it is found at the time of inspection that the previous wear will not permit holding to this tolerance, a replacement horn will have to be ordered and installed.
