# SERVICE BULLETIN

REPUBLIC AVIATION CORPORATION  
FARMINGDALE, LONG ISLAND, NEW YORK  
SERVICE DEPARTMENT

SERVICE BULLETIN NO. 20

## INSPECTION OF TRIM TAB HORN AND ROD ATTACHMENT

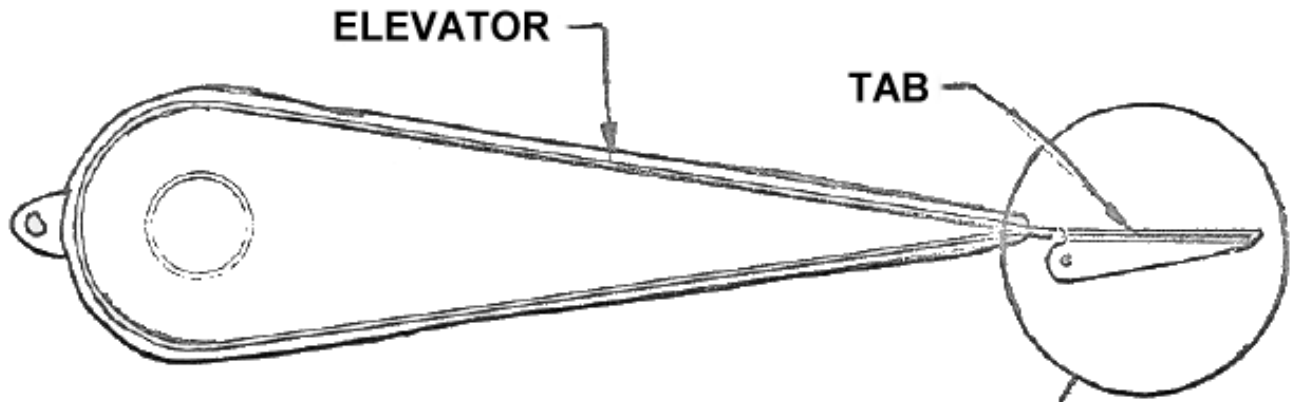
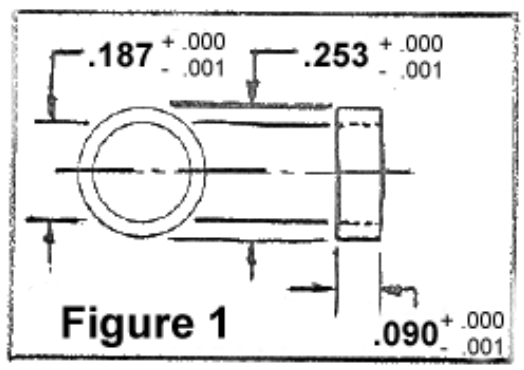
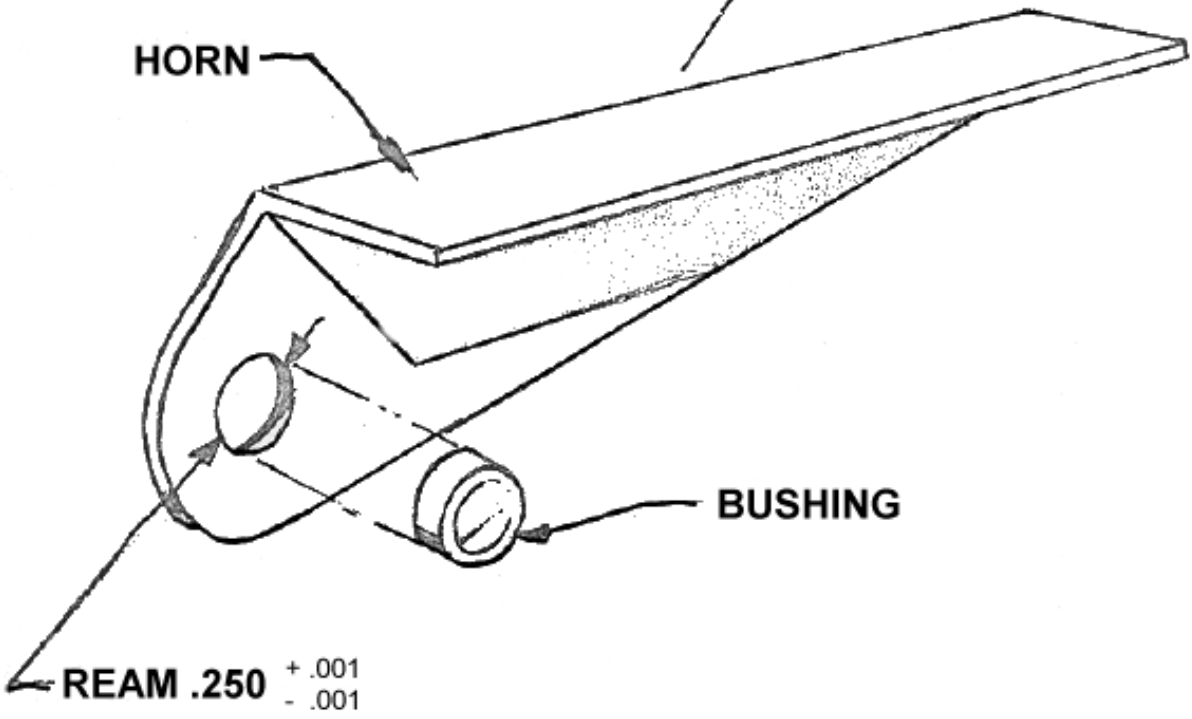
Reason for Change: An investigation of several recent reports of excessive vibration or buffeting in flight disclosed a wearing or elongation of the trim tab horn attaching hole which permitted play in the tab and resulted in the unsatisfactory flight characteristics such as elevator chatter.

NOTE: A sketch of the bushing (see Figure 1) is reproduced to expedite immediate repair. If facilities are not at hand to accomplish this, these bushings will be available to you through your distributor at no charge.

1. Remove the cotter key and pin from the clevis fitting.
2. Enlarge hole in tab to 15/64".
3. Ream to .250 ± .001.
4. Use a pair of parallel pliers or a suitable clamp to press the bushing into the hole.
5. Reassemble and lubricate the attachment,
6. Make suitable notation of compliance in the Aircraft Log Book.
