REPUBLIC AVIATION CORPORATION
FARMINGDALE, LONG ISLAND, NEW YORK
SERVICE DEPARTMENT

SERVICE BULLETIN NO. 21

INSTALLATION OF PROPELLER SAFETY SPRING

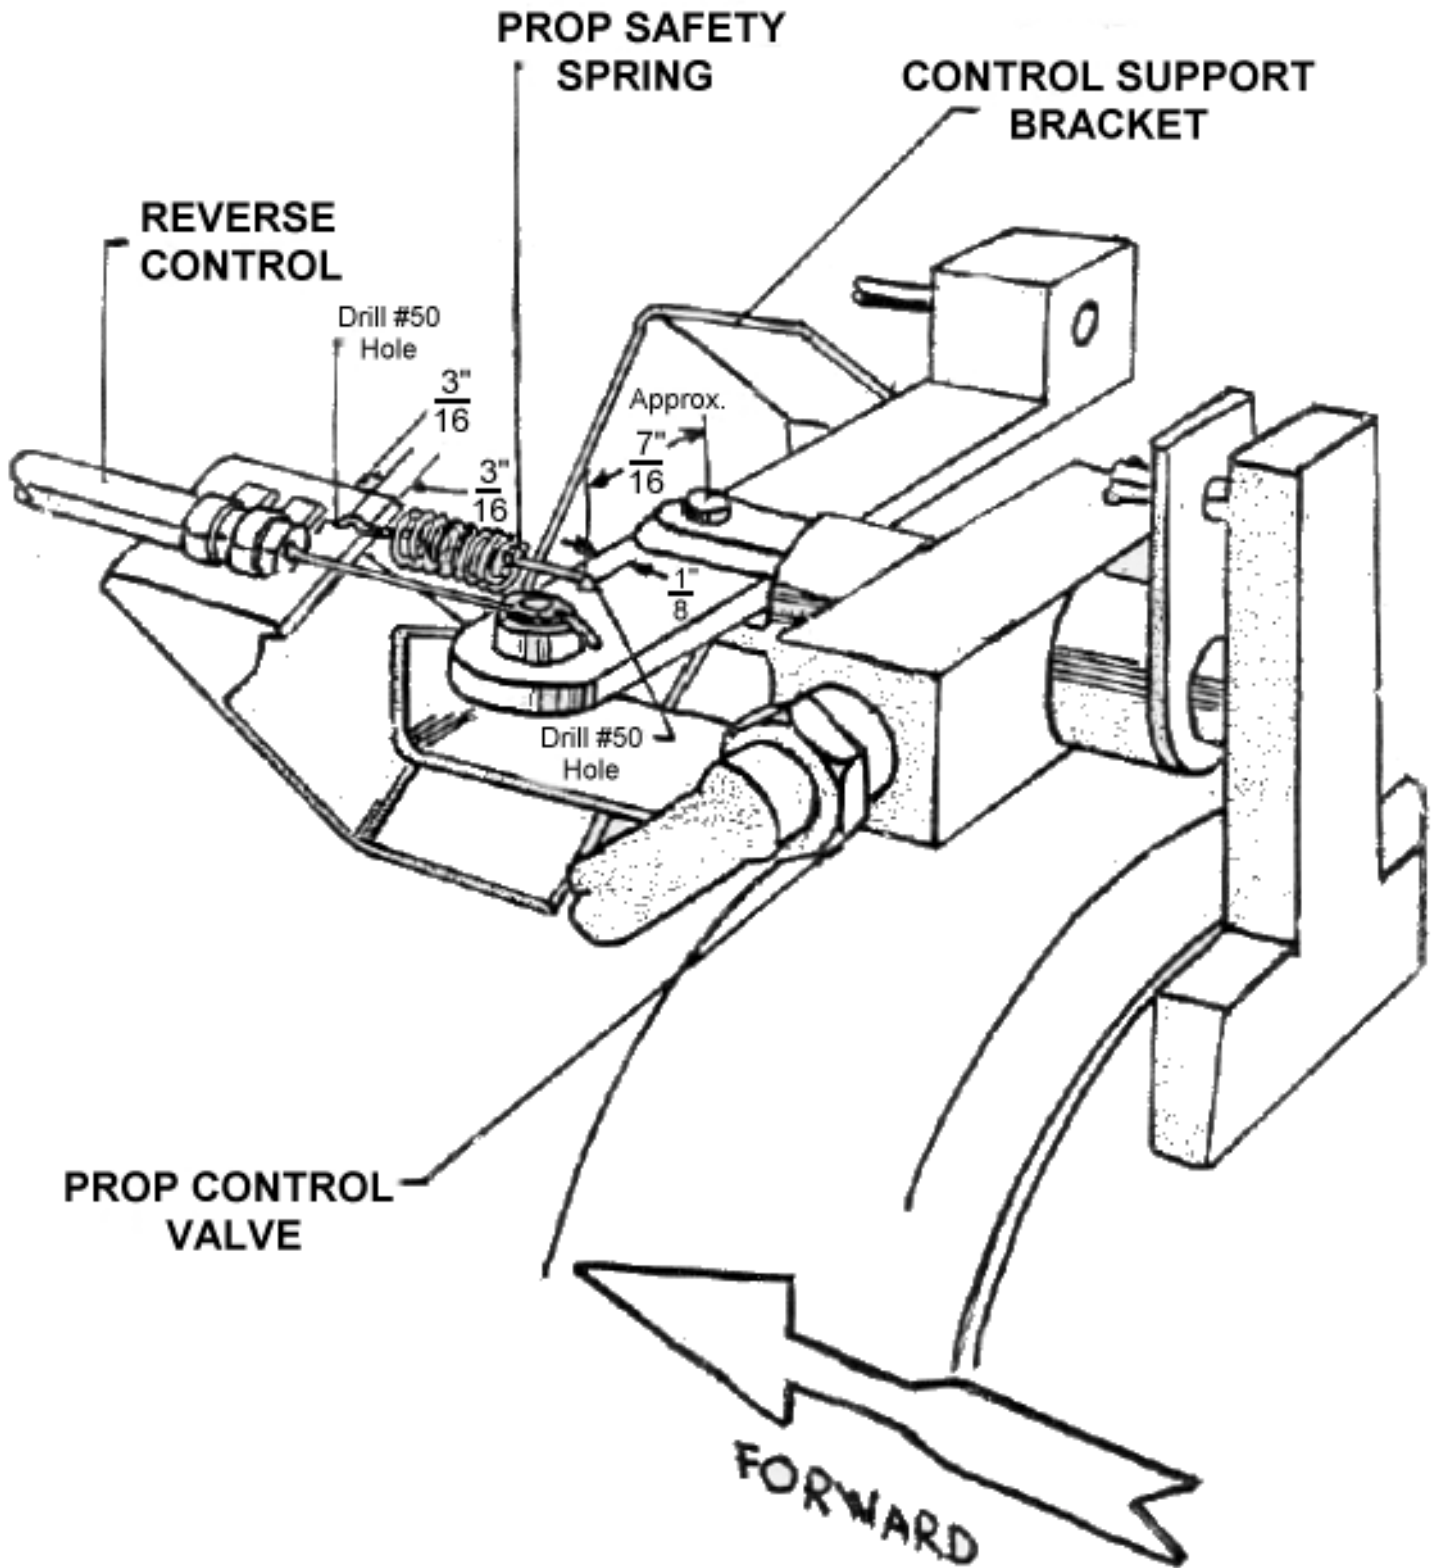
Figure 1

To install a safety spring to prevent the propeller from inadvertently going into reverse pitch in the event of failure of the reverse control wire (cable).

1. Unlatch and lift top engine cowl.
2. Drill hole with No. 51 drill in each of two locations shown on Figure 1.
3. Install SK-18837-1 spring.
4. Due to variations in the internal friction of the propeller control valve, it is suggested that the reverse control wire (cable) be temporarily disconnected, after the safety spring is installed and running the engine with the propeller pitch control in both high and low pitch to check the effectiveness of the safety spring in preventing the propeller from going into reverse pitch.
5. Reconnect the reverse control wire (cable).
6. Make complete ground check of propeller operating controls.
