**REPUBLIC AVIATION CORPORATION
FARMINGDALE, LONG ISLAND, NEW YORK
SERVICE DEPARTMENT**

SERVICE BULLETIN NO. 25
Supplement No. 2

CORRODED FITTINGS

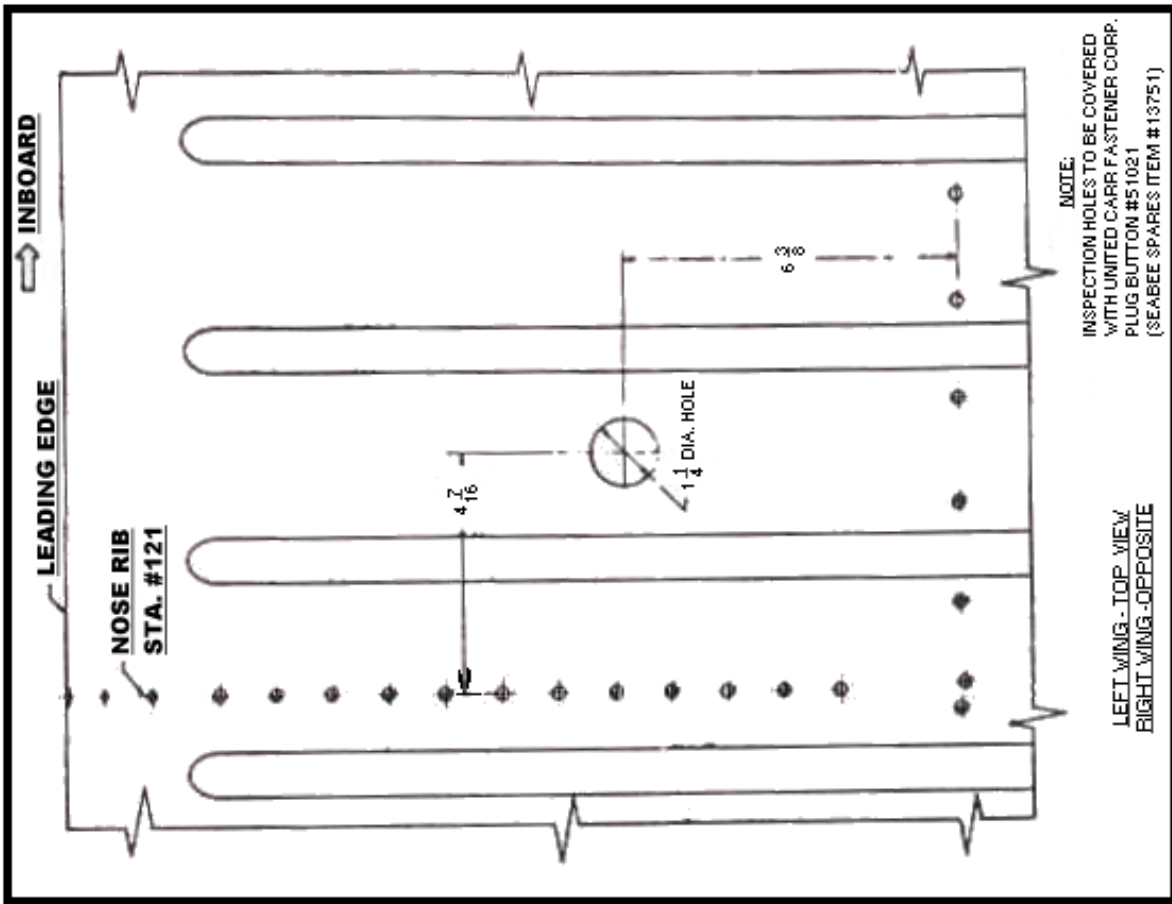
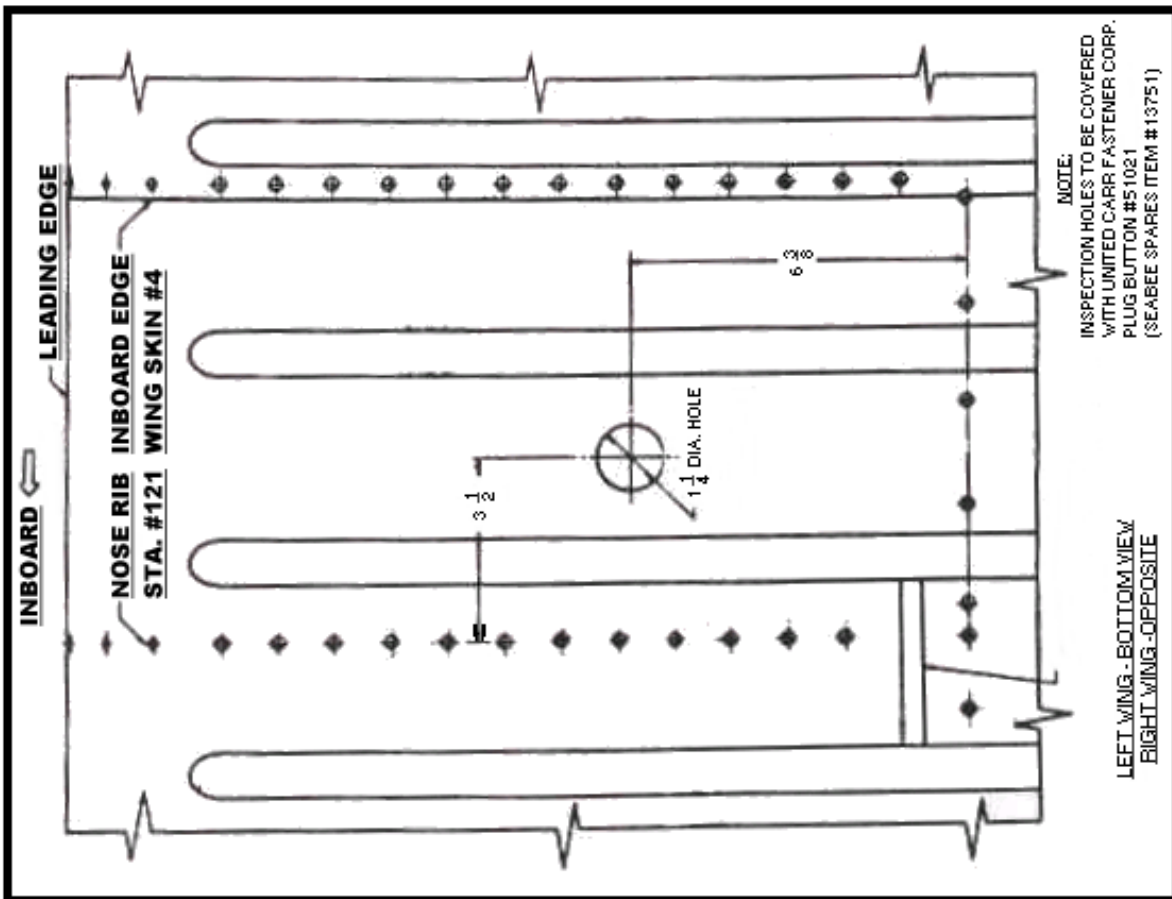
An instance of severe granular corrosion has been reported affecting Part Number 17W22004-1 L/R, Strut and Spar Attachment Assembly which, was referred to in Supplement No. 1 of Service Bulletin No. 25 dated July 15, 1950.

Supplement No. 1 stated that inspection of the section of the fitting inside the wing was not considered necessary unless indications of corrosion were noticed on the section protruding below the wing skin. Since the corrosion on the part referred to above was NOT evident on the section protruding below the skin, a thorough inspection should be made of the part WITHIN each wing, inboard and outboard of the nose rib Station 121, immediately and every six months or 25 hours, whichever occurs first. Access to the part may be gained by means of the accompanying installation sketch or in any manner which will provide adequate inspection facilities installed in accordance with approved C.A.A. practices.

Inspection should be made with the aid of a light (preferably with a goose-neck extension) and a sharp pointed instrument in order to determine the condition of the fittings. Should slight surface corrosion be found which has not, in the opinion of an accredited Inspector, affected its strength the instructions noted in the original issue of Service Bulletin No. 25 covering the treatment of corroded surfaces should be followed. If the corrosion has progressed to the extent of making it unsafe, the airplane should be grounded until new fittings (P/N 17F22004-1 L or R) are procured.
