Service News

No. 35

ADDITION OF STIFFENER AND GUSSET FOR HULL BOTTOM

AT STATION 30

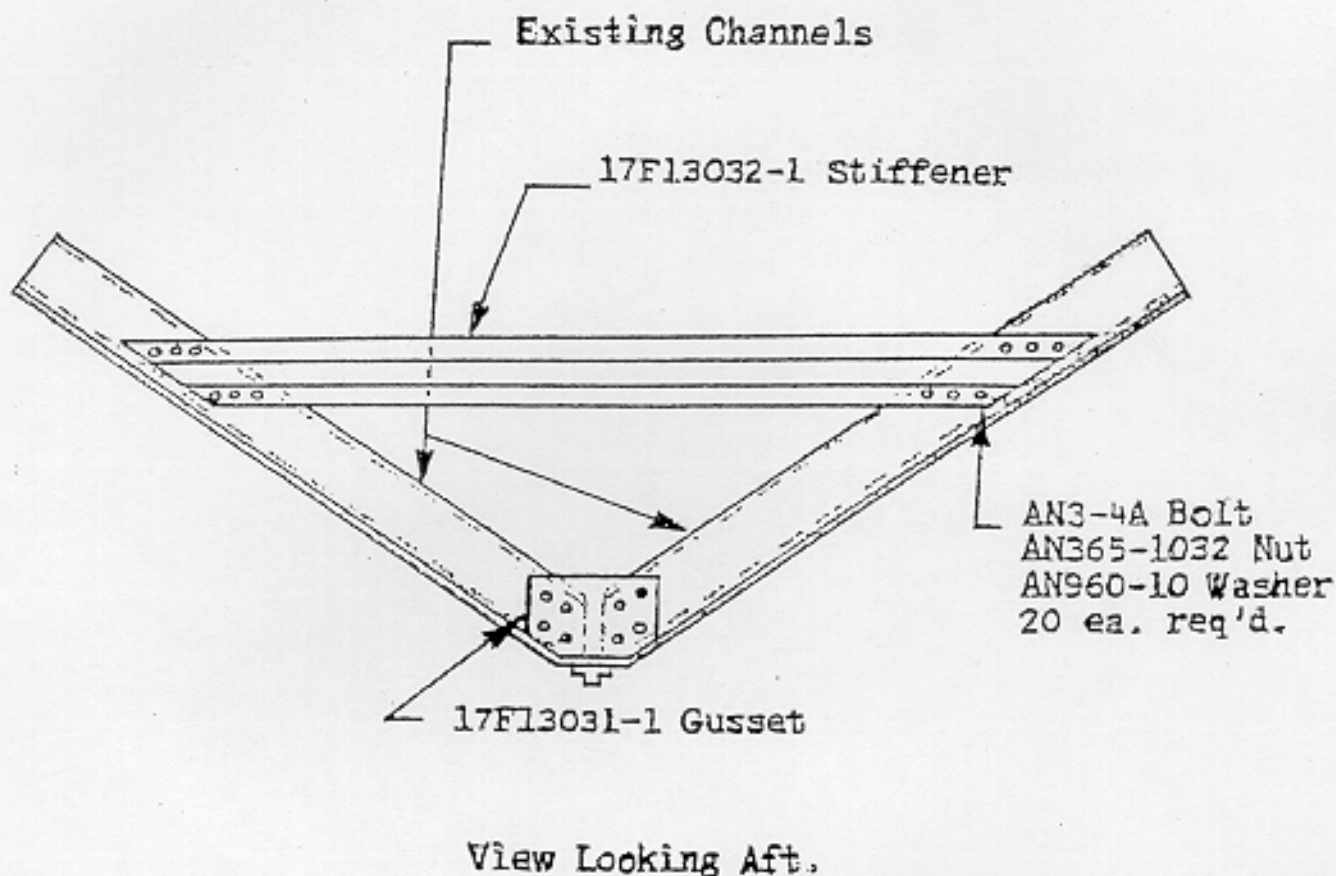
Due to reports of rivets popping out and channel reinforcements being damaged on the hull bottom at station 30, two stiffening members have been designed to strengthen the hull bottom at this point. One member is a gusset which ties the two existing channels together at the bottom and the other member is a hat section which ties the existing channels together near the top. Both the gusset and hat section are easily installed with bolts and nuts.

Gusset 17F13031-1 and Stiffener 17F13032-1 may be installed as shown below. Access to Station 30 is obtained thru the anchor hatch. Drill #10 (.194) holes thru the existing channels for attaching gusset and stiffener with hardware provided.
