REPUBLIC AVIATION CORPORATION  
FARMINGDALE, LONG ISLAND, NEW YORK  
SERVICE DEPARTMENT

No. 35

**ADDITION OF STIFFENER AND GUSSET FOR HULL BOTTOM  
AT STATION 30**

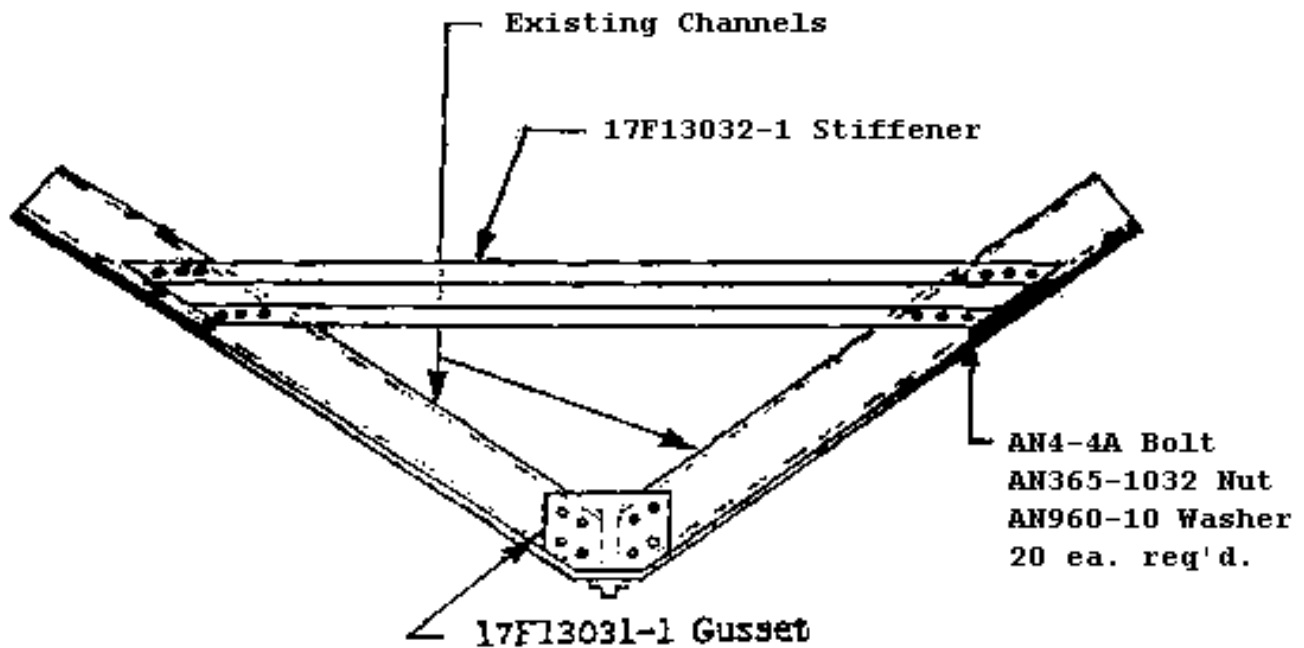
View Looking Aft.

Due to reports of rivets popping out and channel reinforcements being damaged on the hull bottom at station 30, two stiffening members have been designed to strengthen the hull bottom at this point. One member is a gusset which ties the two existing channels together at the bottom and the other member is a hat section which ties the existing channels together near the top. Both the gusset and hat section are easily installed with bolts and nuts.

Gusset 17F13031-1 and Stiffener 17F13032-1 may be installed as shown below. Access to Station 30 is obtained thru the anchor hatch. Drill #10 (.194) holes thru existing channels for attaching gusset and stiffener with hardware provided.
