REPUBLIC AVIATION CORPORATION FARMINGDALE, LONG ISLAND, NEW YORK

No. 51

CORROSION PREVENTION TREATMENT FOR CABIN DOORS

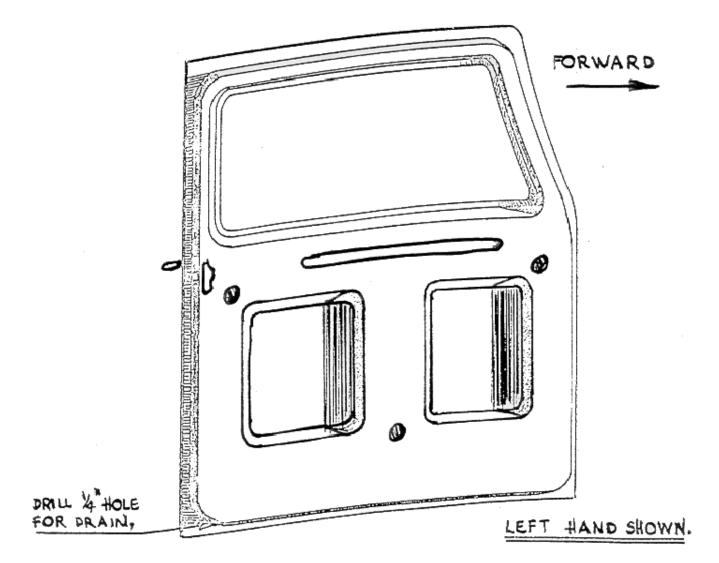
Recently several instances of Seabee cabin doors showing signs of corrosion were brought to our attention and the condition was subsequently investigated as to cause and cure by our research laboratory.

This corrosion is related to the fact that under unusual atmospheric conditions condensation may occur between the inner and outer shells of the spotwelded doors.

In view of the above it is recommended that all Seabee owners inspect their airplanes to assure themselves of the inclusion of $\frac{1}{4}$ " holes in the lower rear corner of each door in conformance with the accompanying illustration.

- 1. Remove the door to be treated from the airplane by pulling the hinge pins.
- 2. Remove the upholstery from the door.
- 3. Fashion a plug from ordinary cork to seal temporarily the drain hole.
- 4. Mix a solution of 2 ¹/₂ lbs. Of Sodium Dichromate with 1 ¹/₂ gallons of warm water. (Standard commercial quality Sodium Dichromate retails at approximately 10 cents per pound.)
- Position the door with the outer shell down and pour the solution into the doors through the (2) 1-13/32" holes in the inner shells. Fill the door slowly to the saturation point and permit to soak for approximately ¹/₂ hour.
- 6. Remove the plug from the drain hole and partially raise door to an upright position permitting the excess solution to drain for a minimum of 12 hours.
- 7. When dry replace the upholstery and reassemble door to cabin.
