REPUBLIC AVIATION CORPORATION
FARMINGDALE, LONG ISLAND, NEW YORK
• • • SERVICE DEPARTMENT • • •

No. 55

SEAM WELDED WING FLOATS

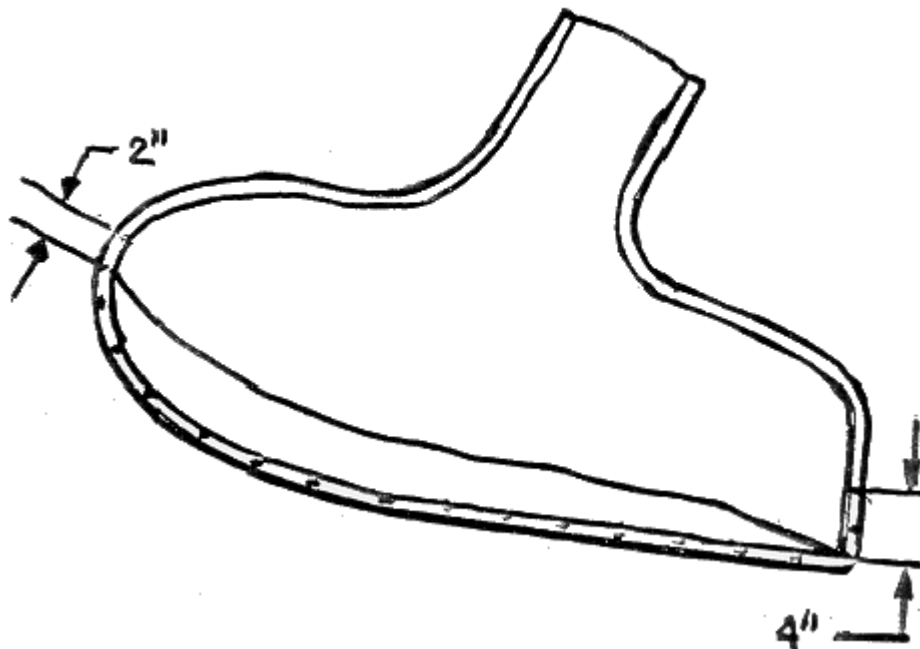
A few failures of the Wing Float Seam Welded Flanges have been reported to us which have undoubtedly been caused by inordinately hard landings in water or when the Seabee has landed under abnormal and unsafe operating conditions not considered in its design. These resulted in sudden changes in water loads on the floats, which flexed the welded seams and eventually permitted them to separate.

It is recommended that if your Seabee has been subjected to either of the above conditions, an inspection be made and any open seams repaired with AN456-AD4 rivets, using a one-half inch pith extending one inch beyond the ends of the split after applying Zinc Chromate Compound in the crack.

As a precautionary measure and in order to eliminate the possibility of future failures of these assemblies from the same causes AN456-AD4 rivets, with a two inch pitch, may be placed as indicated in the sketch shown below.
