REPUBLIC AVIATION CORPORATION
FARMINGDALE, LONG ISLAND, NEW YORK
• • • SERVICE DEPARTMENT • • •

No. 58

LANDING GEAR TORQUE TUBE ASSEMBLY

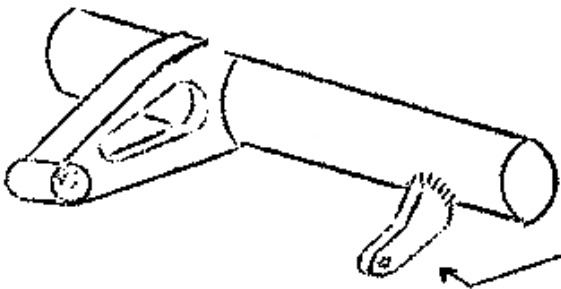
There have been a number of failures of the Landing Gear Actuating fittings. An examination with a 20X magnifying glass will determine if cracks at the base or in the weld are present. The item number is 1110 for the Torque Tube and Actuator Assembly. (Electrol, Inc, Drawing Number A5110).

**FITTING THAT FAILS.
HYD. ACTUATING CYLINDER
ATTACHES TO THIS FITTING.**

A recommended repair is to grind off all existing weld down to parent metal and arc weld with nickel steel rod, building up the bead around the fitting.
