<u>The Marty B II</u>

Unless otherwise noted photos and article by Steve Mestler

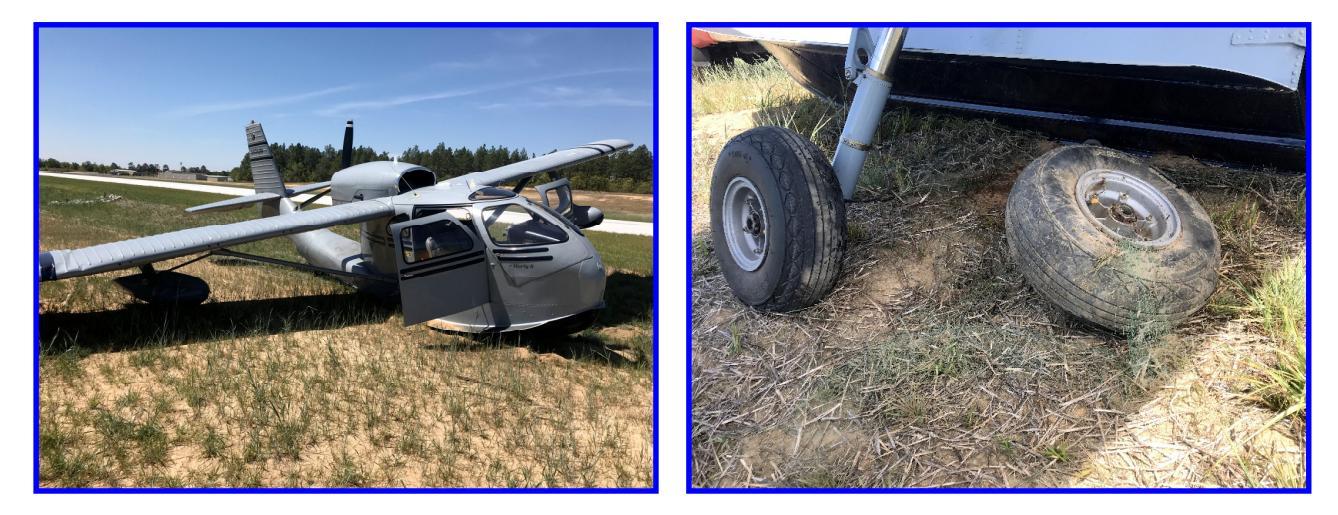
Before

The Seabee departed the runway surface and into the grass but wait, there's a ditch! Well below flying speed hitting the ditch was inevitable. As the Seabee continued on its journey I was just along for the ride. The down slope of the ditch was not the problem the up slope was! It hit at an angle, which caused the right main gear to separate from the Seabee. The separated gear then went under the hull and down into the valley of the ditch. The Seabee, controlled by Newton's third law of inertia, continued on past the ditch and the right wing hit the sandy terra firma. It bent the right wing up at about a 10-degree angle from the float strut attach point out and took out the right wing float, float strut and damaged the right flap as well. In a cloud of dust the Seabee finally came to rest. Engine still running.

After I shut the engine down, I got out and looked over the Seabee. What a catastrophe! If it were not for that &#\$%* ditch I would have taxied to the fuel pumps, got gas, started up and flown home to Whiteplains where the winds were more favorable. About ten minutes after the "incident", I got a call from NOAA; "We see you are at Lexington Executive Airport. Is everything ok?", said the man at the other end of the phone. I said, "yes, no one hurt." The ELT in the Seabee had activated and NOAA knew exactly where I was. I didn't even think about the ELT but those 406 ELT's really do work. I made the next phone call to a friend at Whiteplains and explained the situation. Within an hour we had four trucks and trailers ready to haul my Seabee home and within three and a half-hours it was in my hangar in four or five big pieces. (An amazing bunch of people at Whiteplains). Now I had to decide what to do. Rebuild? Scrap it? Donate it? I had to take time to think.

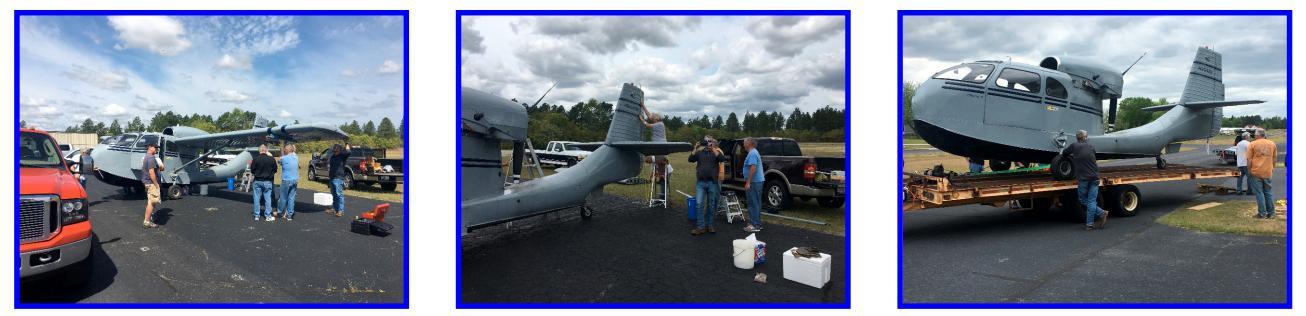
Whiteplains crew during disassembly (photos by Mike Moore)

After much consternation and discussion with the local mechanics and friends, we decided to rebuild. When something like that happens it always seems to not be that big of a deal but it eventually was. This was April 2018.

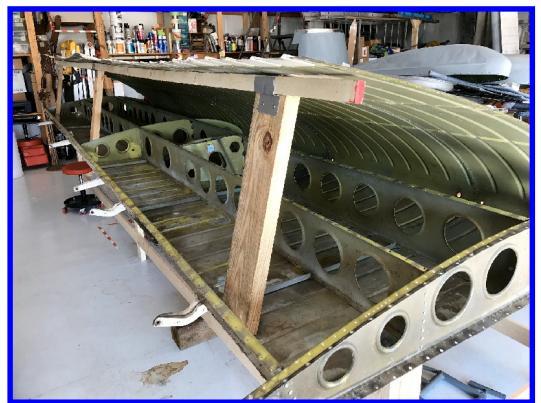
The new standard wing was a different story. After the "new" wing was in my hangar the real fun began. The wing only had 200+ hours on it BUT it had been in storage for who knows how long. Many animals and insects decided to make this wing their home and remnants of their nasty hygienic habits posed a real challenge to get this wing in shape. It was obvious the wing had to come apart to be cleaned, primed and painted. With the help of a "super mechanic" at Whiteplains the wing was disassembled. I had never done anything of this magnitude on my Seabee before but with the help at hand it was do-able. All the upper rivets had to come out and the aft spar had to come off to allow for bucking the rivets close to the leading edge. When the top rivets were out, the trailing edge was supported to aid in internal access. All the hardware inside the wing was changed. The hydraulic lines and flap actuator was changed. All the wiring was changed. The wiring was the original Republic wiring with the fabric covering which was not acceptable. The aileron cables were changed.

"New" wing before (Partially cleaned)

The cleaning started by just rinsing out the loose stuff inside. Birds, mice and who knows what made their nests in the wing for decades. Uugh! What a miserable job. I finally got down to bare metal (at least the zinc chromate primer) and etching and priming began.

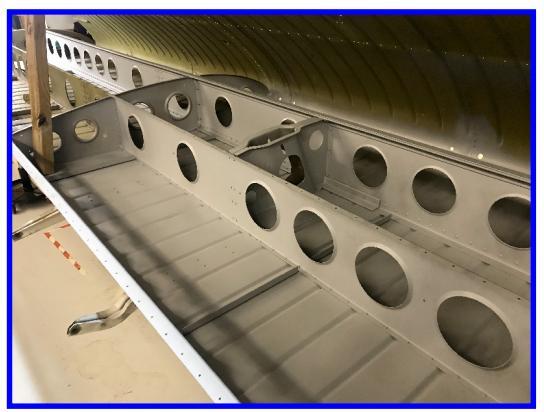
"New" wing after priming (Acid etch primer)

When I was satisfied, it was time to close up the wing. Starting from the leading edge my helpful mechanic and I drove rivets moving aft ever so slowly checking each rivet after each one was set. There were four or five different

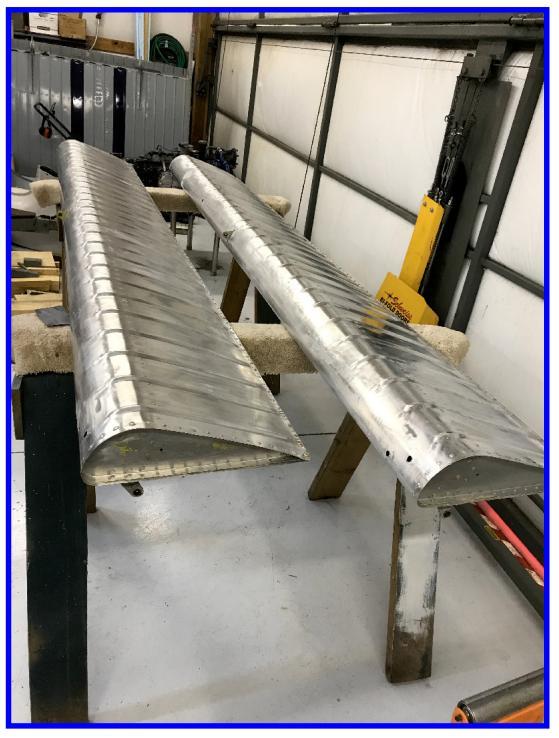
"New" flaps ready for primer

Because the left wing was lengthened caused the flaps to be lengthened as well which meant they had to be shortened OR new ones installed. I was lucky to have a set of original flaps I could use but they were in the same shape as the "new" wing. Mice, birds and bears oh my! They must be taken apart, cleaned, primed and painted; more laborious work.

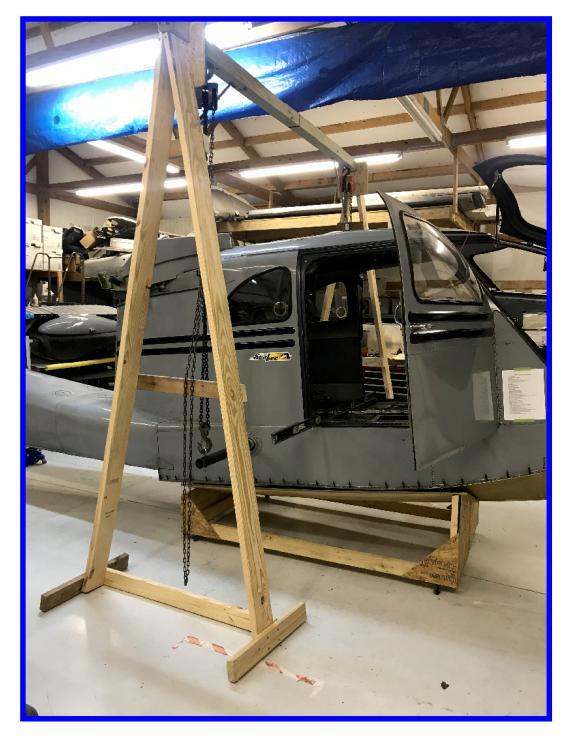
"A" frame and hull cradle in position

The Seabee was raised using a 2×6 "A" frame with chain falls on either side. Two well-poised men were in charge of lifting the Seabee at an even rate high enough to get the Seabee off the ground enough to place the hull cradle in position.

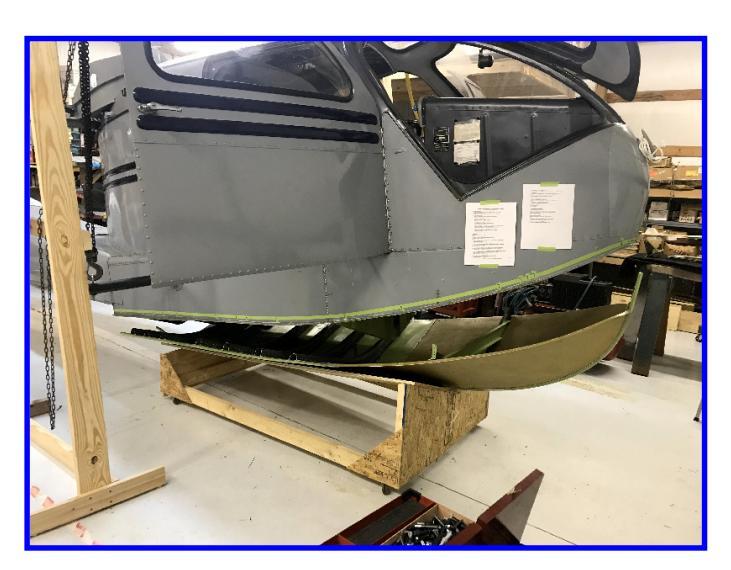
Hull Cradle supporting the bottom

Our attention then went to the removed hull bottom. We noticed a few spots that had separated the bow skins from the hull bottom at the seams and new rivets were installed along with copious amounts of ProSeal. It was now time to gather the "Seabee Army" to rivet the bottom onto the fuselage.

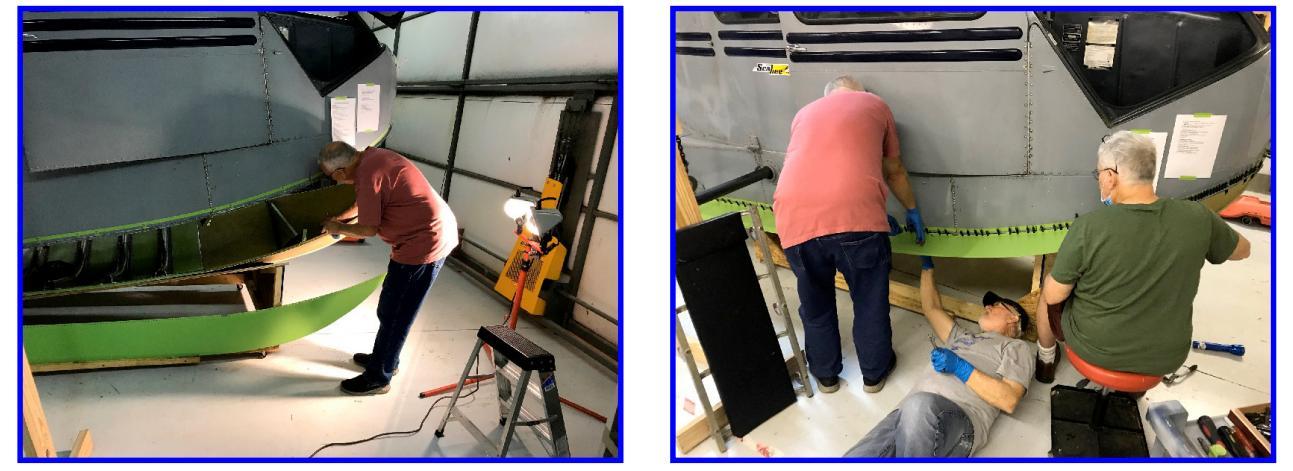
The Seabee "Army" at work

On the faithful day the bottom was repositioned under the fuselage, the spray rails put in position next to the respective fuselage side and one guy (me) was charged with mixing ProSeal while the others brushed it on the edges of the hull bottom and the bulkheads. We had two hours to complete the entire mission. The plan was to Cleco the bottom, with the spray rails, on completely...in every hole! We found that the draw Clecos (with the hex head) worked best as you can tighten them way down to form a tight seal.

Compressors were started and commencement of the hammering began. This four-man Army operated like a fine Swiss watch. Rivets were organized by size and positioned next to the hull and the ProSeal kept coming. It turns out that the ProSeal (thinned slightly with Toluene) stayed workable 'til we were ready to drive rivets. All the rivets were checked more than once and some were replaced more than once. All in all it went very smoothly thanks to very competent help.

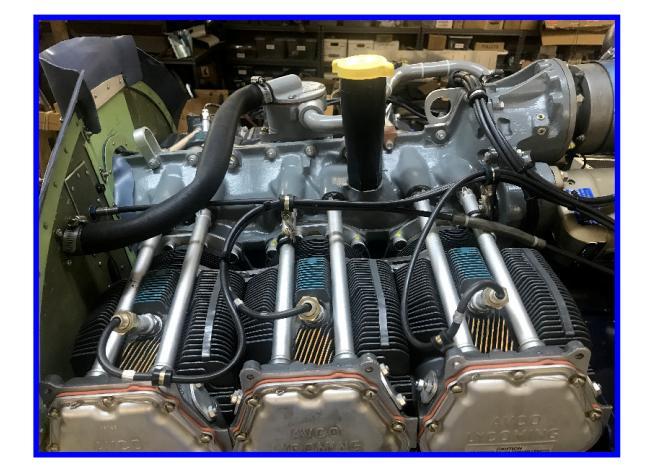
Newly overhauled GO-480-G1D6 ready to go

The GO-480-G1D6 engine had been sitting on the pallet for 5 years! It was covered with plastic and the desiccant plugs installed. I did let the plugs lapse a bit and after a Borescope of all cylinders my friendly mechanic and I decided to take the cylinders off and inspect them more closely. The Borescope revealed what we thought was corrosion on the cylinder walls. After the cylinders were removed we found that most of the "rust" was the preservative oil the engine company installed. There was a small amount of rust close to the top of the cylinder and I dressed each one out with an abrasive pad. If I had known the cylinders looked that good I would have flown it that way!

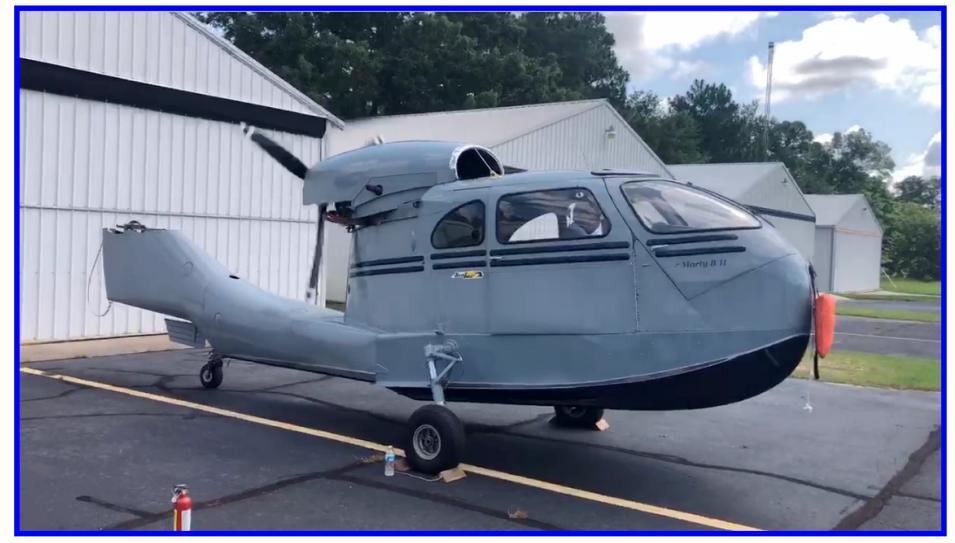
First engine run (Photo by Ed Fisher)

During the engine run the temperatures were noted and the cylinders never got over 350° F (redline is 475°). Granted, the engine was running at 1200 RPM for just 5 minutes but I was happy so far. All the engine instruments worked. The electric fuel pump, which is required to get fuel up to the engine, worked flawlessly (Almost TOO flawlessly). The fuel pressure from the pump should be 9-16 psi but I was getting over 20 psi! (I'll have to get that checked out). The engine was shut down and the inspections began. No oil leaks, no fuel leaks and all fasteners were secure. What a good day! The "Army" was given the day off.
