Elevator Trim Rigging and Adjustments

Except where noted otherwise, photos and article by Steve Mestler

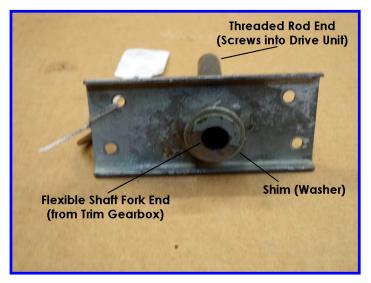
2- The drive unit that the threaded trim tab pushrod screws into has excessive play. A shim <u>MAY</u> solve this problem (see drive unit photo below). Otherwise a drive unit replacement will be necessary.

Trim Drive Unit mounted inside each Elevator (Right Drive Unit Shown)

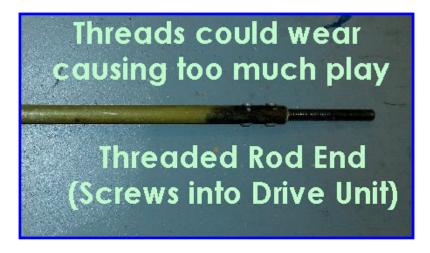
3- Threads on the trim tab rods or inside the drive units are worn. Threaded rod or drive unit replacement might be necessary. The thread should be a standard 1/4-20 thread.
