Control Wheel Play Elimination

Description: There have been Seabees that have an inordinate amount of up-and-down play in the control wheels. The movement is noticed when the Control Tube is held while the Control Wheel is lifted up and down. If you notice excessive "play" the three bolts holding the Control Wheel Housing (RPN 1211) may have elongated the holes in the Control Wheel Tube (RPN 1218 or 1441 depending on A/C serial number) running through the instrument panel. Although not a safety hazard unless the three bolts come completely out of the tube, too much play in any flight control system is never good and will only get worse with time. If you notice unwanted play in the control wheels this procedure may help.

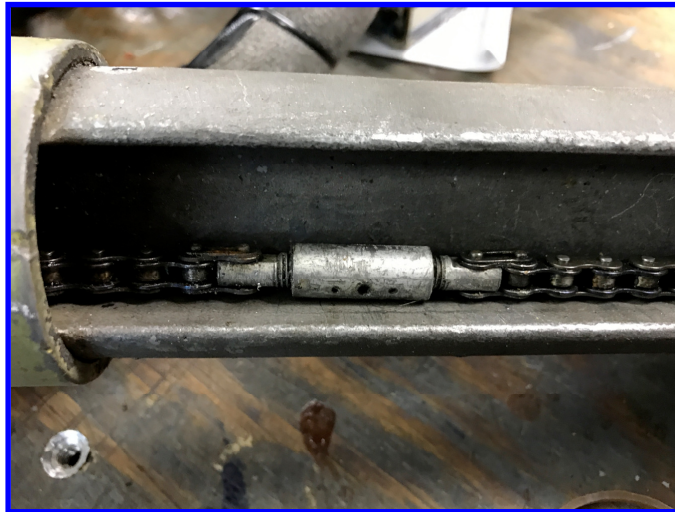
Control Arm cover removed showing turnbuckle and chain.
Safety wire removed.

- ☐ Remove the copilot's control wheel and stow it
- ☐ Remove the eight (8) screws holding the Control Wheel Arm Cover (RPN 1212)
- ☐ Remove the cover
- ☐ Remove the safety wire from the Control Wheel Chain (RPN 1208) turnbuckle
- ☐ Unscrew the turnbuckle barrel and remove the chain taking care removing it around the center sprocket

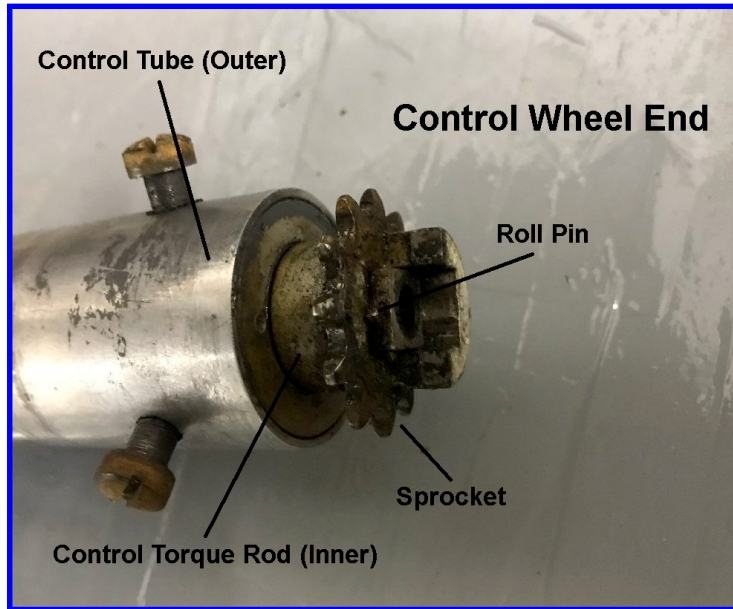
Control Wheel End of Control Tube removed. Note 1/16" roll pin.

- ☐ Remove the safety wire securing the three 1/4-28 Housing Bolts
- ☐ Remove the three bolts
- ☐ Pull the Pilot's Control Wheel and Control Wheel Housing straight aft to remove it. This will expose the sprocket and the three threaded holes on the Control Wheel Tube that need attention.

Note: There is a Torque Rod inside the Control Tube that is very close to the inner side of the Tube. Care must be taken if you are using option 1 or 2 to keep the Locktite or JB Weld away from the torque rod. Using JB Weld, Apply **ONLY** to the hole threads. Using Locktite apply to the first two threads on the bolts only.

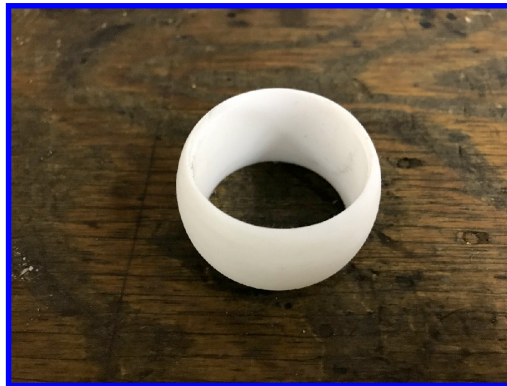
Teflon Control Tube Bearing

Note: This may be a good time to replace the phenolic Control Wheel Tube Bearing (RPN 1163) that supports the Tube. There is Teflon replacement bearings available that make the Control Tube slide effortlessly through the instrument panel. No lubrication is needed nor wanted. You should also polish the Control Tube to a mirror finish that will reduce the effort required to pull the controls aft plus, it really looks good when you are done.

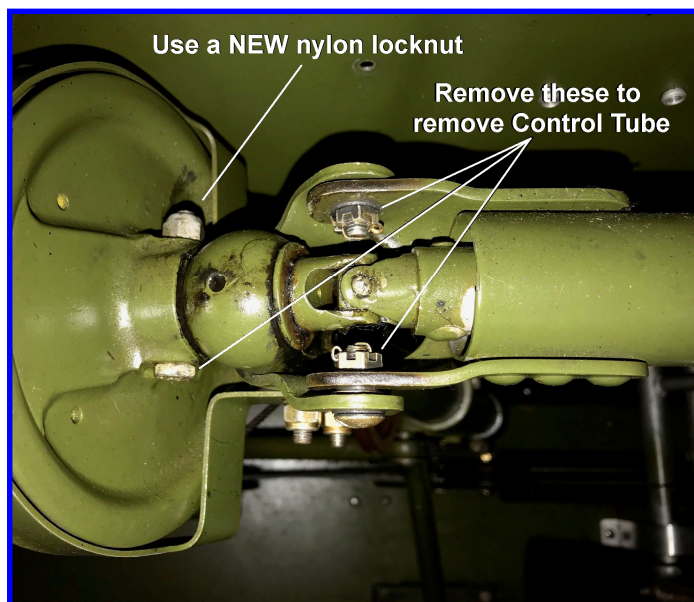
Control Tube shown in place. Three bolts will allow removal of Control Tube.
USE A NEW NYLON LOCKNUT ON THE AILERON PULLEY!

Warning: Use a NEW elastic stop nut for the aileron pulley bolt

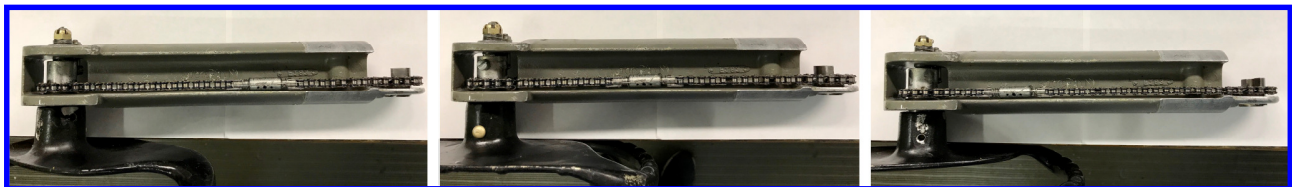
Full Right Aileron

Turnbuckles in correct position
Aileron Centered

Full Left Aileron

- ☐ Safety the three bolts together with one piece of .032" safety wire
- ☐ Lubricate the chain and both sprockets (drive end and control wheel end)
- ☐ Neutralize the ailerons and feed the chain through the Housing so that the turnbuckle is on the top and in the center of the Control Arm channel
- ☐ Tighten the turnbuckle just until the slack is taken up in the chain, not too tight! There should be a slight vertical slack in the chain but not enough that the chain could jump off the sprocket

- ☐ Move the aileron controls full travel each way and check for accuracy and binding. The turnbuckle should not touch the sprockets.
- ☐ Safety the turnbuckle using .025" safety wire (see photo on page 2)
- ☐ Replace Control Arm Cover
- ☐ Install copilot's control wheel
- ☐ Check that all controls work correctly through their full travel with no binding
- ☐ Replace the forward instrument panel top covers
- ☐ Make a logbook entry
