## **WING-ADECTOMY (or How to open your wing)**

**Note:** This procedure explains how to open the wing for inspection, cleaning or replacement of various internal parts. It is very time consuming and requires the advice and guidance of a certified A&P (AME) mechanic that knows about riveting and structural aircraft components. Do not undertake this without their help!

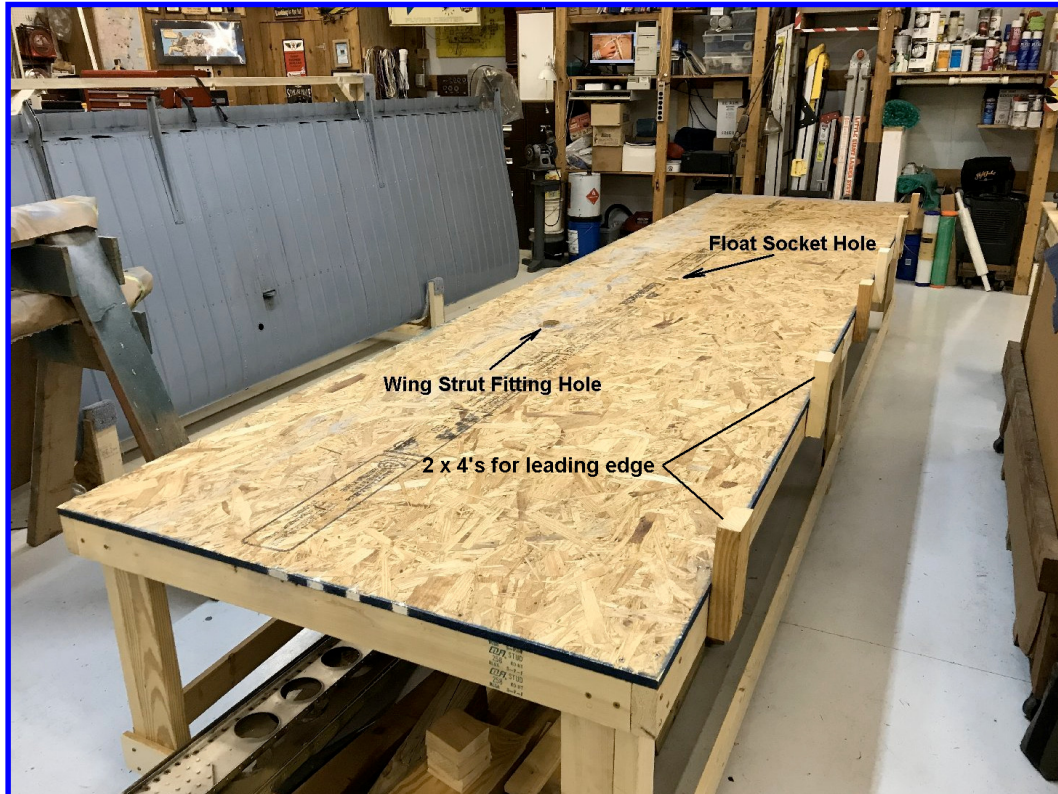
Wing table – Notice 2 x 4's for holding the leading edge in place and holes for fittings.

First, a flat, 16-foot table was to be made. Two four by eight OSB (particle board) sheets on top of a 2 x 4 frame did the trick. It stands about 34 inches high and is completely flat. Two holes were drilled into the top of the table to allow the float strut fitting and the wing strut fitting to sit down into. This allowed the wing to sit flat on the table. Cost? About \$75 USD.

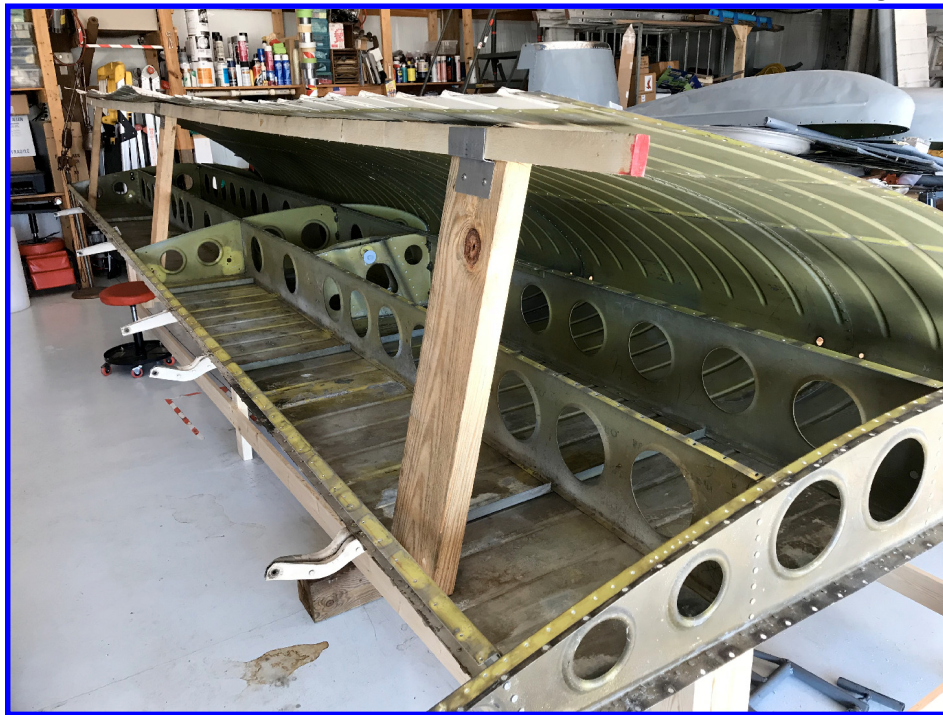
Wing opened up on the wing table. This allows full access to everything.

Once all the rivets were removed a 24-inch wood support was made to hold up the wing skin so that cleaning and painting could begin (see photo above). When I first opened it I was shocked at the amount of wildlife remains that were in there. There was a slight amount of surface corrosion on some sections of the lower wing skin but very little on the upper wing skin, which was a relief. The cleaning process soon began.

I initially removed all the grass and hay that the birds used for their nests and vacuumed the wing completely. Stubborn "stains" were removed with a hot water mix of soap (Dawn Liquid) and a green Scotchbrite pad (the red ones are too coarse). Each "bay" of the wing was cleaned and scrubbed to remove the surface corrosion and then cleaned with lacquer thinner and treated with Alodine in the spots that were bare aluminum.

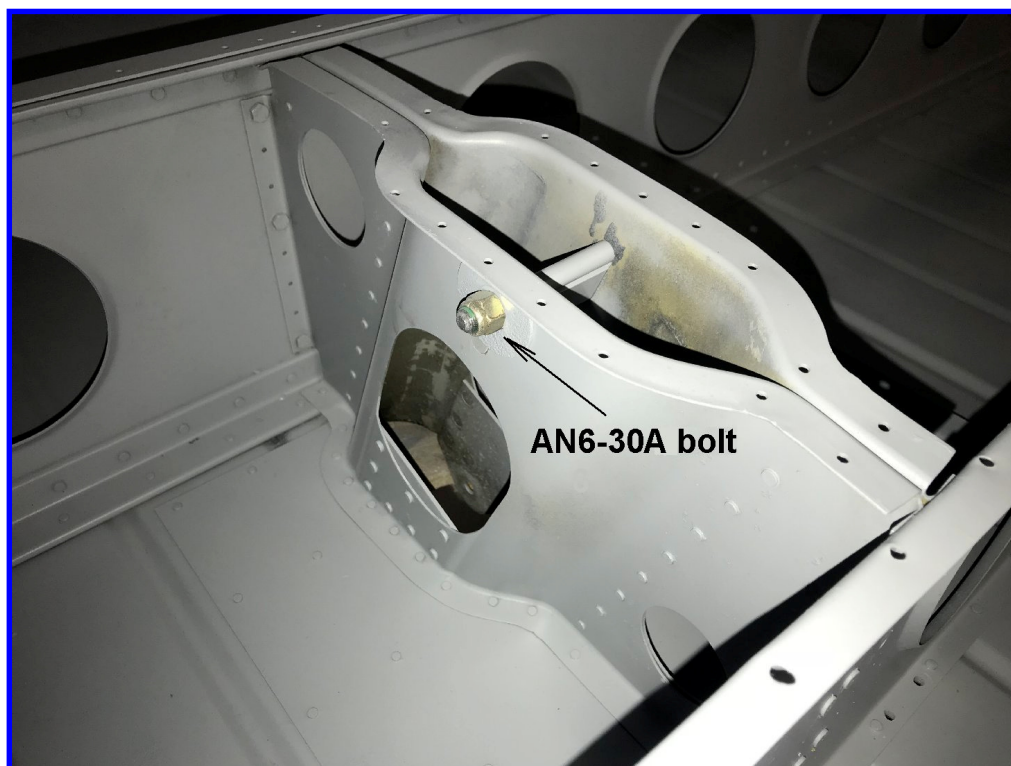
Wing Float Socket with bolt and the "key" below the bolt.

The aileron bellcrank and flap hydraulic systems were removed for cleaning, painting and replacement. With the wing totally exposed like this, it made it much easier to inspect and replace inner components that would have been a nightmare otherwise. All steel hardware was replaced as the years of exposure caused much rusting of those parts. The navigation light wire was also replaced as the original wire was frayed and seemed to be a fabric covered wire not suitable by today's standards. The float strut socket hardware was removed and painted and the bolt holding the float strut "key" was replaced. This bolt is an AN6-30A bolt and could never be replaced any other way. Two large AN970-6 washers are used on the outside of the socket to hold the "key" in place.

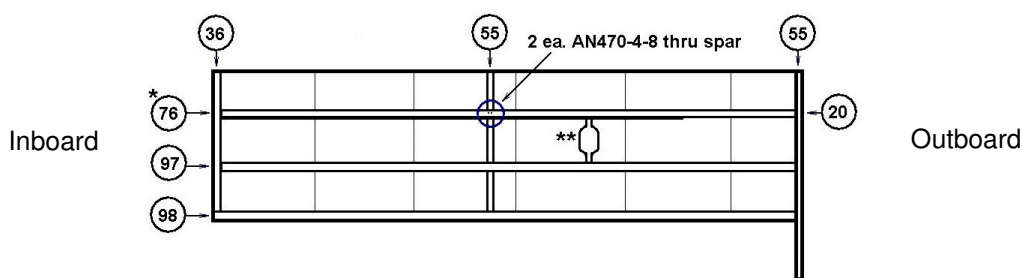
### Wing Rivet Count

Forward Spar	- .065" - AN442-4-8 - 76 ea. (1 ea. - AN442-4-8 at root)
Forward Outboard Spar	- .065" - AN442-4-5 - 20 ea.
Middle Spar	- .035" - AN442-4-4 - 97 ea.
Aft Spar	- .050" - AN442-4-5 - 98 ea.
Wing Tip	- .040" - AN470-4-4 - 98 ea.
Root Rib	- .055" - AN470-4-5 - 36 ea.
Float Socket	- .050" - AN470-4-4 - 36 ea.
Center Rib	- .055" - AN470-4-5 aft of forward spar - 70 ea. CR3213-4-2 on forward center rib - 17 ea.
Root Rib Nut Plates	- .156" - AN470-3-4 - 16 ea.
Float Strut Fitting	- .055" - CR3213-4-2 - 16 ea.

- (76) = Rivet Count per Spar/Rib  
 Center Nose Rib must be CherryMax Rivets  
 \* = From root to end of spar doubler  
 \*\* = Float Strut Socket  
 Root Rib has 8 Anchor Nuts (16 AN470-3-4 rivets)  
 Cherry Max CR3213 = Nominal. CR3243 = 1/64" oversize.

It was now time to reset the wing skin onto the ribs and spars. Clekoed in place, a rivet count was done and the rivet gauge was used to determine the rivet "grip" (your rivet count may be different). See rivet count drawing above.

The riveting began at the main, forward spar working from the middle out toward the ends of the wing (This was the hardest part). Putting most of your upper body inside the wing and holding the bucking bar in place provides the best access to the "shop" end of the rivet. A Cleko was removed, an AN442AD rivet was installed and so on until all the rivets were installed in the spar. There is 1/8" angle reinforcement along the upper part of the forward spar that requires longer rivets than the remaining forward spar (see drawing above).

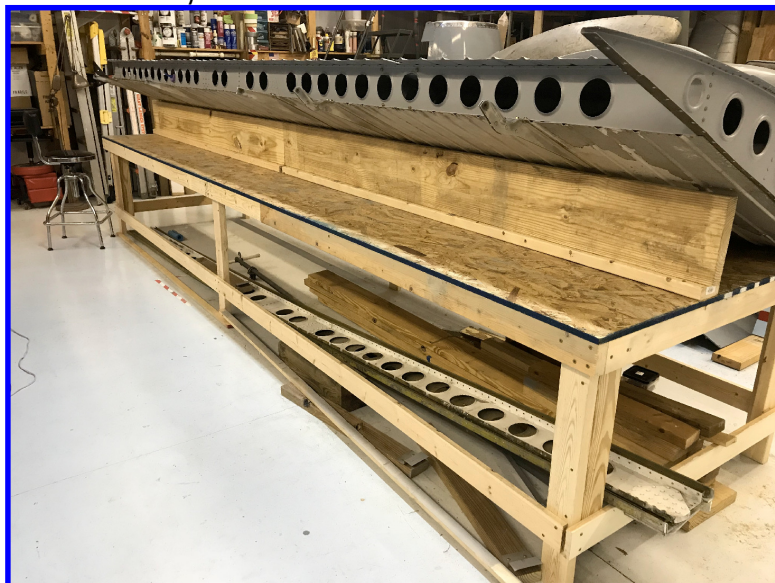
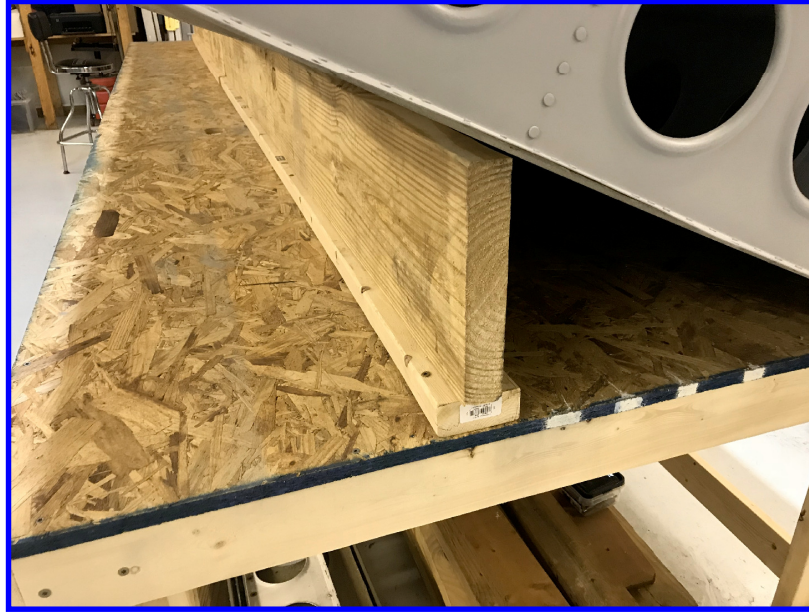
End view of wing support for aft spar installation.  
(2 ea. 2 x 8 and 2 ea. 2 x 4)

The wing support is simply two 2 x 4's screwed to the bottom of two 2 x 8's. The smaller length lumber is much easier to handle as it is much lighter. This provided excellent wing support for installing the aft spar. Remember to put the small, 8-inch 2 x 4's on the wing table edge to prevent the wing leading edge from sliding and screw in the 2 x 4 support to the table. The aft spar can then be riveted using a rivet squeezer. If you don't have a rivet squeezer, get one! They are indispensable if you do any riveting at all. The rivets on the end of the aft spar that attach to the end ribs are AN442AD-5 rivets, which are larger than the wing spar rivets. These must be driven as a squeezer will not work.

After the forward and center spars were riveted the aft spar had to be installed. A 2" x 8" wing support was made to assist in access to the lower part of the aft spar (see photo below).

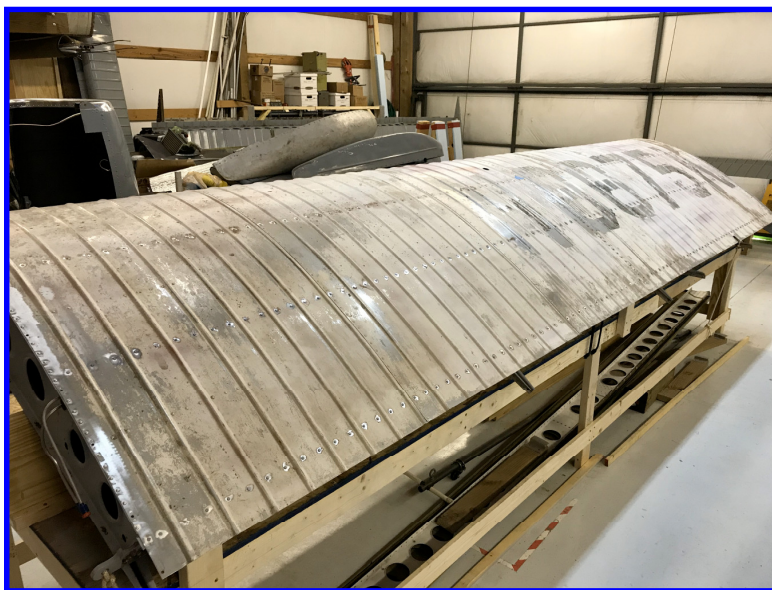
Completed wing!!

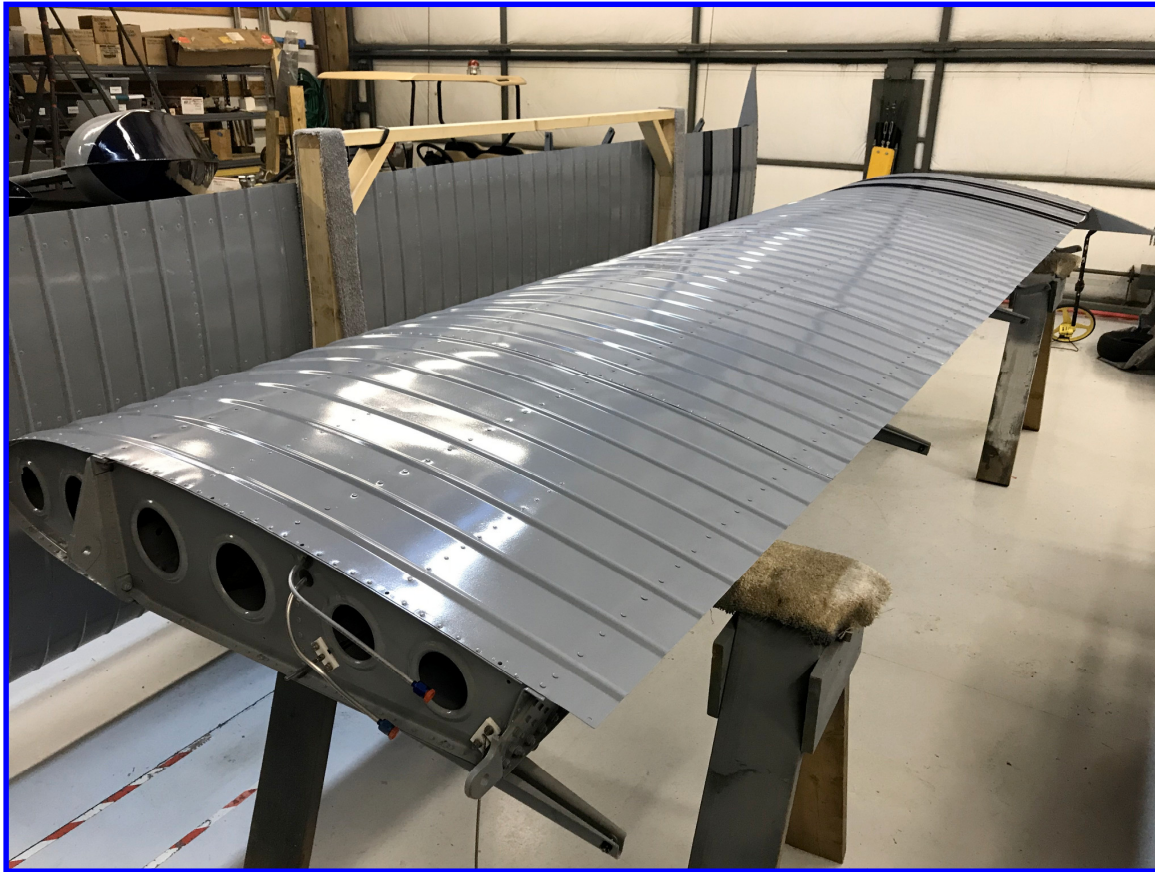
Completed painted wing
