MAJOR REPAIR AND ALTERATION (Airframe, Powerplant, Propeller, or Appliance)

1. Aircraft	Make Republic	Model RC-3
	Serial No. 1000	Nationality and Registration Mark N5166B
2. Owner	Name (As shown on registration certificate) Davey Darrell L Davey Deborah A	
	Address (As shown on registration certificate) 6613 Santa Rosa Rd Camarillo Ca 93012-5672

Republic RC-3 N5166B Ser.# 1000

Elevator Trim

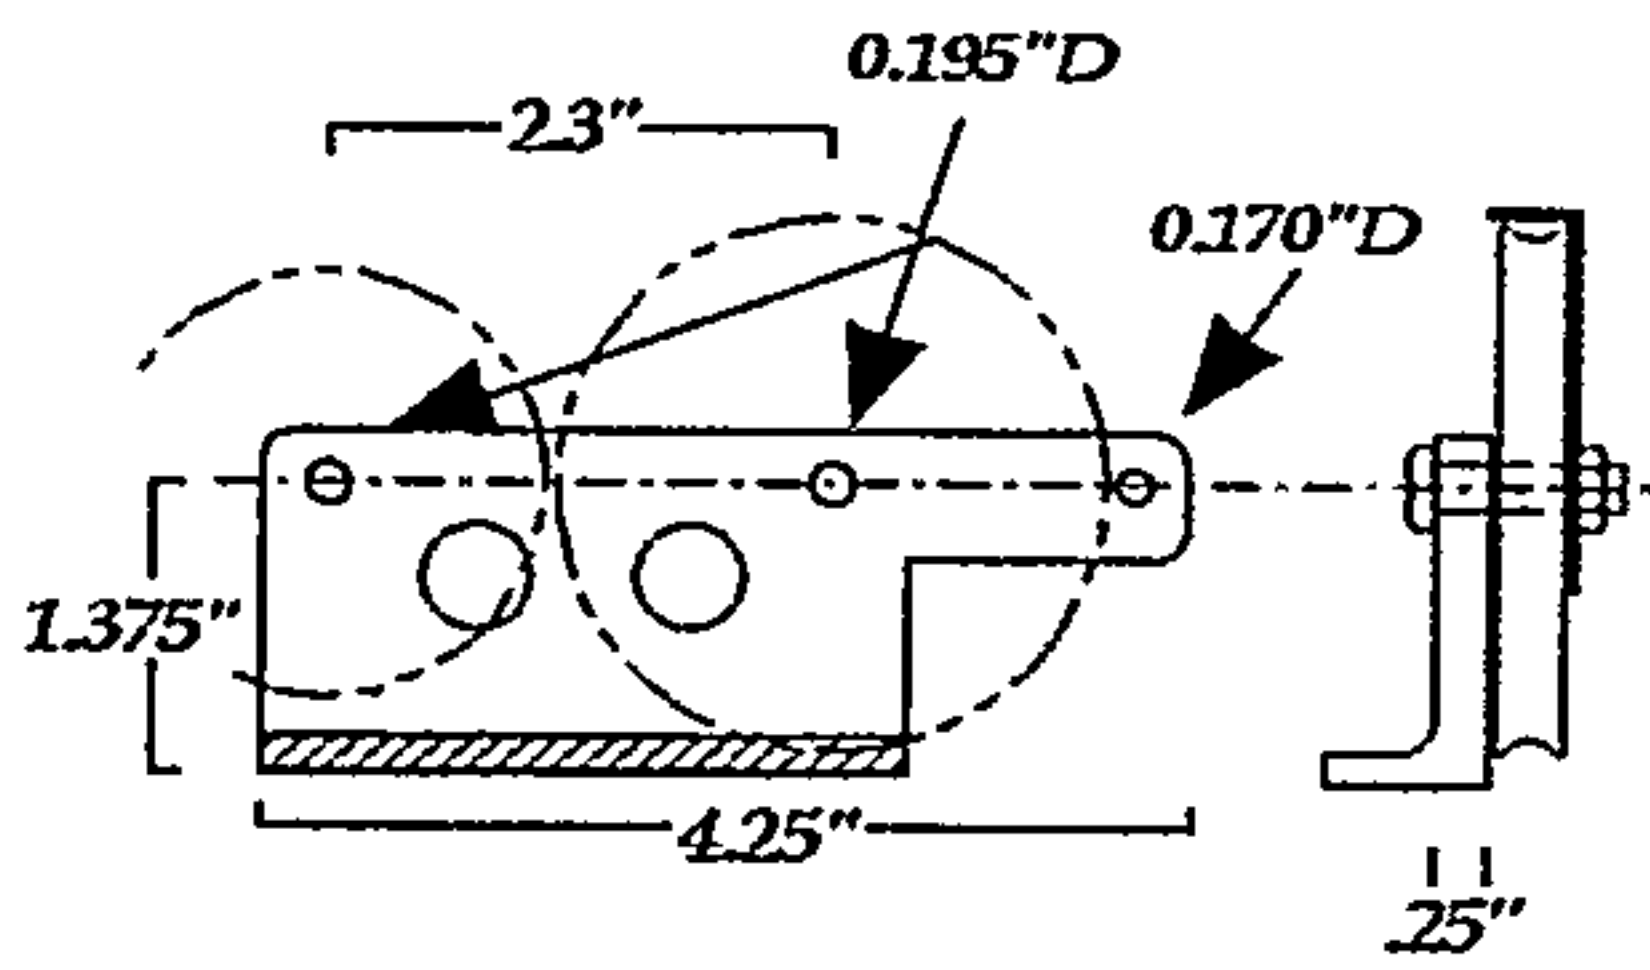
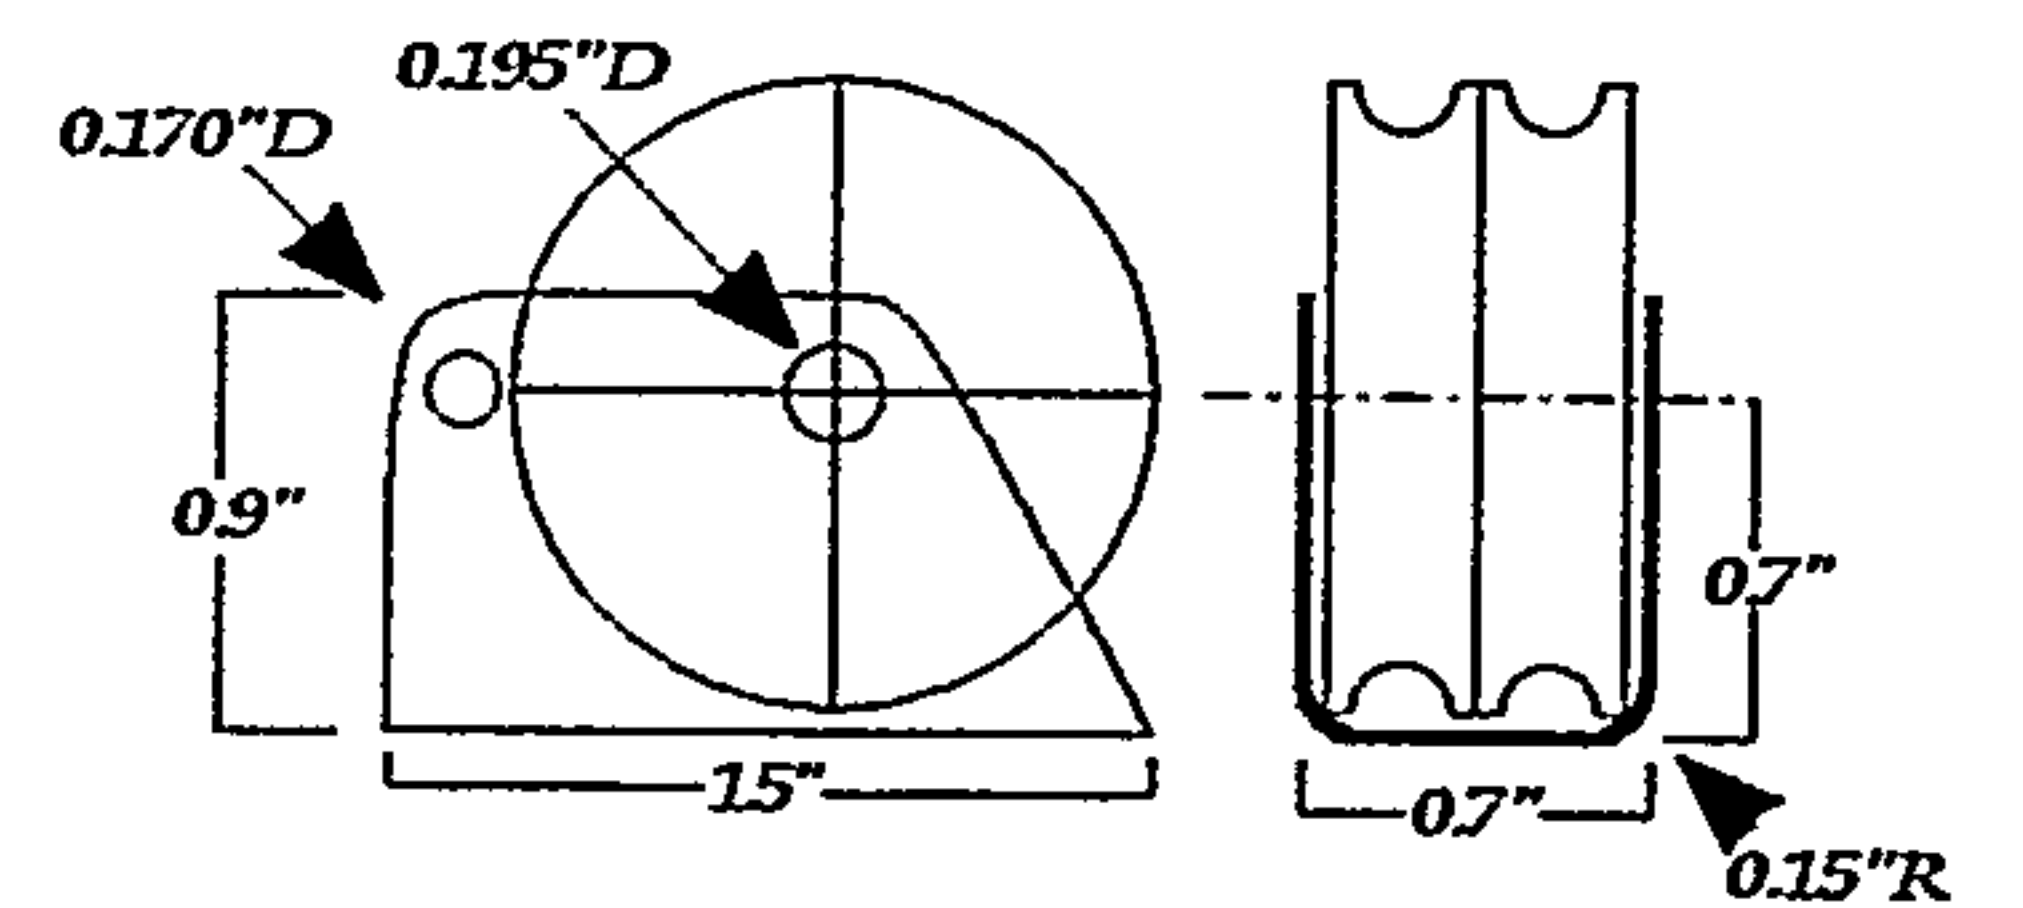
2. Description: Modified elevator trim control by removing original trim control from top of cabin to instrument panel. Installed Cessna P/N 0510127-2 Wheel, tab control and Cessna P/N 0432134-1 Sprocket, tab control on .250" 303 stainless steel shaft with roll pins, Cessna P/N NAS561P3-4, mounted with Torrington bearings, Cessna P/N M-451 (2ea.), in brackets fabricated from .250" 6061 T6 aluminum plate and secured to instrument panel with MS24693C screws. Trim position indicator fabricated from 1/16" welding rod and attached to trim wheel position follower fabricated from .040 2024 T3 aluminum sheet. Position indicator is held in place with groove cut in avionics mounting support. Trim control cable, 1/16" stainless flexible control cable conforming to MIL-W-83420, is attached to trim control chain, Cessna P/N 0432138-7, with modified MS21260-S2RH swage end turnbuckle end. Trim control cables are protected underneath instrument panel with enclosure panel, fabricated from .032 317 stainless steel. Trim control cables are routed down thru cabin floor with 2 ea. MS24566-2B control pulleys mounted on 6061 T6, 1 1/2" X 1 1/2" X 1/4" extruded aluminum 90 deg. angle, and bolted to cabin floor with 2 ea. AN3 bolts. Trim control cable routed at bulkhead #4 thru pulleys, Cessna P/N S-378-1(2 ea.), mounted in bracket fabricated from .032 303 stainless steel and attached to bulkhead with AN3 (2 ea.) bolts. Trim control cables attaches to original aft control chain with modified MS21260-S2RH swage end turnbuckle end. Elevator trim control gear box and attachment to trim tabs unchanged.

Blue - Original Routing of Trim Control
 Red - Modified Trim Control Routing
