## **Tail Wheel Microswitch**

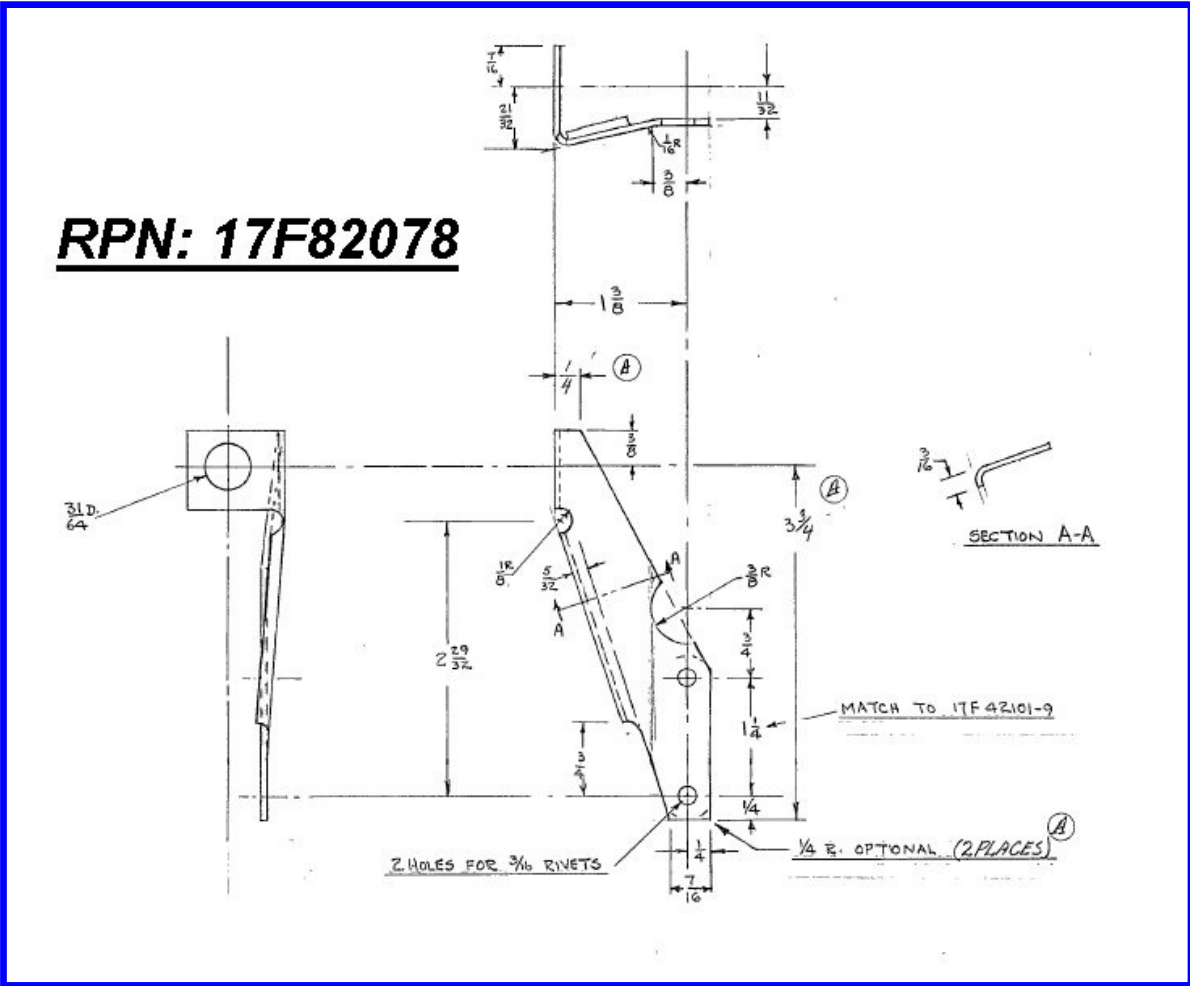
Original Republic Drawing-Microswitch Bracket

It turns out that there was another issue with the microswitch; the bracket holding the switch was bent (see photo below). This, along with the above symptom, must have caused the tail wheel mechanism to “jam up”. Please check your microswitch and bracket. Unfortunately the bracket may be riveted to the control arm of the tail wheel mechanism. You may have to remove the lower linkage of the mechanism to straighten it out or replace it (see drawing page 5).

If you find that no matter how tight the lock nuts are on your switch and your switch still rotates, you may need to change the “cage” around the switch. This is a separate part (with the loose collar) and is still available from Honeywell (Part No. MC2711 or AN3168-2). The microswitch is also available (Part No. BZ-2R-A2).
