<u>The Marty B II</u>

Unless otherwise noted photos and article by Steve Mestler

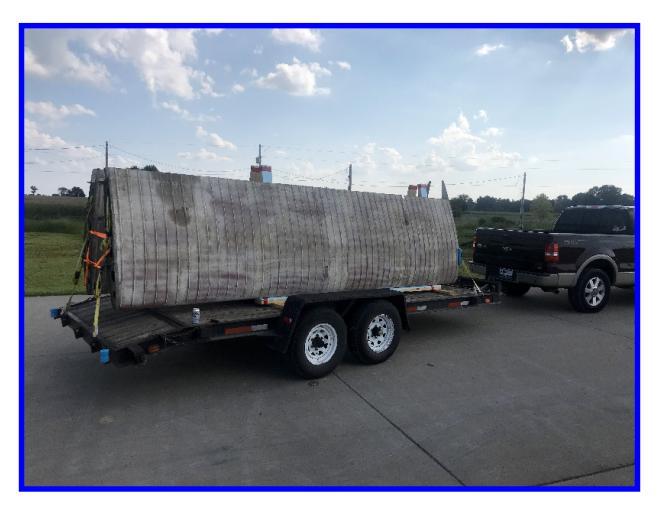
The "standard" wings in Kentucky

aforementioned consternation that we will shorten the good wing and get another standard wing.

Getting the other wing was a non-issue thanks to another Seabee owner that had one I could buy. After negotiations the wing was on its way to Whiteplains via Kentucky. He was (and is) a real lifesaver.

So, to shorten the left wing was an easy job; drill out all the extension rivets and put the end rib back were it was 35 years prior. The flap hinges and aileron hinges had to be repositioned back to the original positions and that was pretty much it.

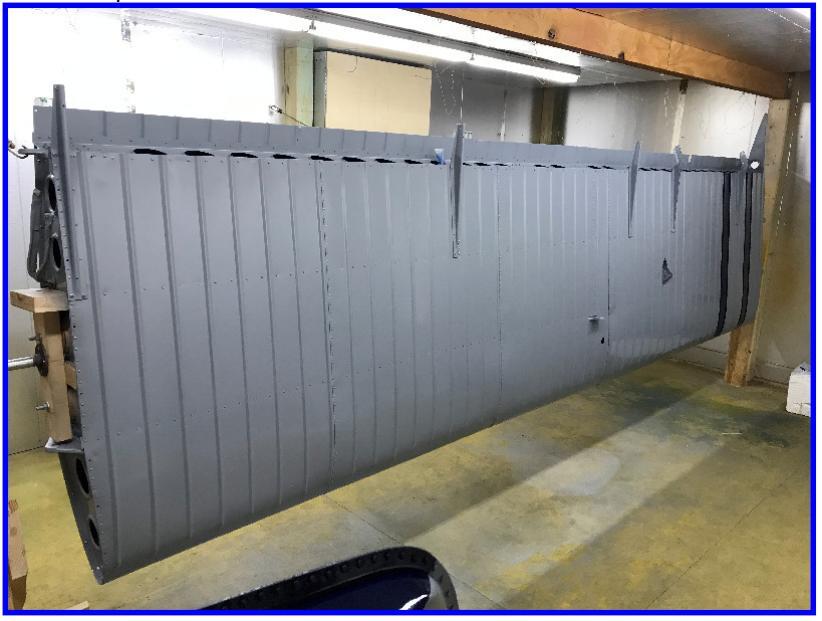
Completed wing panel at an undisclosed location

When the "new" wing and flaps were cleaned and primed it was time to paint. The original paint used in 1986 was Dupont Centari; an acrylic enamel I had used before which works really well. Due to EPA restrictions Dupont stopped making it (of course). Acrylic enamel is still available but it isn't as forgiving as the Centari paint. We used it anyway. The colors matched pretty close and the finish is totally acceptable. Blue stripes were added like the original and the wing assemblies were complete.

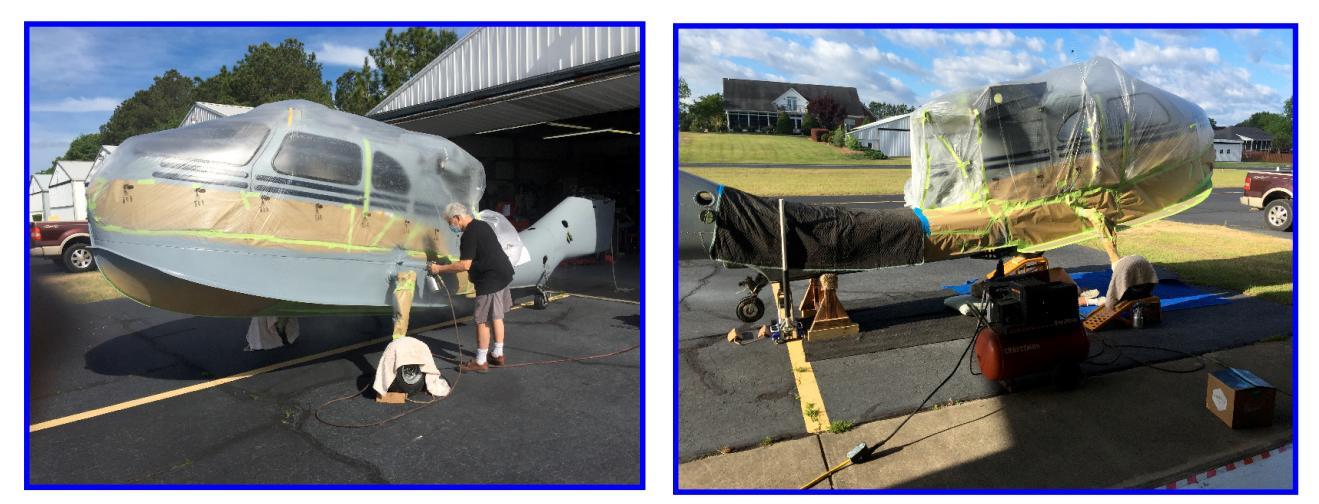
Our expert painter at work...

...now the hull bottom

Oh Yea, the painting. The Seabee hull sits only inches from the ground. How are we going to get enough room underneath to spray the hull? After masking the upper half of the Seabee off, we took it outside and painted the gray part. The blue part would come later. After the gray paint set, we masked off the top from the spray rail edge up to get the hull ready for paint. The tail was jacked up and a small hull stand was put in place under the tail then each wheel was jacked up and put on automobile ramps and chocked. The struts were inflated to full length (10.5"). This gave us plenty of room for spraying the hull from underneath. The painting was excellent! Now the engine...

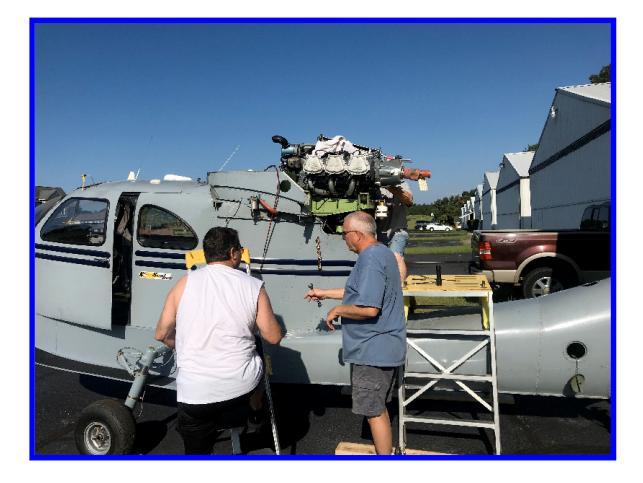
The "Seabee Army" hanging the engine

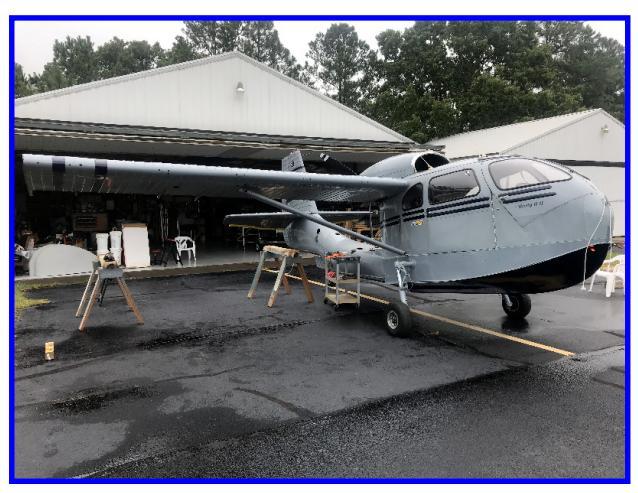
Left wing on...

Right wing on! Yes we malletized this one.

needed to be moved to the Seabee hangar. One wing panel at a time, on the back of a truck, came up the steep embankment on their way to the fuselage. One rider was in the back of the truck holding the wing from shifting and driving at 5 MPH we made it safely to the installation site. The right wing was first. I figured it was a new wing for the Seabee and if we were going to have problems it would be here. The wing is mounted to the airframe spar carry-throughs first with two large (AN10) bolts through the fittings. For some reason Republic has a large bushing that goes into the rear spar after the wing is in place then the bolt can be installed. The forward bolt can then be slammed into place. One guy holds the wing strut goes in the lower fuselage fitting first and then pushed up into the upper strut fitting. Other than an alignment problem with the upper fitting the wing went on fairly easily. Bolts were installed and tightened.

Now for the left wing: I thought the left wing would be easier...NOT SO AVGAS BREATH! The left wing was the "good" wing but gave us a little trouble with alignment. Much moaning and groaning was apparent during this process but eventually both wings were on and secure. It was looking like a Seabee!
