MAJOR REPAIR AND ALTERATION
(Airframe, Powerplant, Propeller, or Appliance)

1. Aircraft	Make Republic	Model RC-3 Seabee
	Serial No. 462	Nationality and Registration Mark N6255K
2. Owner	Name (As shown on registration certificate) Robert Allen Gould	Address (As shown on registration certificate) 44-365 Kaneohe Bay Drive Kaneohe, HI 96744-2664

1. Installed Precise Flight, Inc. Pulselite Control Unit in the landing light system in accordance with Precise Flight Installation instructions No. PPRI-1000, Rev #5, and PPRI-2000, both dated 14 July, 1987 and PPRI-3000 dated 4 April, 1989 as per Supplemental Type Certificate Number SA4005NM.
2. Control Unit attached to aircraft sidewall at Station 21 per drawing #1.
3. System wired in accordance with Precise Flight, Inc. drawing number OOP019M dated 3-24-89 and drawing #1 (attached)
4. Functional and operation checked. The installation has been inspected and found to not adversely affect the airworthiness of the aircraft.
5. Weight and balance data to be incorporated into the Equipment List.

DRAWING #1

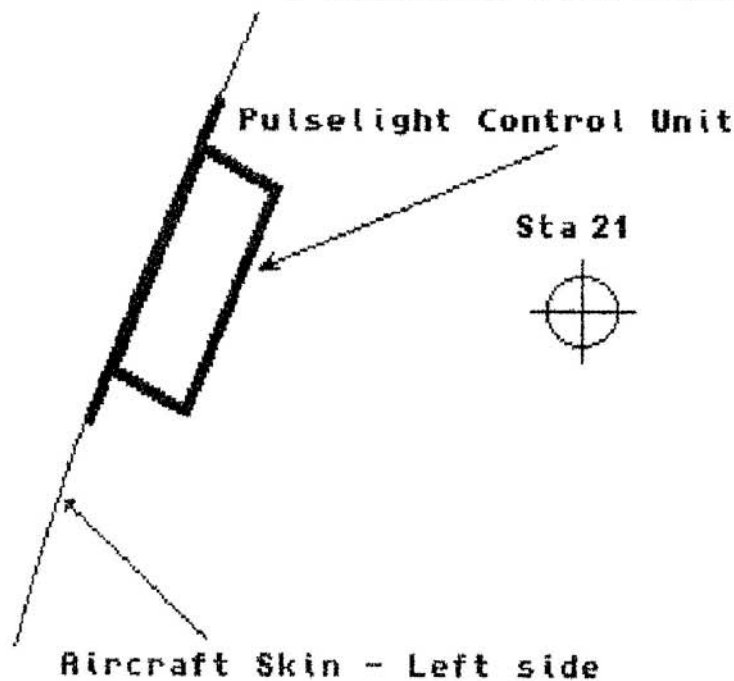
Pulselite installation

TYPICAL AIRCRAFT WITH 2 LIGHTS CONTROLLED BY 2 SWITCHES CONNECTED TO 2 CHANNELS (YELLOW AND BLUE WIRES)
