Seabee

SEABEE CLUB INTERNATIONAL
NEWSLETTER

No. 9 (July 1986)

Dedicated to the preservation and enjoyment of our 40-year old water-borne wind-wagons, the RC-3.

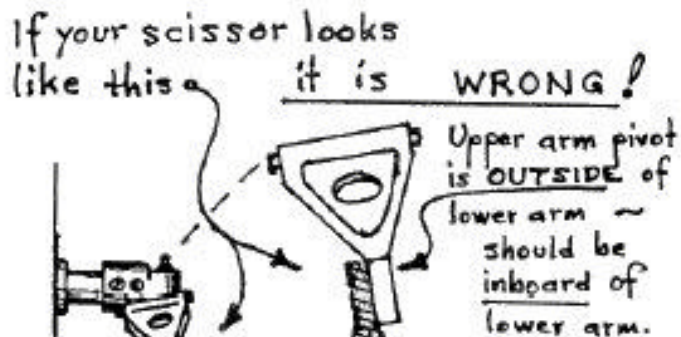
"Bottom out"
 LH or RH gear

Correcting a WRONG configuration will eliminate the "toe-in" of the wheel, thereby reducing both tire wear and the tendency to ground loop in a crosswind. REMEMBER: the bottom scissor pivot should be OUTSIDE.

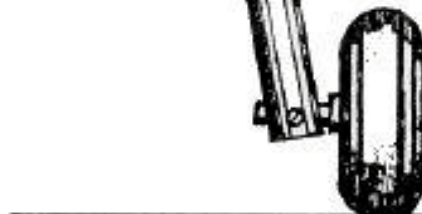
TO CORRECT:
 Remove the upper and lower attach bolts and turn the scissors upside down. Replace bolts.

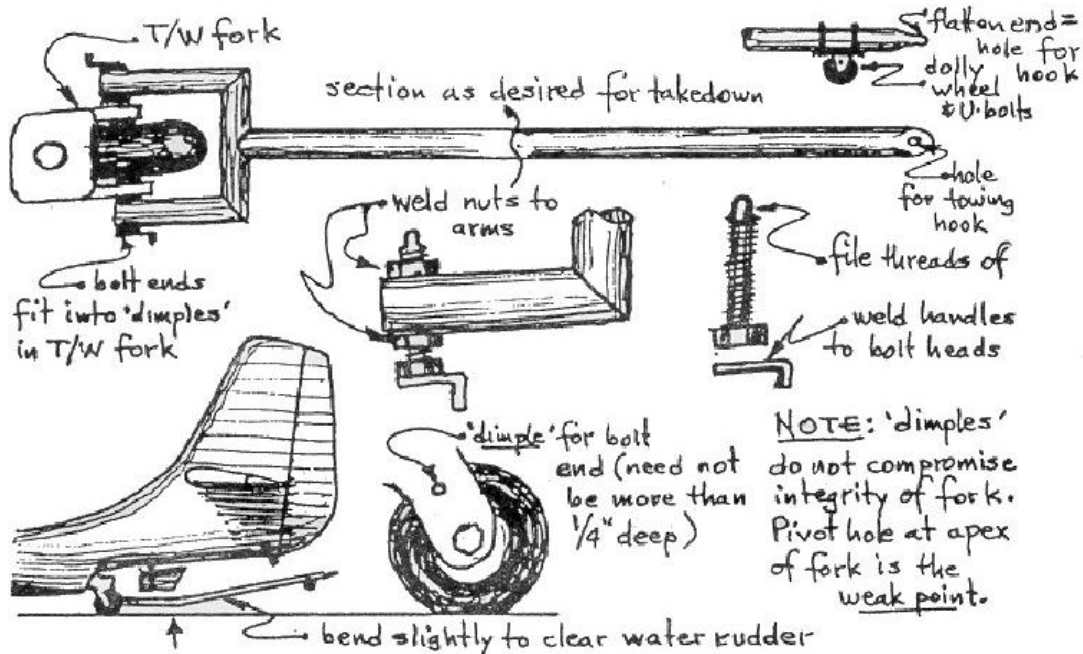
TAILWHEEL TOWBAR: If you hangar your 'Bee, and we wish everyone could protect his 'Bee that well, one of the most useful items to have is a towbar. A friend made one for me years ago and I could not imagine having to do without it. In fact, when I moved from the Dallas/Ft Worth area to Ft Lauderdale, I had to bring it in the plane with me so that I wouldn't have to be without it when we arrived. That towbar is 9' long, made of heavy plumbing pipe, and weighs 20 lbs. How did I get it into the poor ol' 'Bee? I sectioned the towbar so that it would be in shorter lengths. Does that emphasize its importance? But, if given the chance, I'd make it of much lighter material. If it were constructed of aluminum tube, or square tube, it'd be a fraction of that weight. And I'd section it into lengths that would fit sideways in the baggage compartment, or secured to the rear frame of the front seat. The rather simple drawing will give you an idea of what's involved. The "dimples" in the T/W fork are NOT compromising the integrity. If you landed so hard on the T/W as to break something, that something would be around the pivot bolt hole in the T/W fork. That's the weak point.

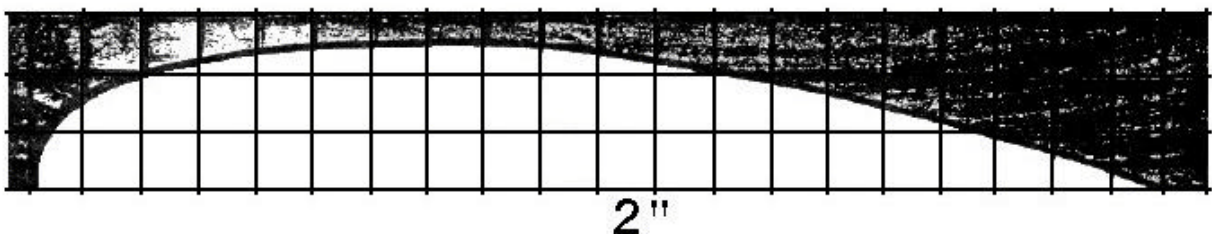
WING PLATFORMS are also indispensable pieces of equipment for your 'Bee. Years ago I made two, covered them with padded carpeting, and they've prevented an untold number of scratches and dings on top of the wings whenever the engine needed working on. Using as a guide the blueprint-style drawing shown in Republic Service News #1, p2, I modified them to be much lighter and easier to move and store. Reducing the width and height saved a large percent of the total weight without compromising their usefulness. When not in use, they're hanging from hooks on the hangar wall. The contour of the wing is given in the "blueprint" and the construction is done quite simply, with only basic tools. Additionally, here's a pictorial graph-like wing contour illustration, contributed by Ted Lissauer, s/n 482, in Kentucky. As noted, the squares are of 2" sides that you can transpose measurements from directly. Once you've used the platforms, you'll agree that they are indeed indispensable. And your wings will thank you.
