# SERVICE BULLETIN

SERVICE BULLETIN NO. 2

## REPLACEMENT OF INDUCTION SYSTEM BACKFIRE SCREEN

Reason for Change: To meet latest C.A.A. (FAA) requirements for backfire screens.

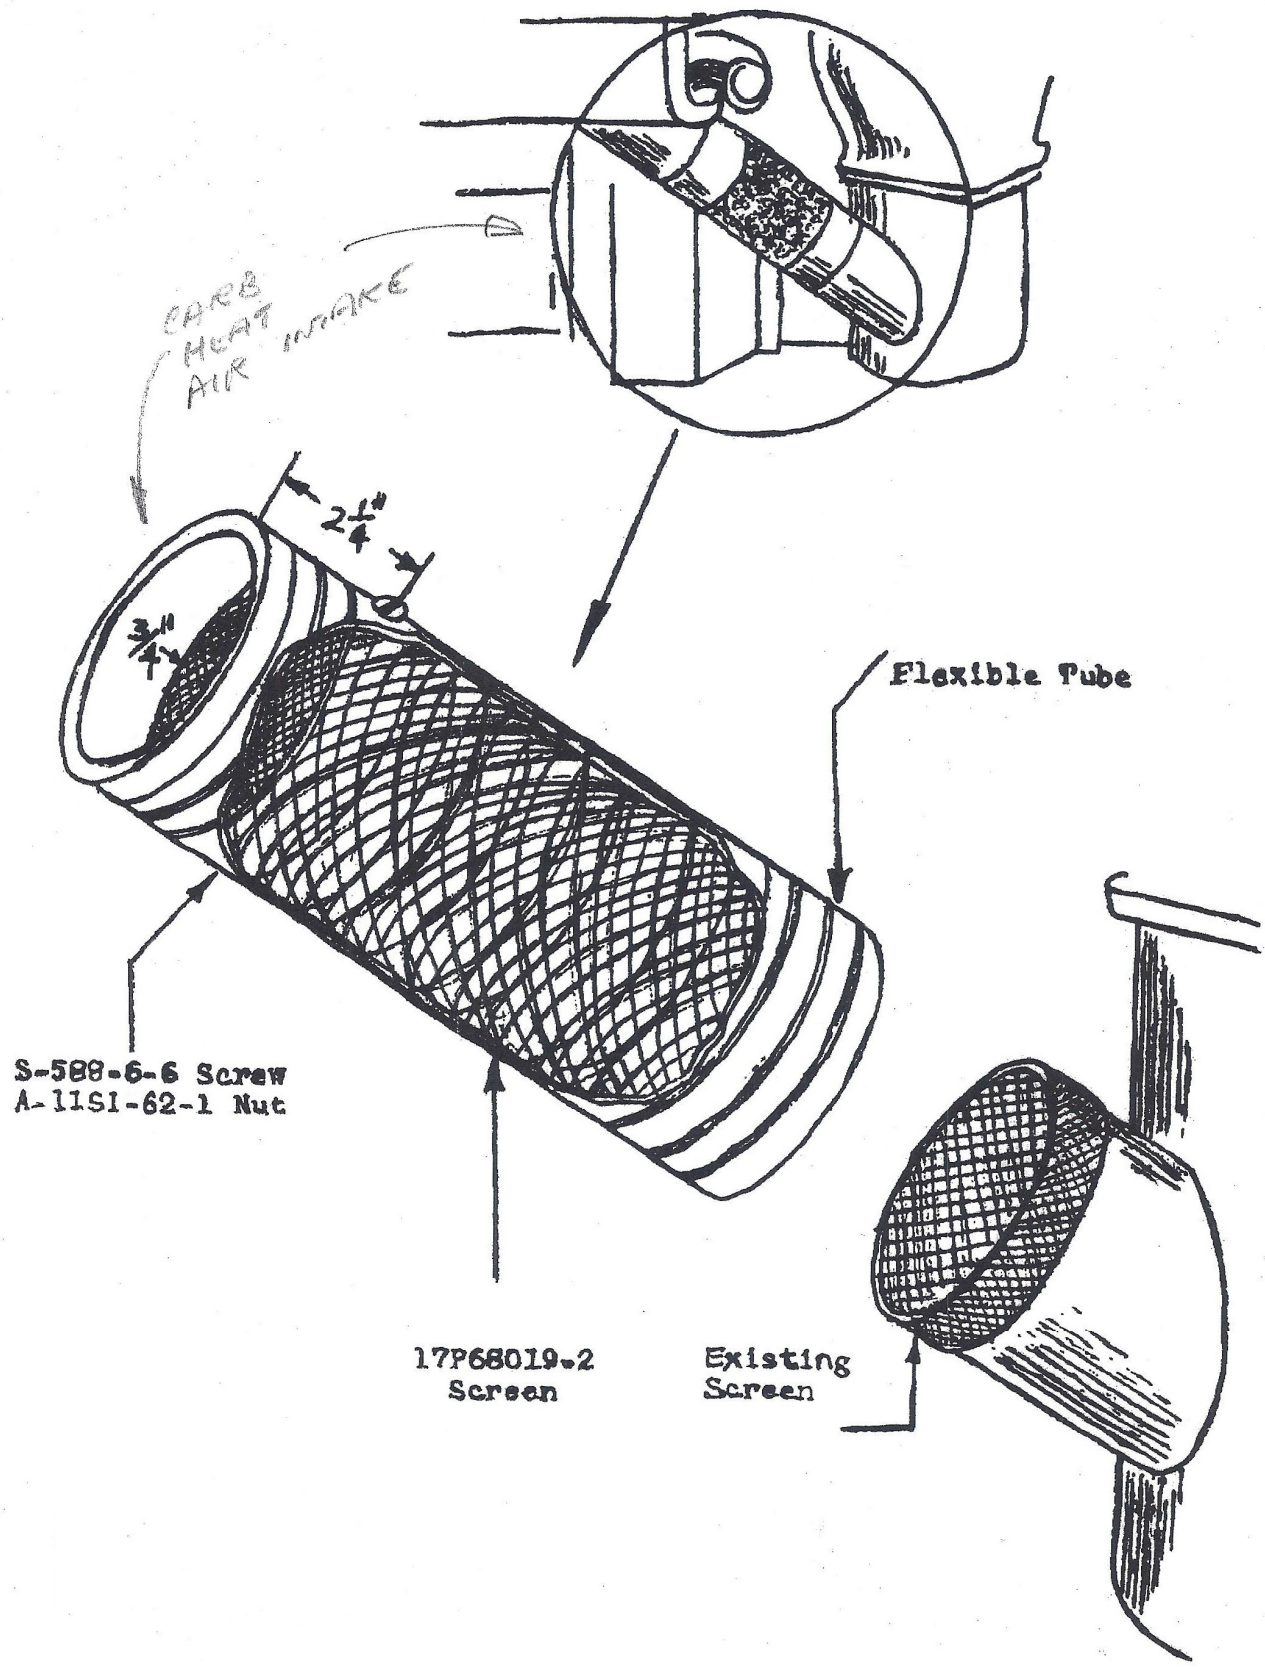
This change involves removing the flexible tube between the hot air shroud on the manifold and the carburetor intake duct, installing the new backfire screen in this tube and reinstalling the assembly and shall be accomplished as follows:

1. Open engine cowl.
2. Remove lower left engine cowl.
3. Remove five (5) screws from the flexible hot air tube assembly. This is located on the left side between the hot air shroud on the exhaust manifold and the carburetor intake duct.
4. Remove four (4) screws from heat shroud around exhaust.
5. Remove tape from crankcase breather line.
6. Slip hot air tube from the exhaust shroud and the carburetor air box.
7. Remove existing screen from flexible hot air tube.
8. Drill two (2) 1/8" diameter holes on opposite sides of the flexible hot air tube, 2 1/4" from the outboard (intake) end.

9. Install new type screen with the flush end at the carburetor air duct end of hot air tube, locating it so that no interference will exist with the carburetor air duct or the old screen which will be reinstalled. Attach screen to tube with two (2) S-589-6-6 self tapping screws and A-1181-62-1 Tinnerman nuts using holes just drilled. Refer to Fig. 1.
10. Reinstall cold screen.
11. Install hot air tube on carburetor air duct and exhaust shroud and attach with original hardware.
12. Attach exhaust shroud to its brackets with original hardware.
13. Secure the crankcase breather line to the intake manifold with friction tape and shellac.
14. Reinstall cowling.
15. Enter modification in engine log book.
